# CONDITION ASSESSMENT REPORT

## THE LINCOLN HIGHWAY HERITAGE CORRIDOR

3435 State Route 30 East  
Latrobe, Westmoreland County, Pennsylvania

Abbreviated  
Condition Assessment Report  
Alexander Johnston's "Kingston House"

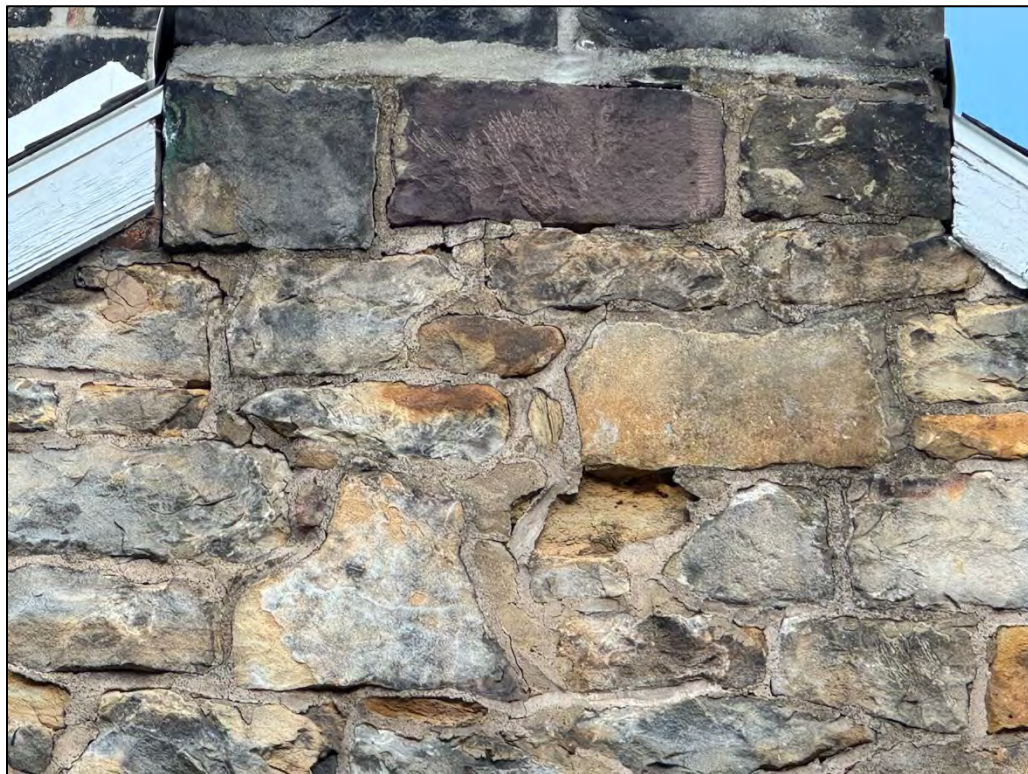
*Plate 23. South Elevation, base of gable end chimney. Note the deteriorated stone and incompatible mortar.*

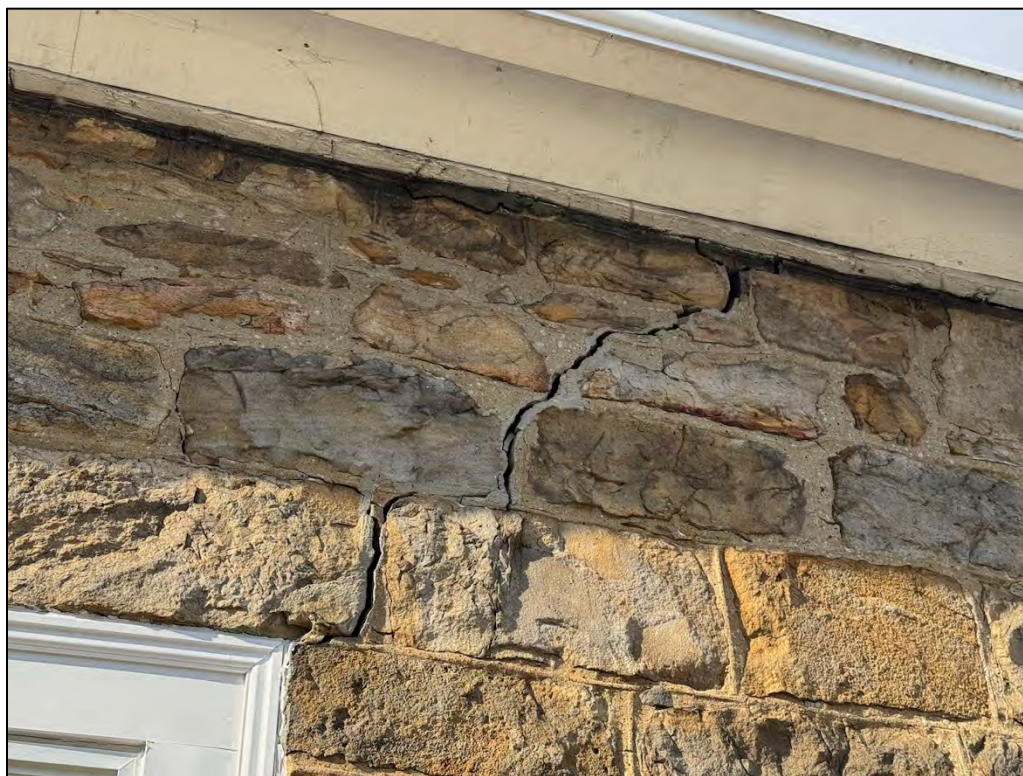
*Plate 24. Stairstep crack in northern wing, east elevation.*

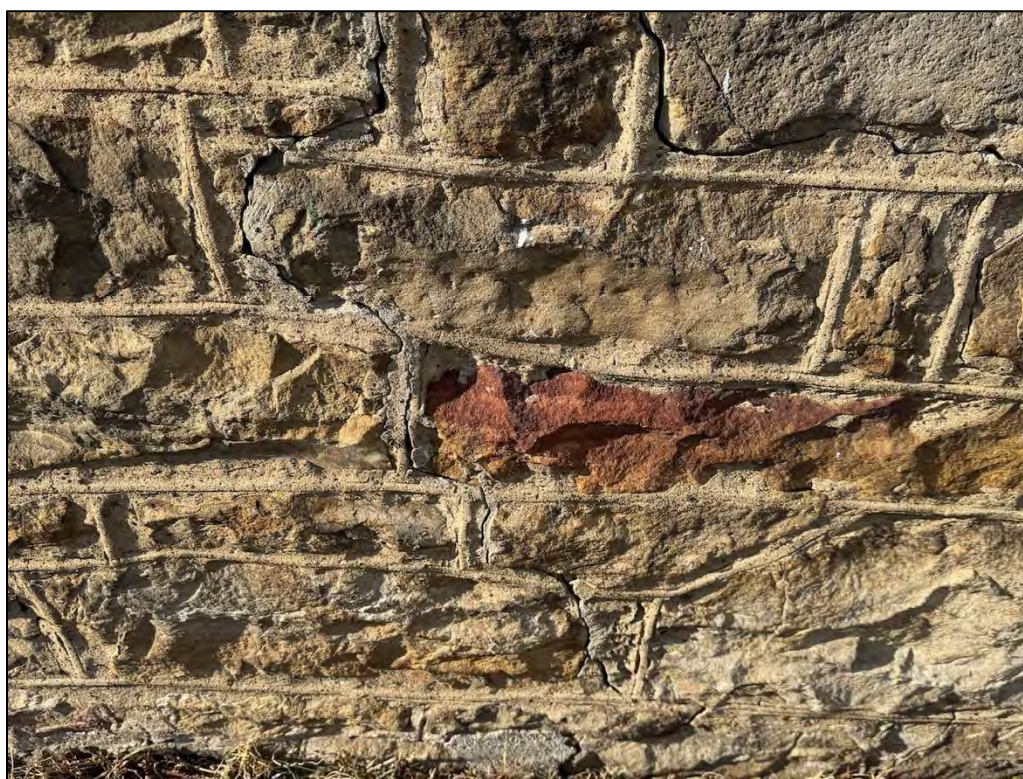
*Plate 25. Crack near lower left (southeast) corner of window in the northernmost wing.*

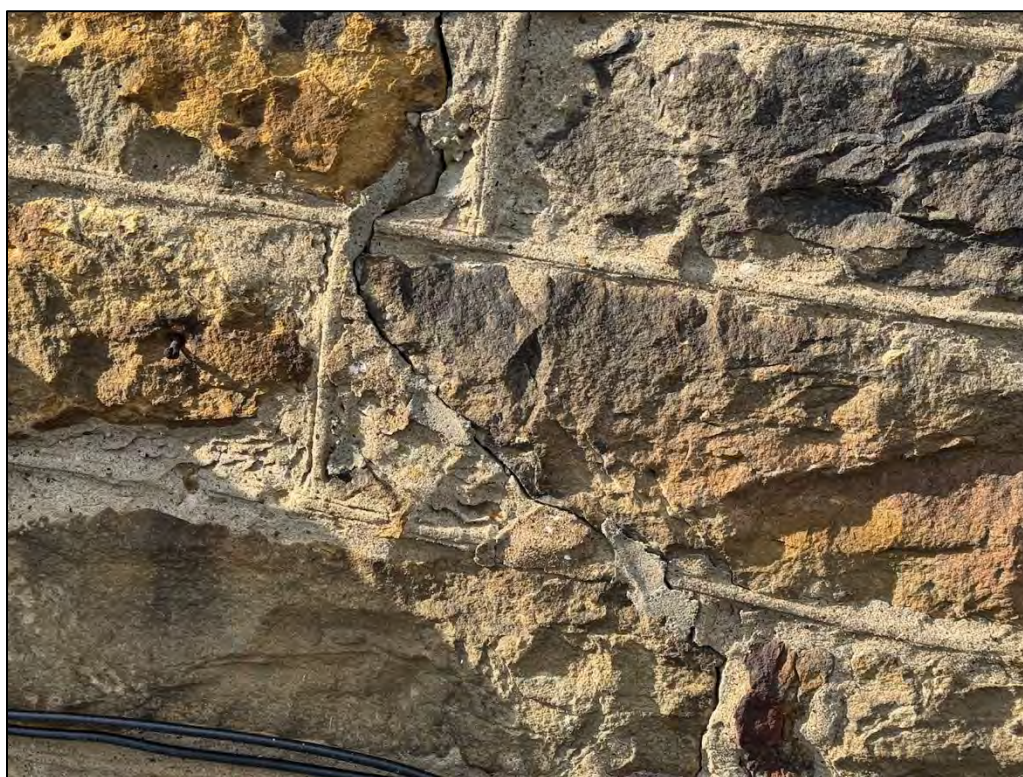
*Plate 27. East elevation crack near ground.*

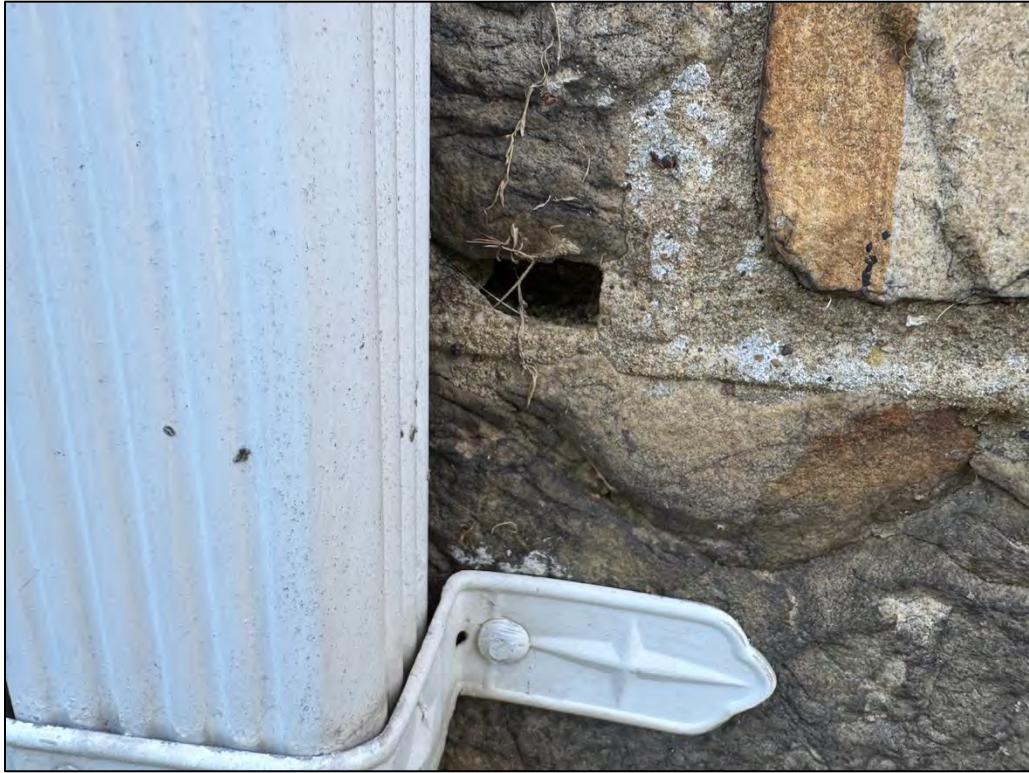
*Plate 28. Missing mortar*

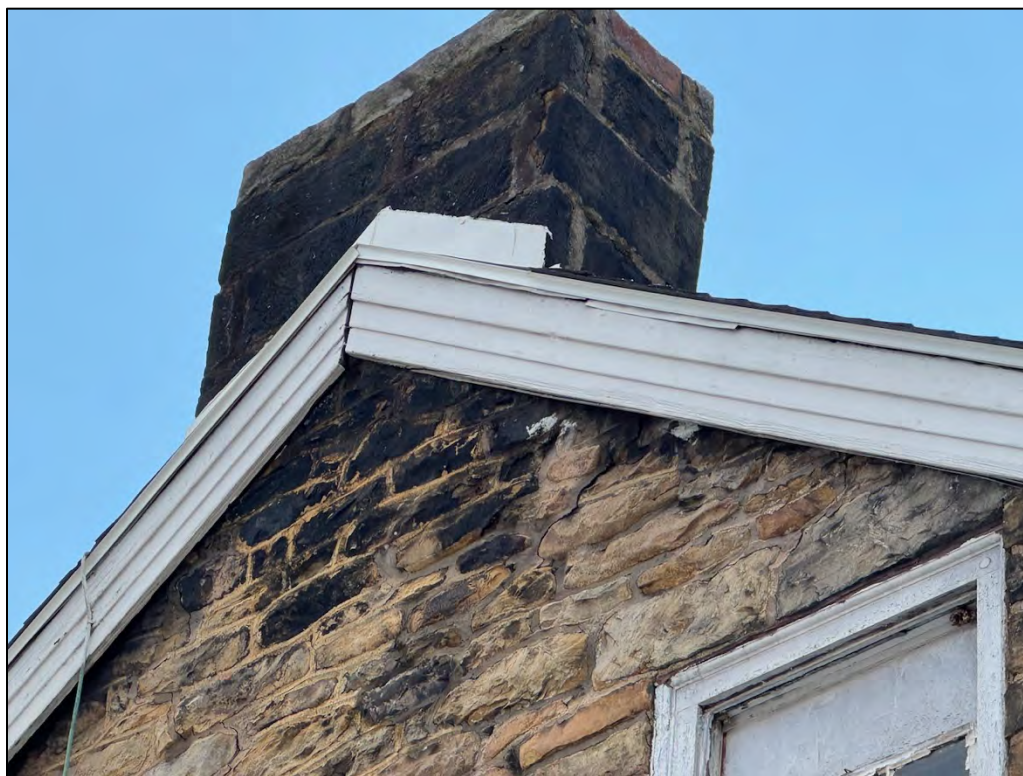
*Plate 36. North elevation, note the staining of the stone and incompatible mortar*

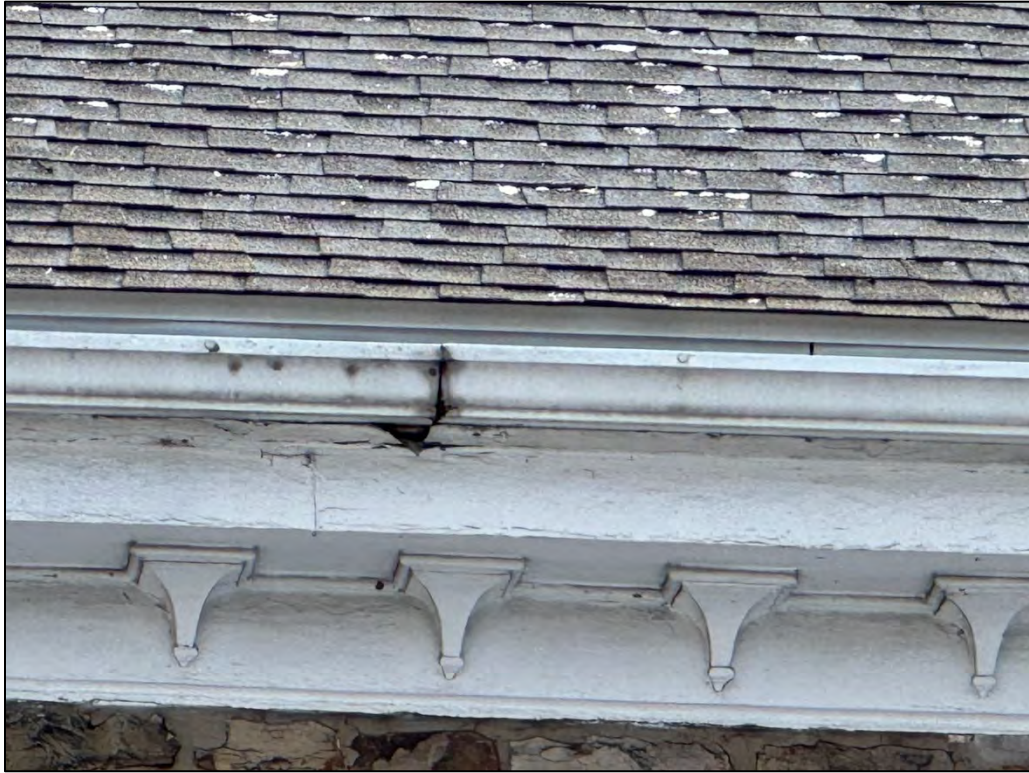
*Plate 47. Overall, the gutters on the main building are damaged with broken joints, holes and deterioration.*

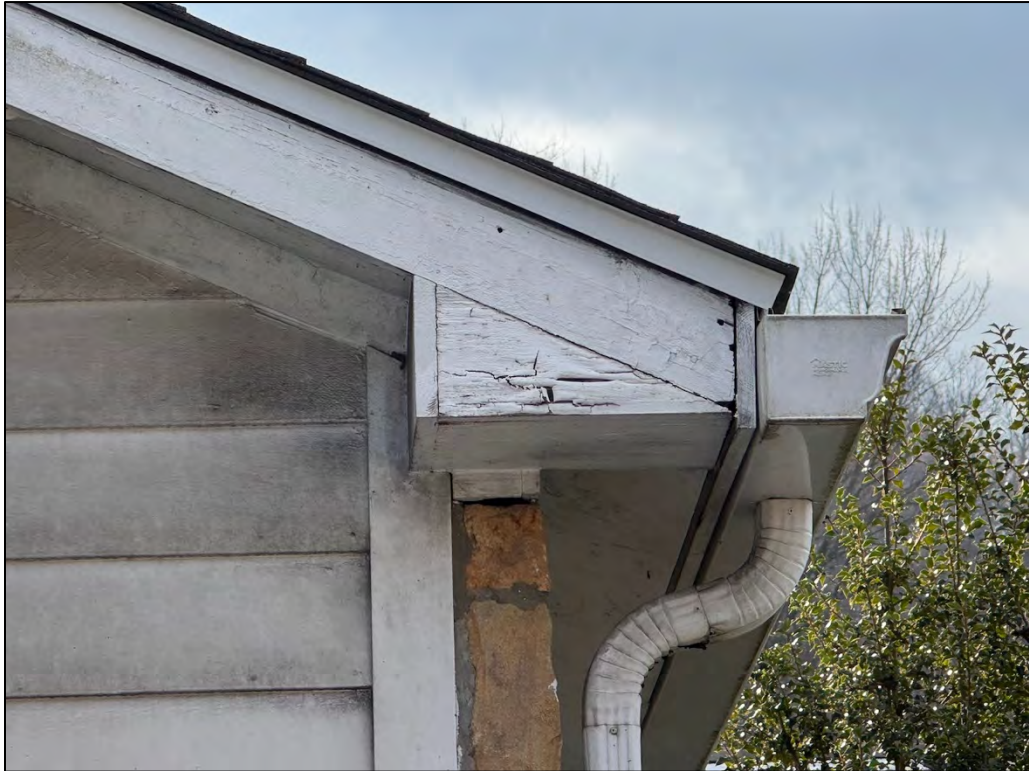
*Plate 48. Typical connection of gutter and downspout. Deteriorated paint on fascia.*

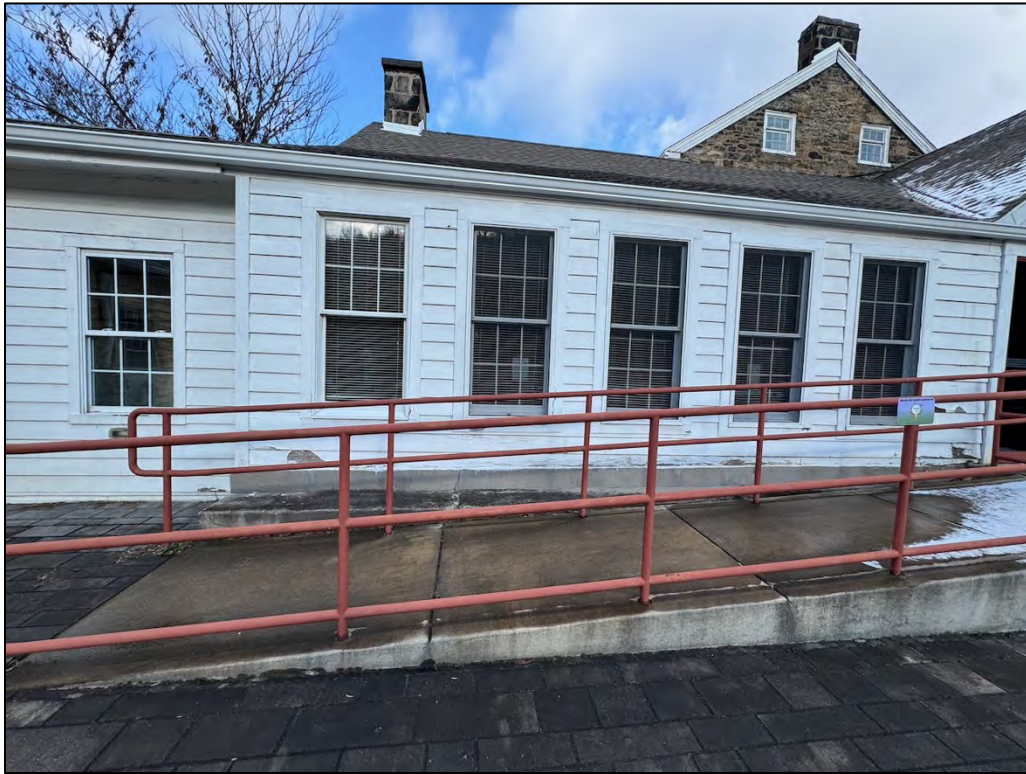
*Plate 51. Existing gutter on enclosed porch. Water damage is affecting the nearby siding. [See 2026 updated in Appendix].*

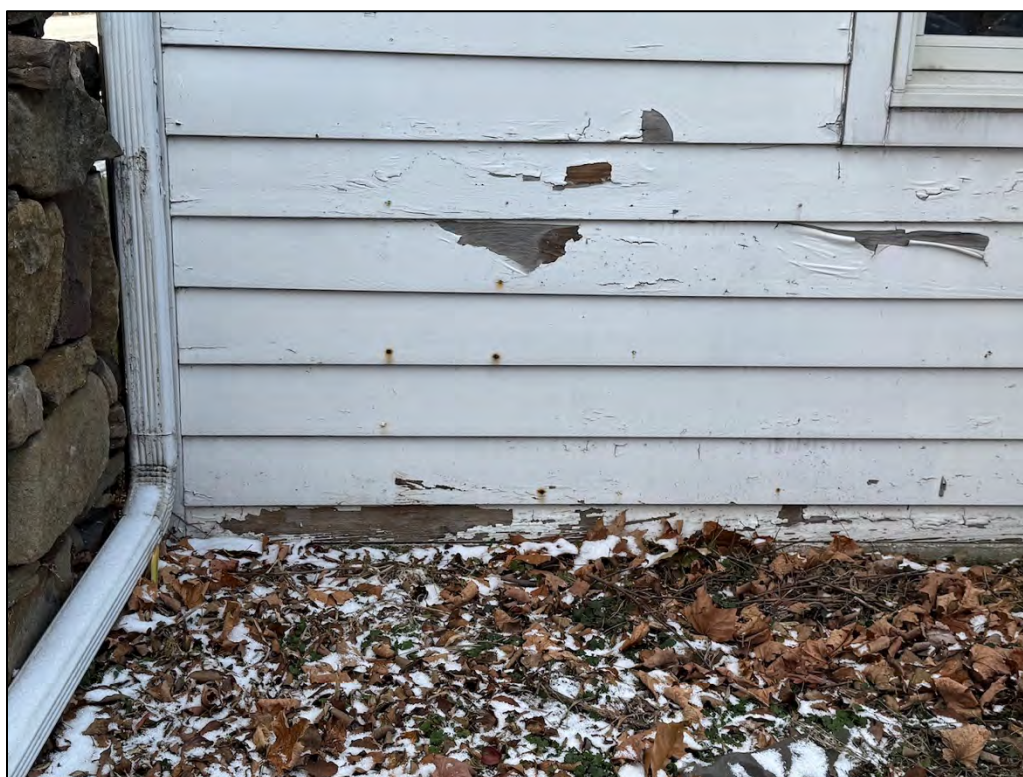
*Plate 77. Deteriorated paint on siding, west elevation.*

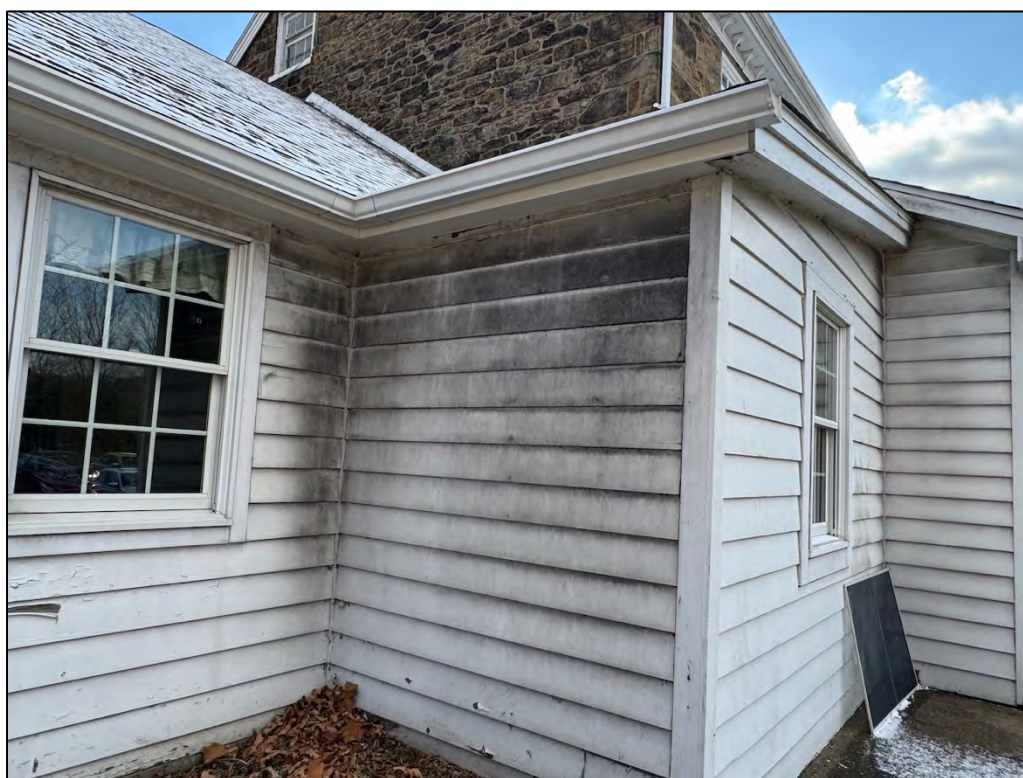
*Plate 78. North side of the addition, note the peeling paint and sediment.*

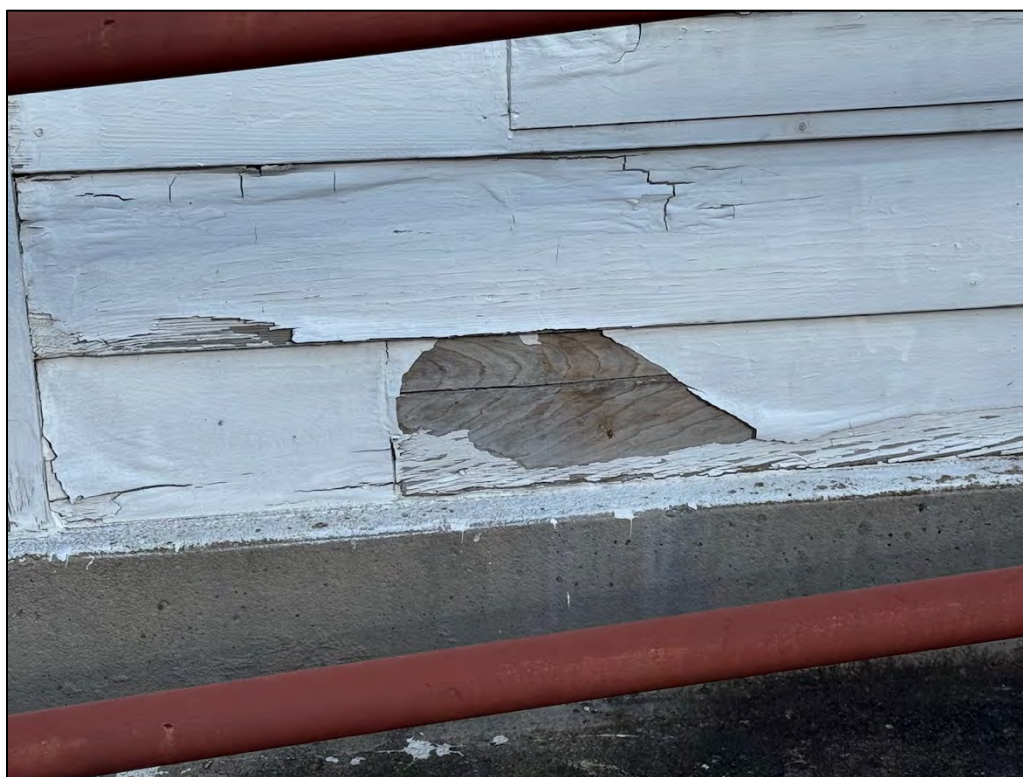
*Plate 81. Detail of water damaged siding.*

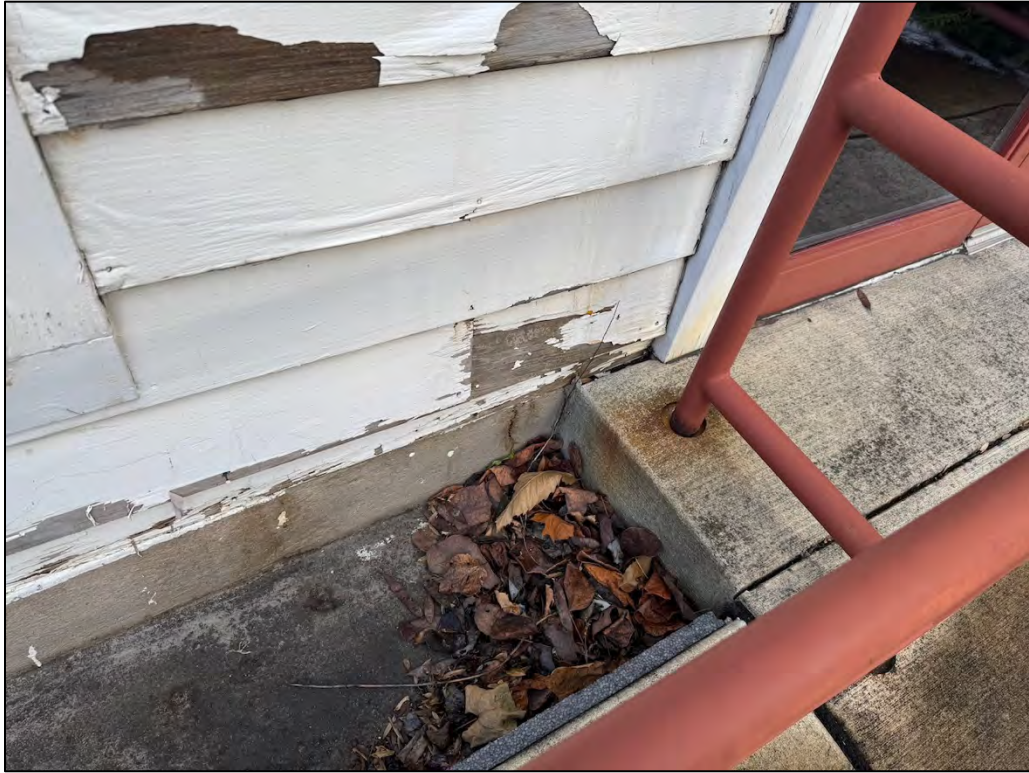
*Plate 82. Additional water damage on east side of the south elevation.*

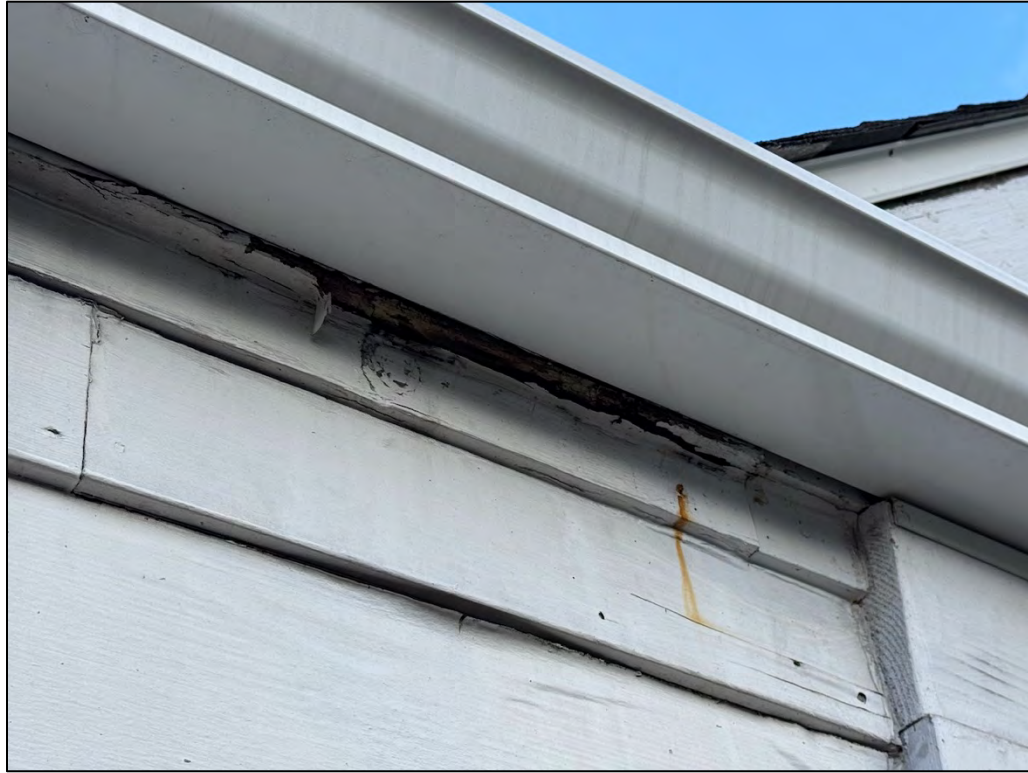
*Plate 84. Deteriorated eaves may indicate a faulty gutter.*

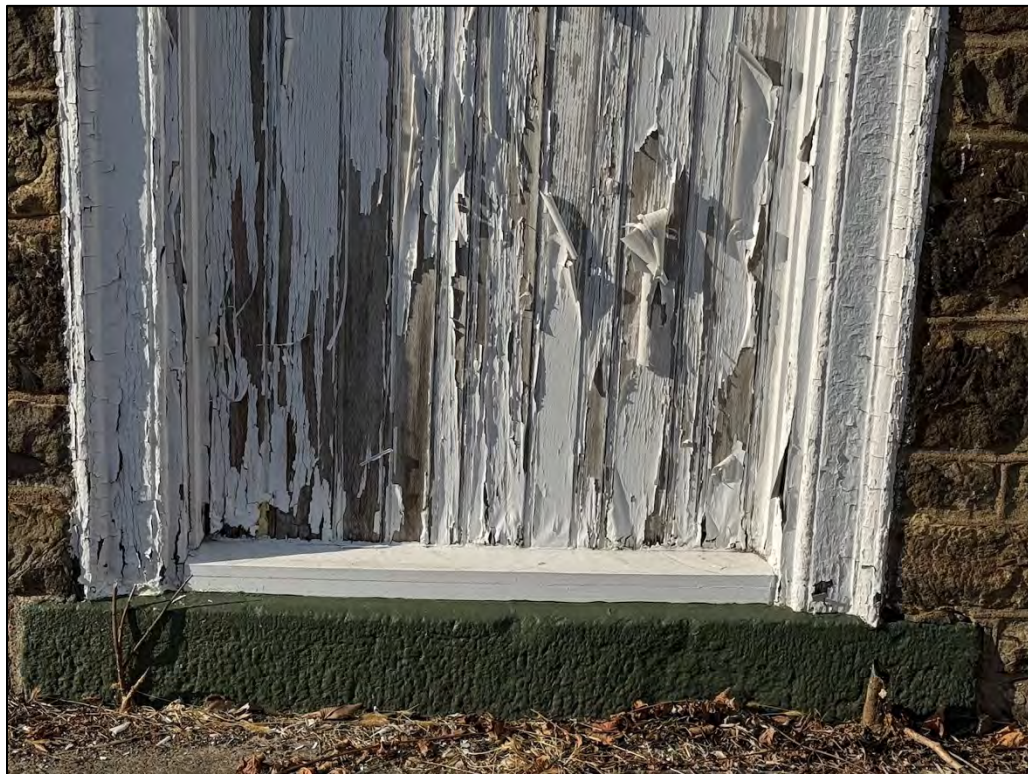
*Plate 86. Base of door, deteriorated wood and flaking paint.*

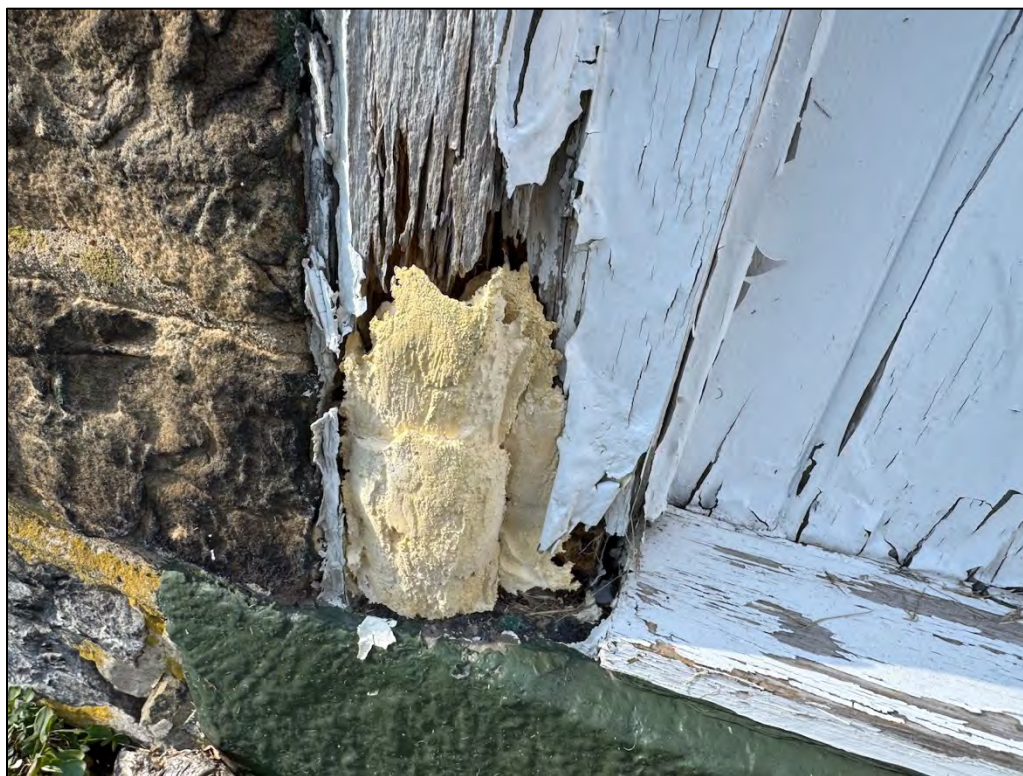
*Plate 97. Lower left corner of the front door. Note the deteriorated wood and flaked paint.*

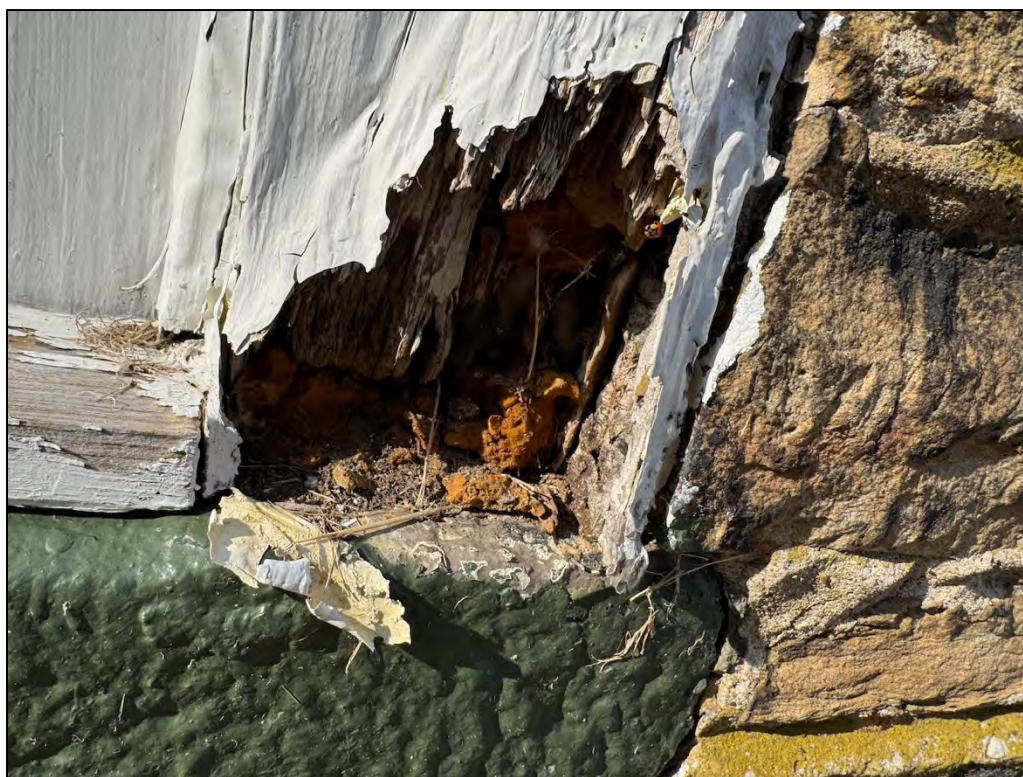
*Plate 98. Lower right corner of front door. The hole was previously filled with foam which has been removed, (possibly by vermin).*

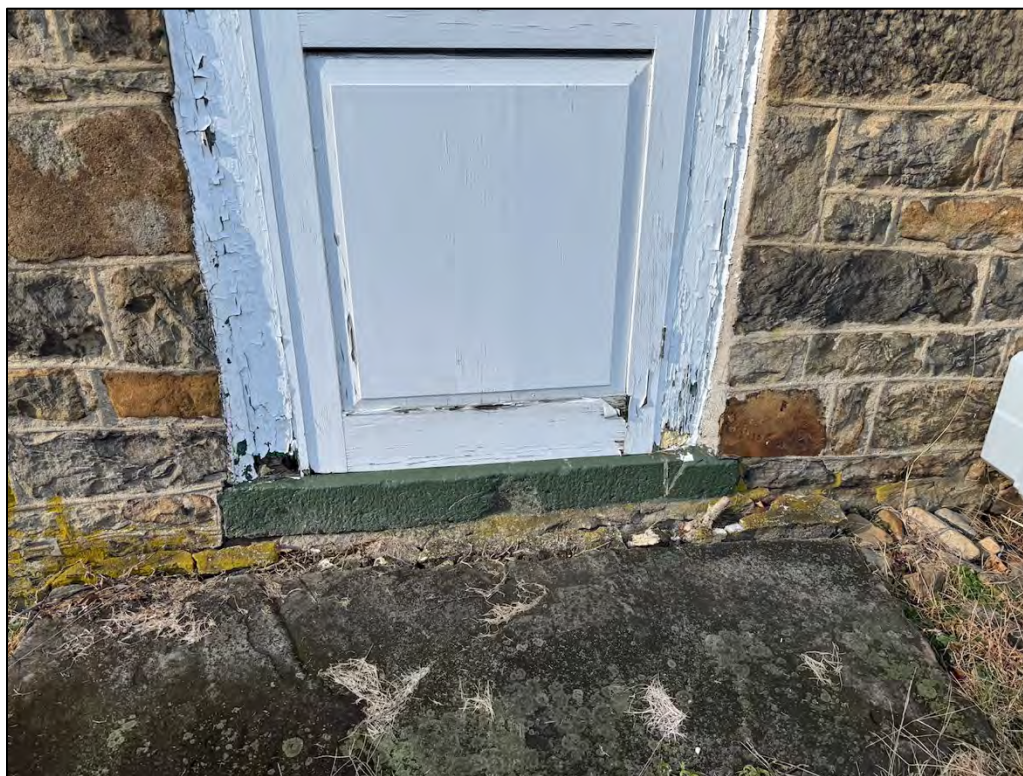
*Plate 103. Deteriorated base of door.*

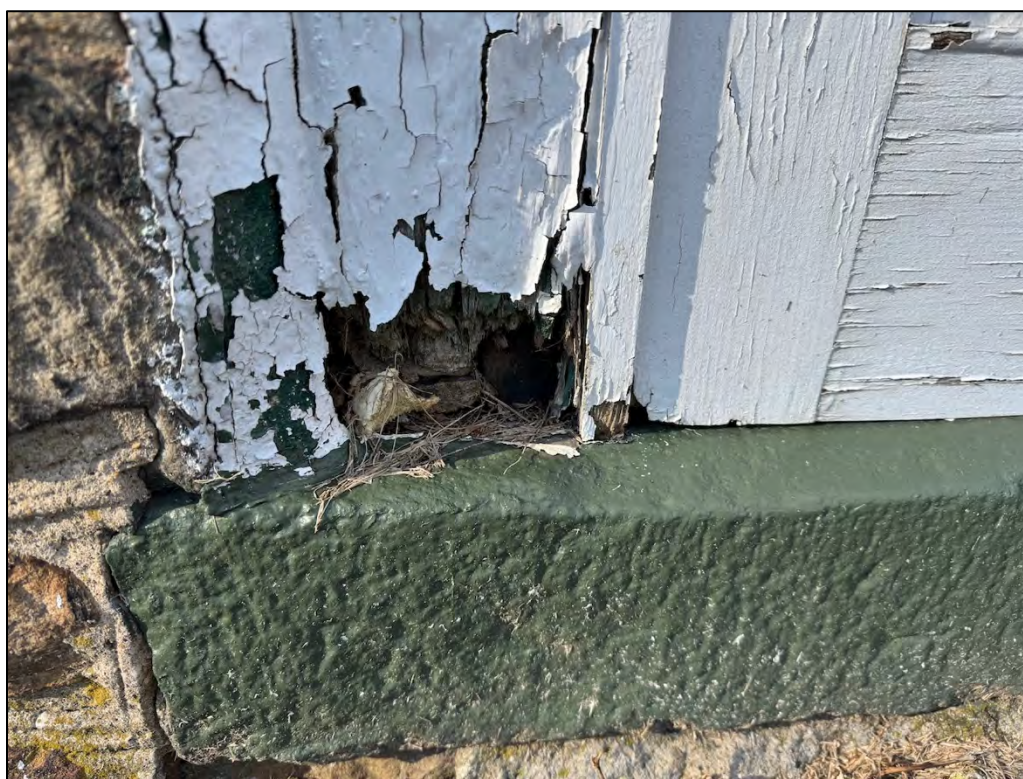
*Plate 104. Detail of lower left of door. Note deteriorated wood and flaked paint.*

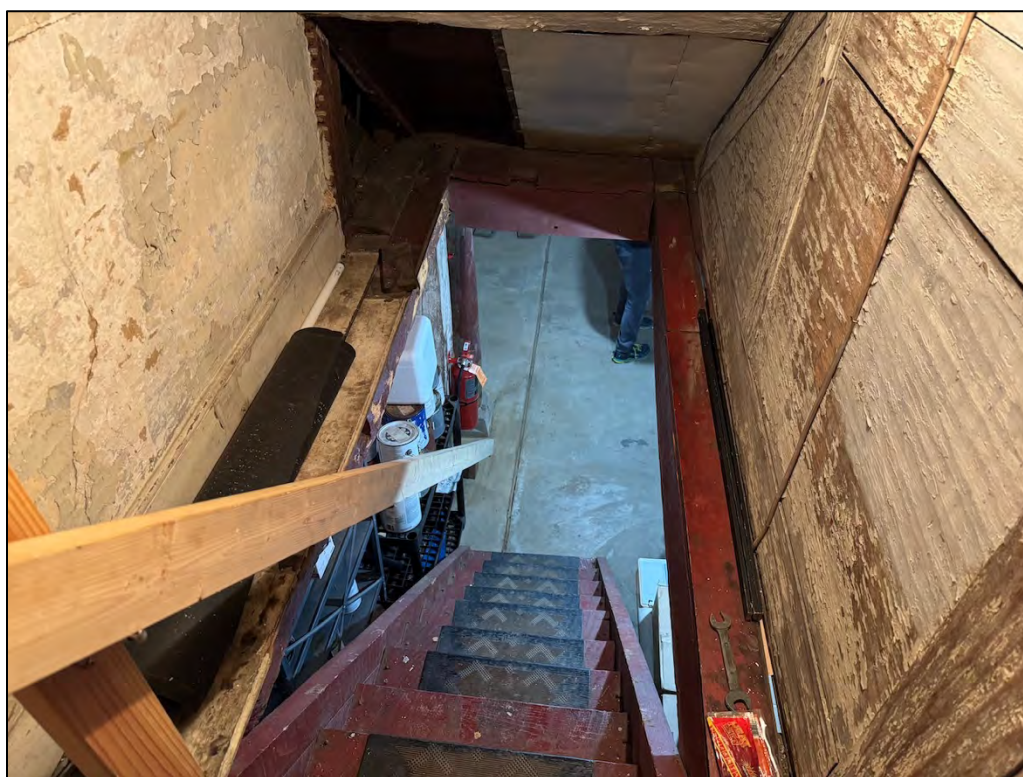
*Plate 123. Room 1, basement entry, facing northwest. Note the crack in the plaster.*

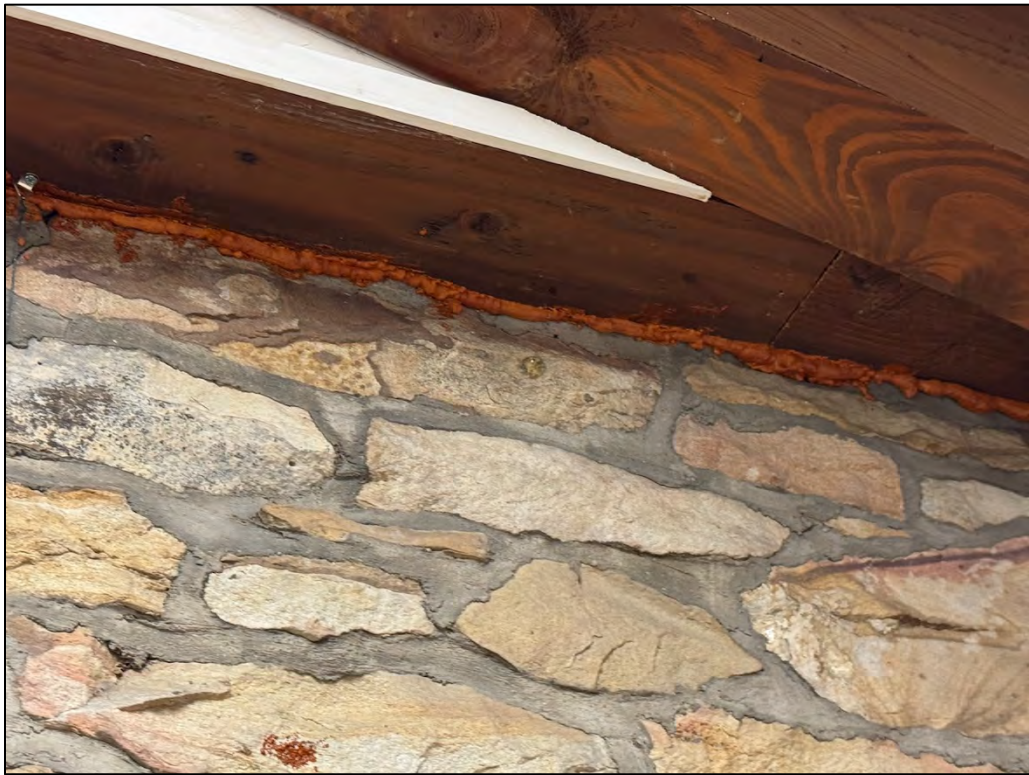
*Plate 139. Cracked mortar, facing southeast.*

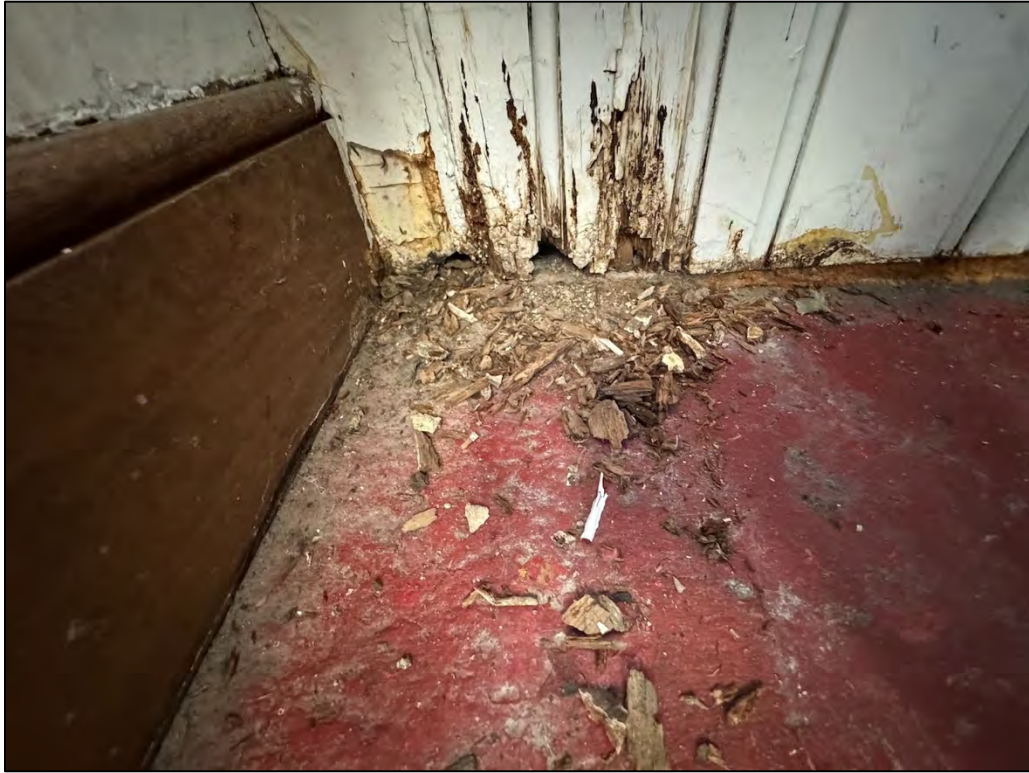
*Plate 156. Detail of the door, facing east. Note deterioration on the lower portion of the door.*

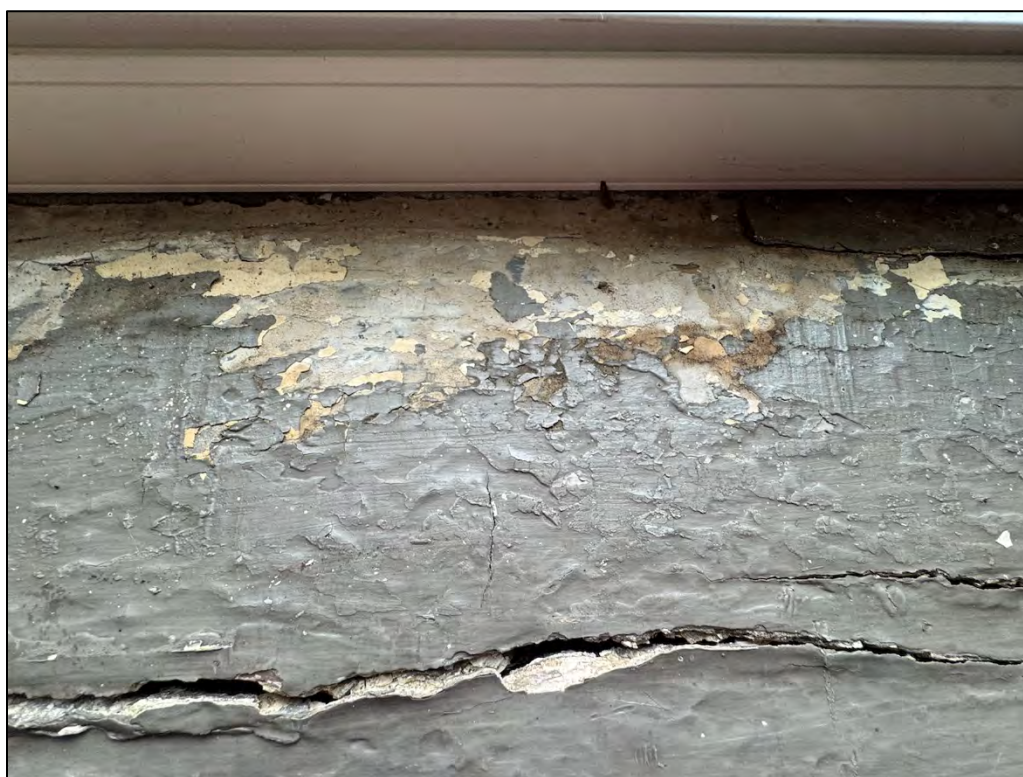
*Plate 208. Window 1-16, detail of water damage, facing southeast.*

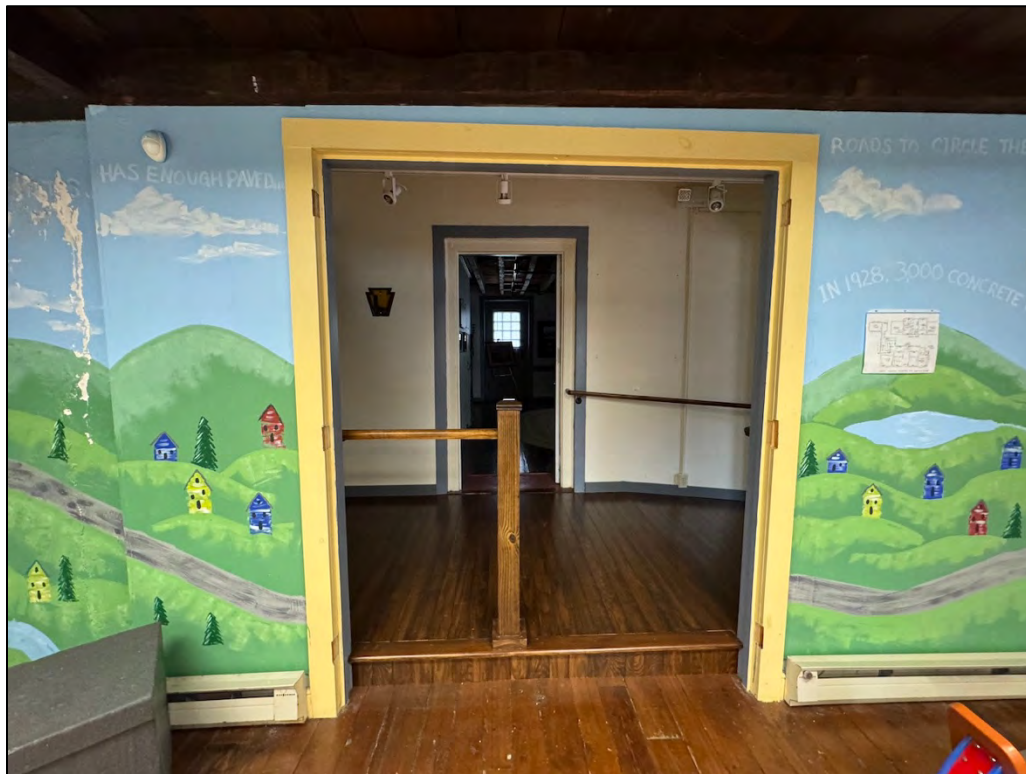
Plate 246. Deterioration due to moisture on plaster wall, facing east.

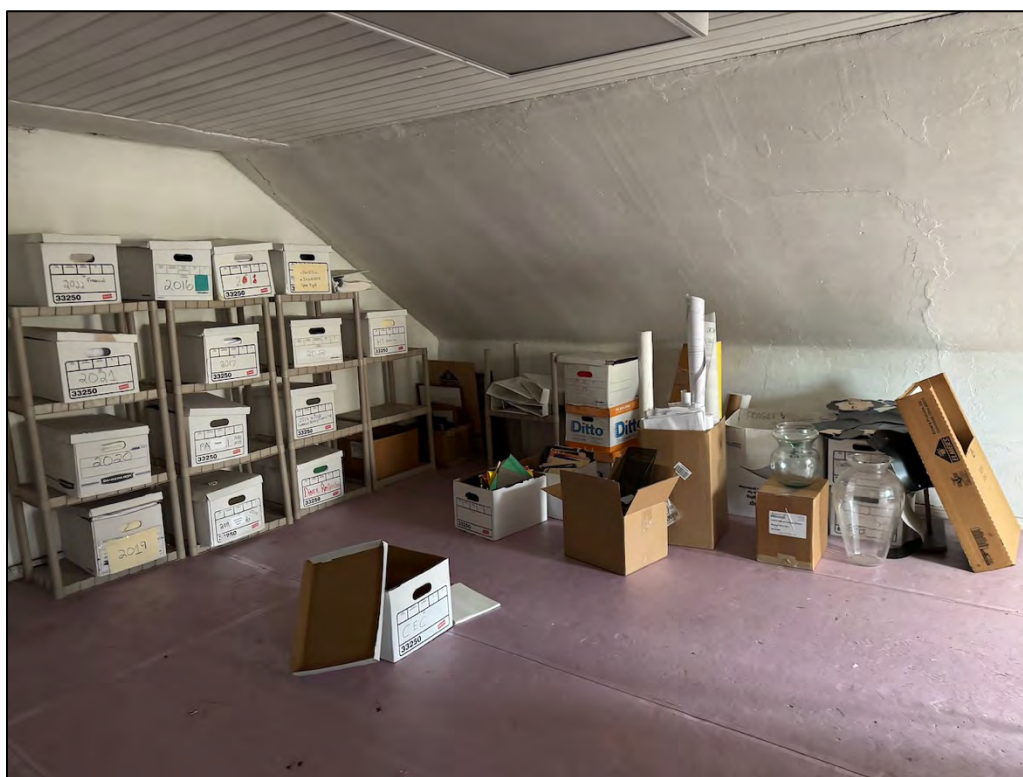
*Plate 271. Room 13, facing southeast. Note crack infilled with spray foam and thick plaster.*

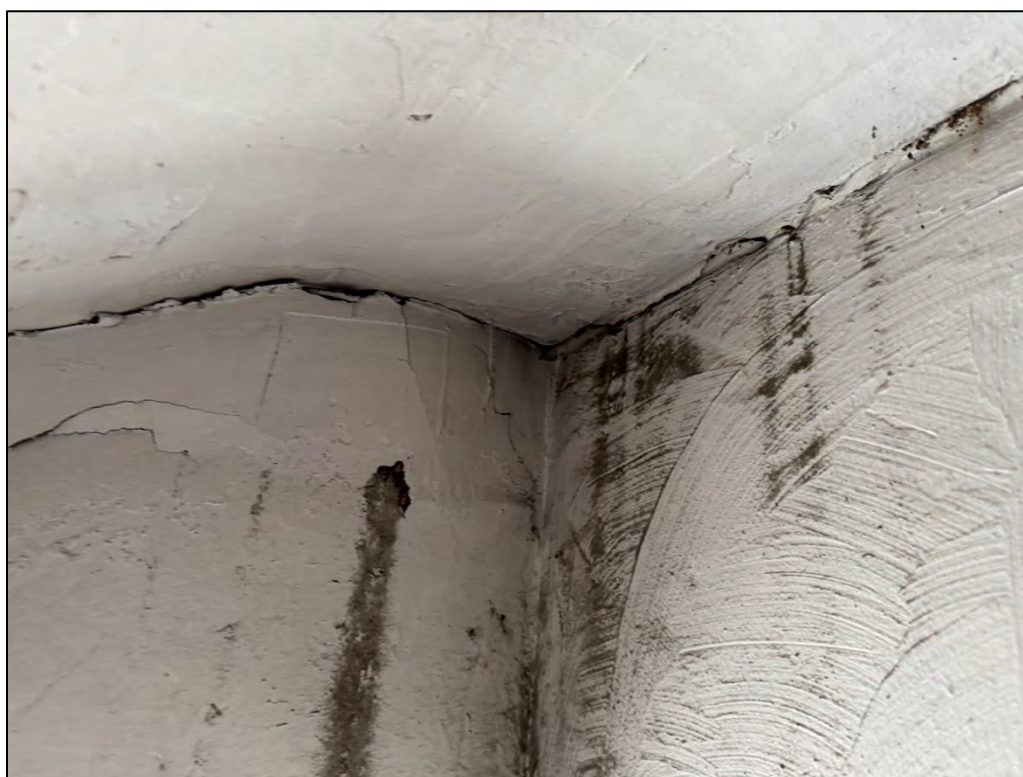
*Plate 273. Room 13, facing north. Crack at ceiling/wall juncture.*

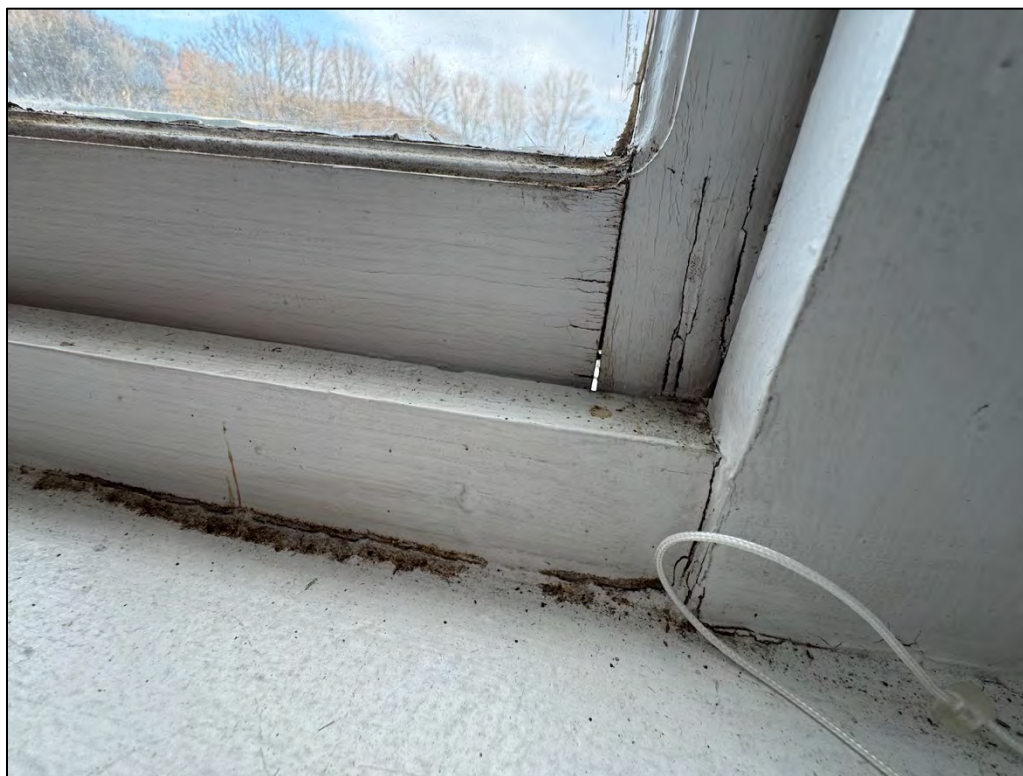
*Plate 286. Detail of wood sash deterioration, failed glazing, chipped paint and overall weathering.*

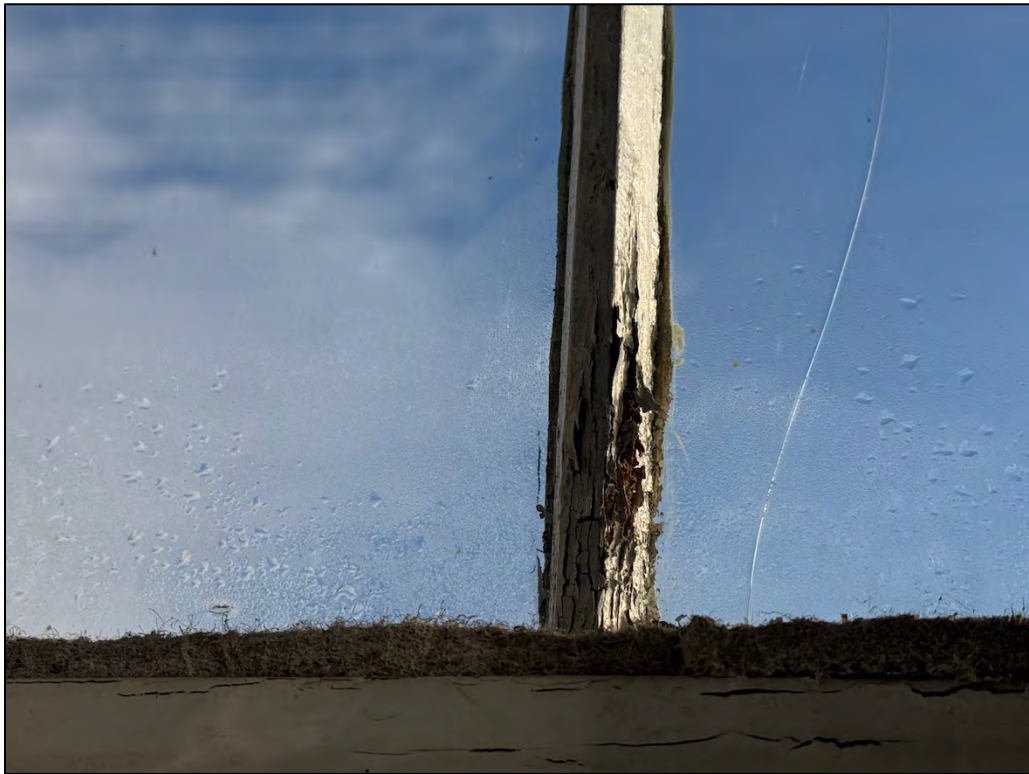
*Plate 297. Detail of deterioration caused by condensation, insects and sunlight, facing east.*
