# CONDITION ASSESSMENT REPORT

## THE LINCOLN HIGHWAY HERITAGE CORRIDOR

3435 State Route 30 East  
Latrobe, Westmoreland County, Pennsylvania

Abbreviated  
Condition Assessment Report  
Alexander Johnston's "Kingston House"

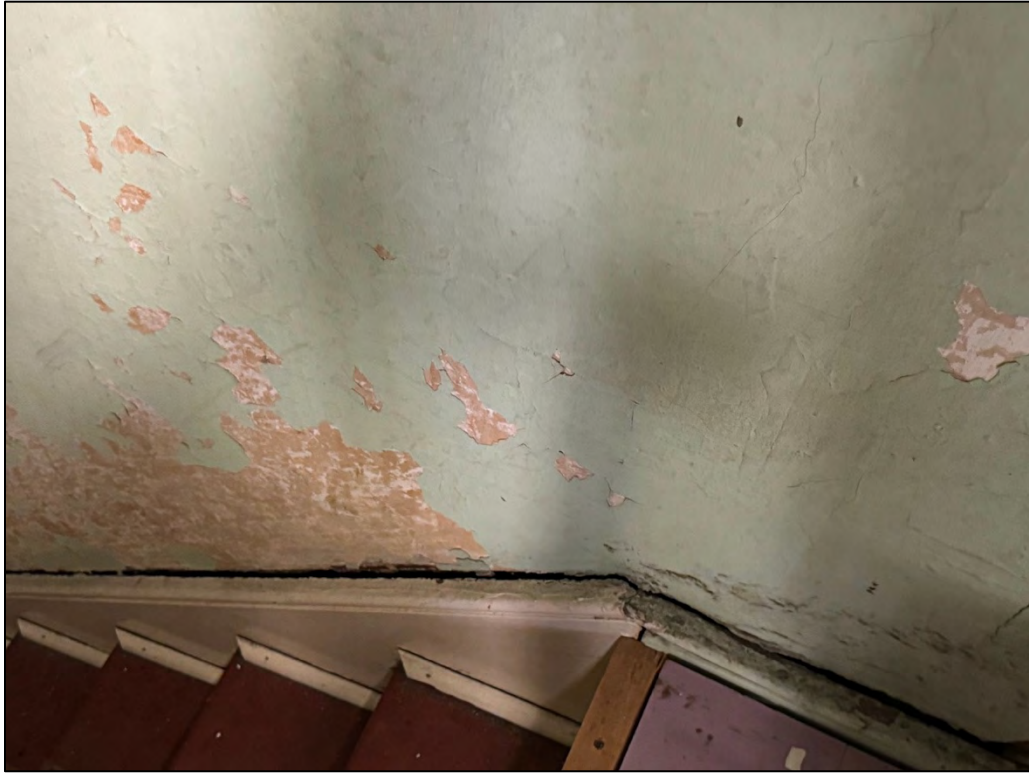
*Plate 326. Room 18, south wing upper storage area, detail of plaster crack.*
