# CONDITION ASSESSMENT REPORT

## THE LINCOLN HIGHWAY HERITAGE CORRIDOR

3435 State Route 30 East  
Latrobe, Westmoreland County, Pennsylvania

Abbreviated  
Condition Assessment Report  
Alexander Johnston's "Kingston House"

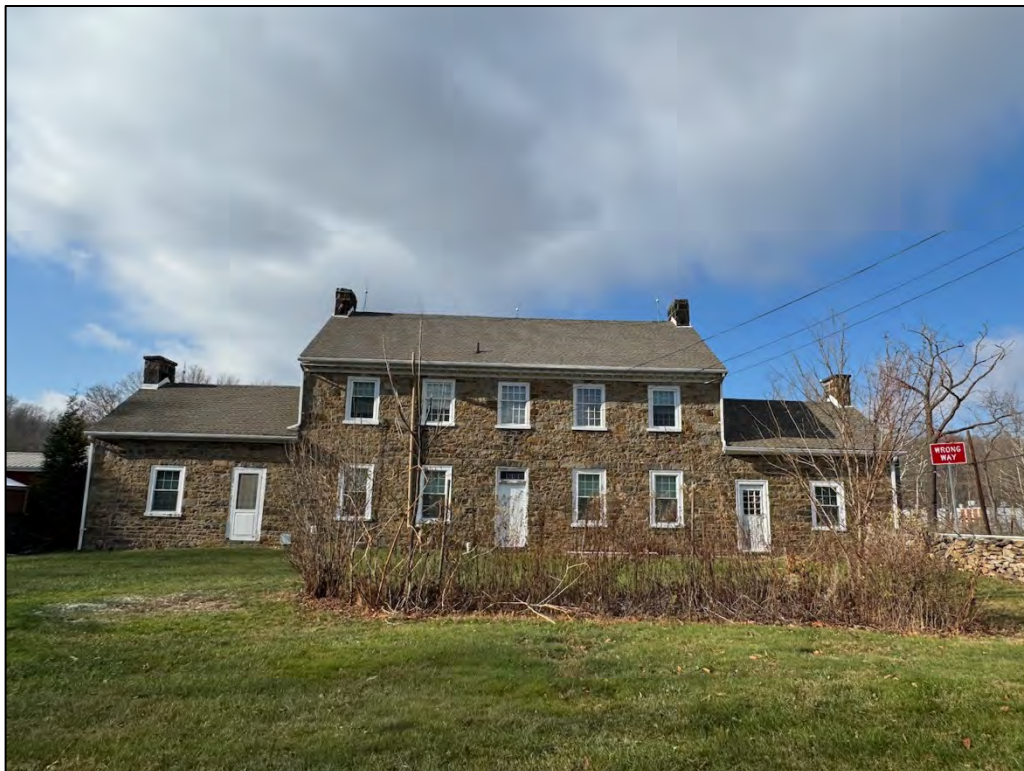
In general, the exterior stone walls of the building are in good condition. The walls appear to be straight without no clear signs of major structural damage, although localized cracking in the mortar and stone is present. The wood windows are in fair condition, and the roof has recently been resheathed with asphalt shingles. The stone chimneys exhibit deterioration and will need attention.

*Plate 21. East elevation, facing west.*

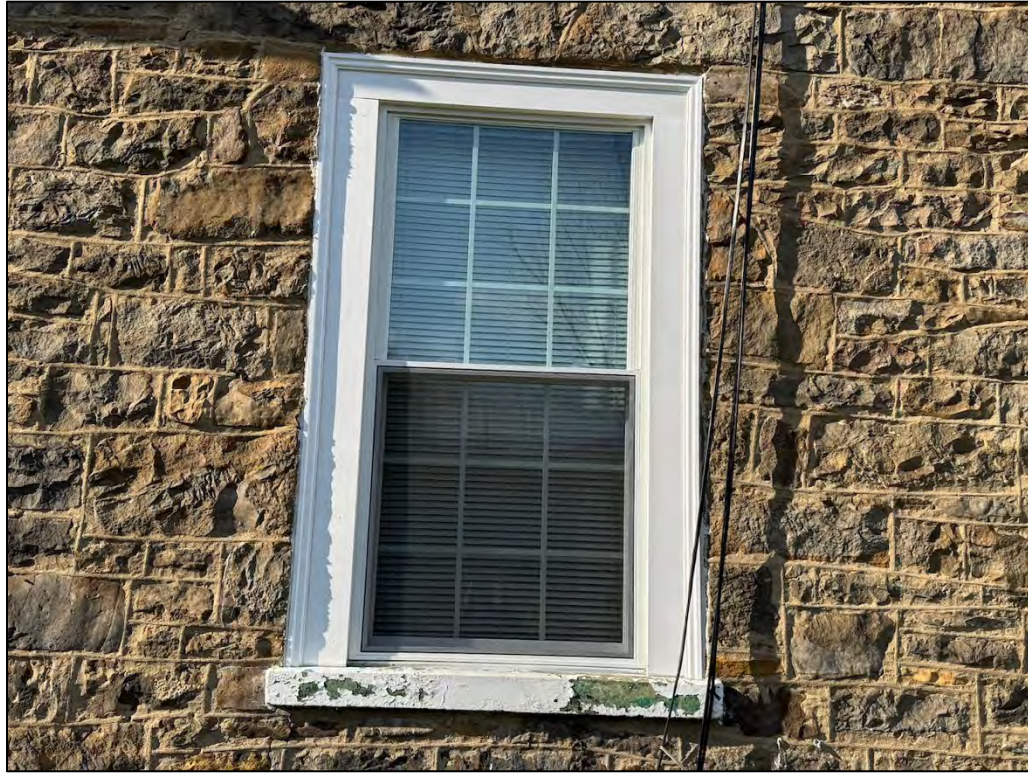
*Plate 22. Detail of typical beaded mortar joint, east elevation.*

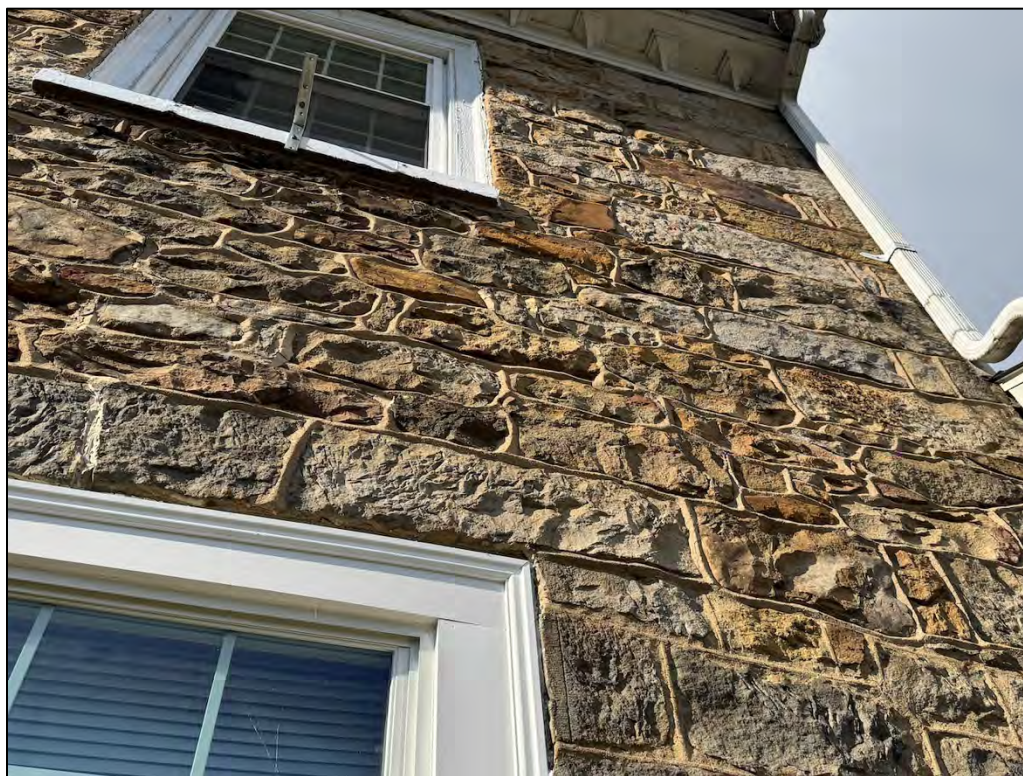
*Plate 26. Angled view, east elevation, revealing differing weathering pattern of mortar and stone.*

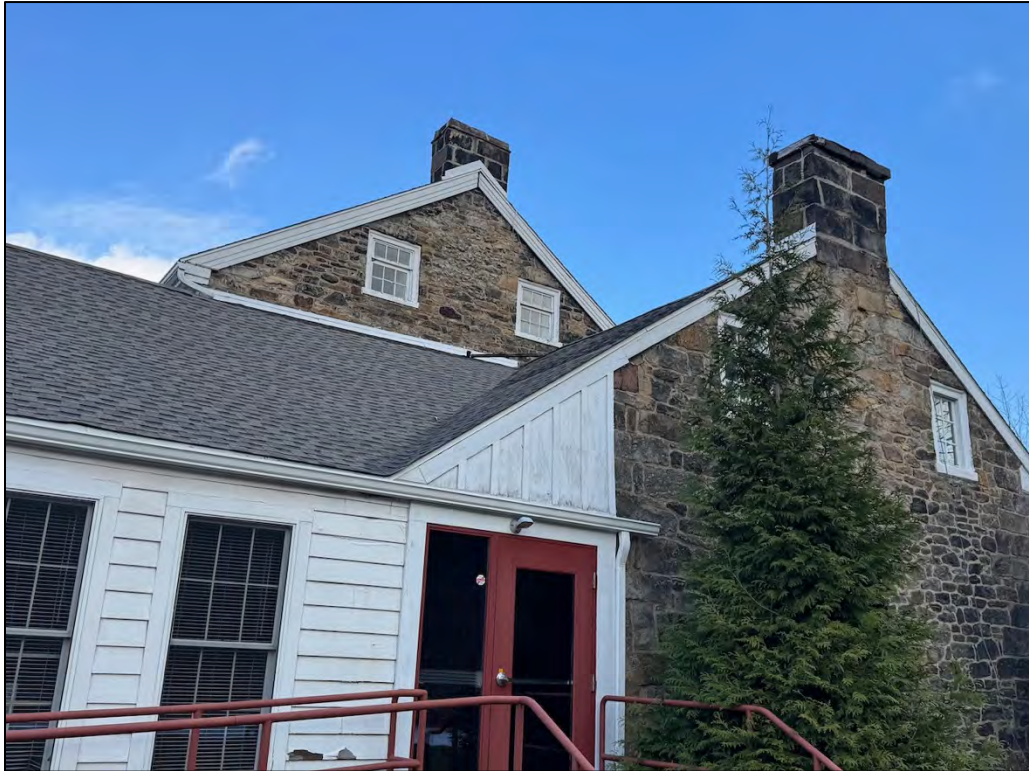
*Plate 29. South elevation. Note the foliage which is too close to the building.*

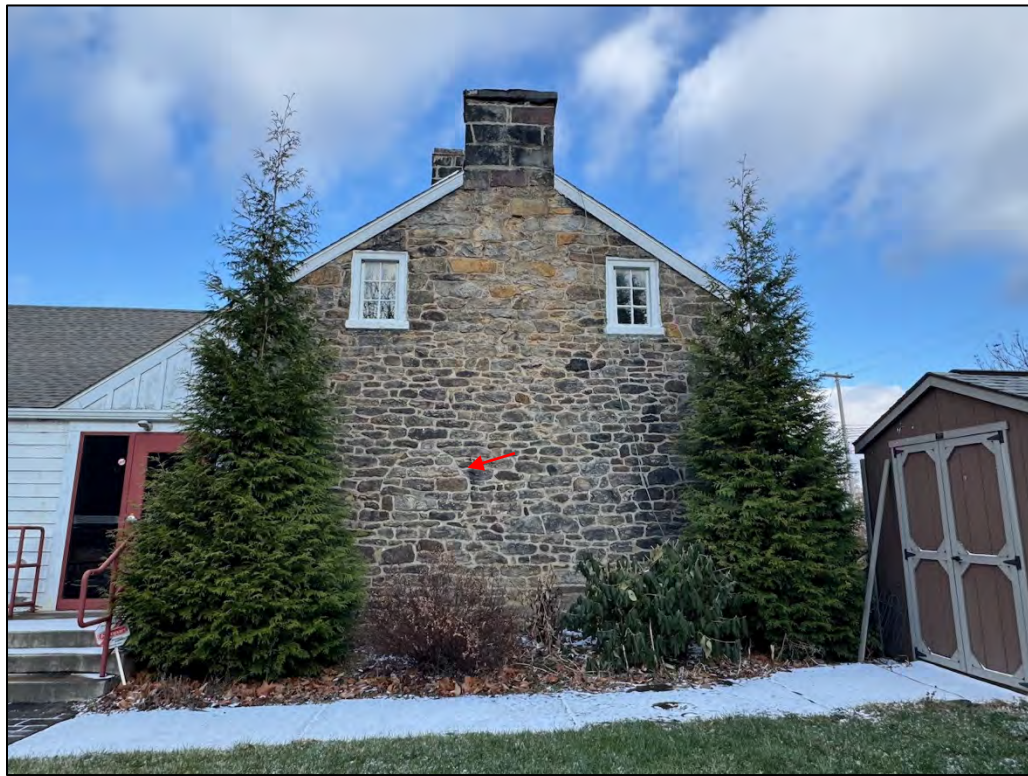
*Plate 30. South elevation. Note the ghost mark of the oven which was previously removed.*

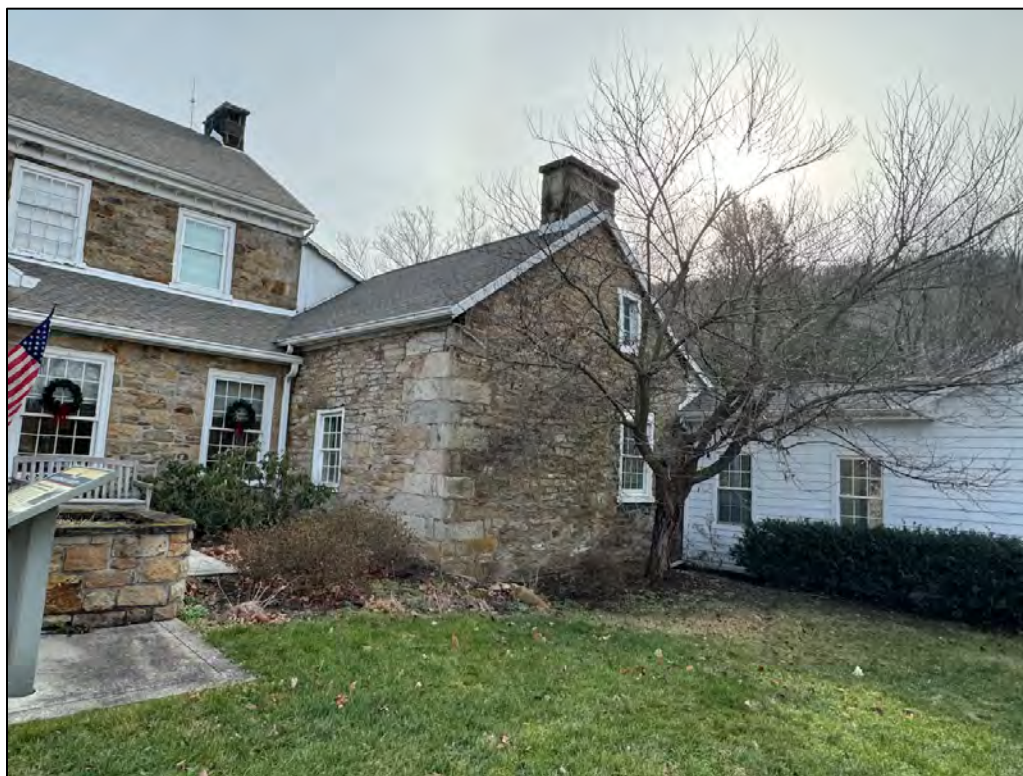
*Plate 32. Tavern ell addition, facing southeast. The ghost mark of the beehive oven has been hidden through repointing.*

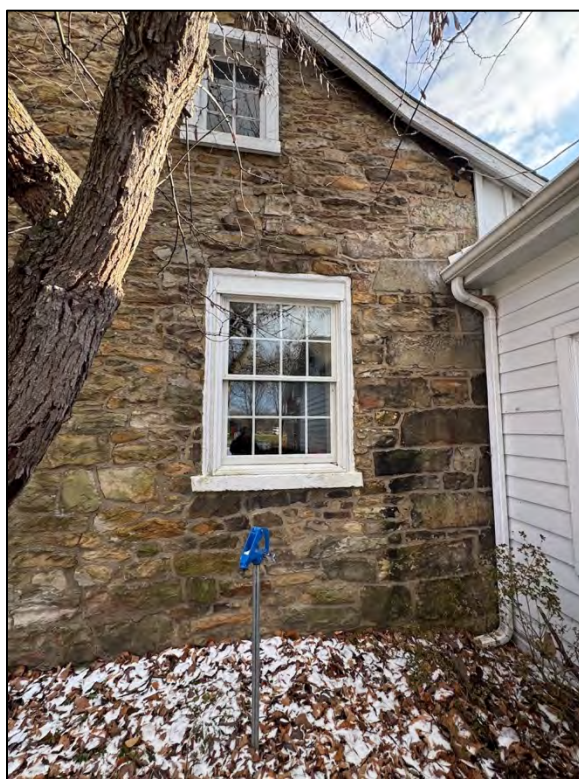
*Plate 33. West Elevation, mortar previously repointed, some organic staining*

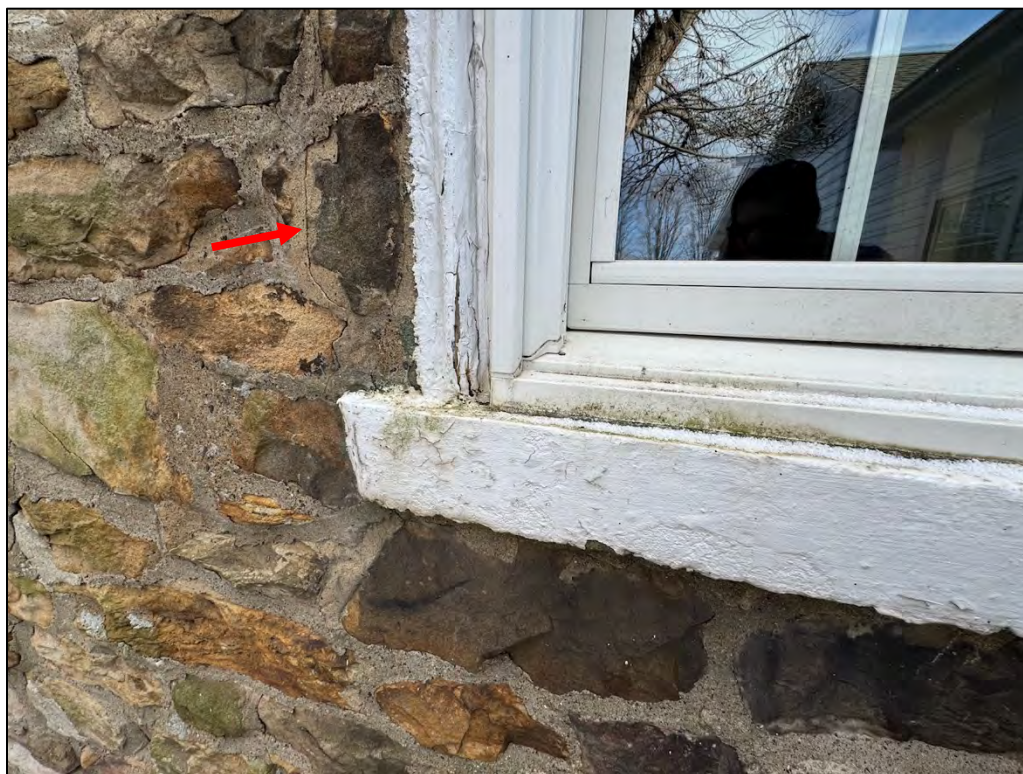
*Plate 34. Detail of crack north side of window*

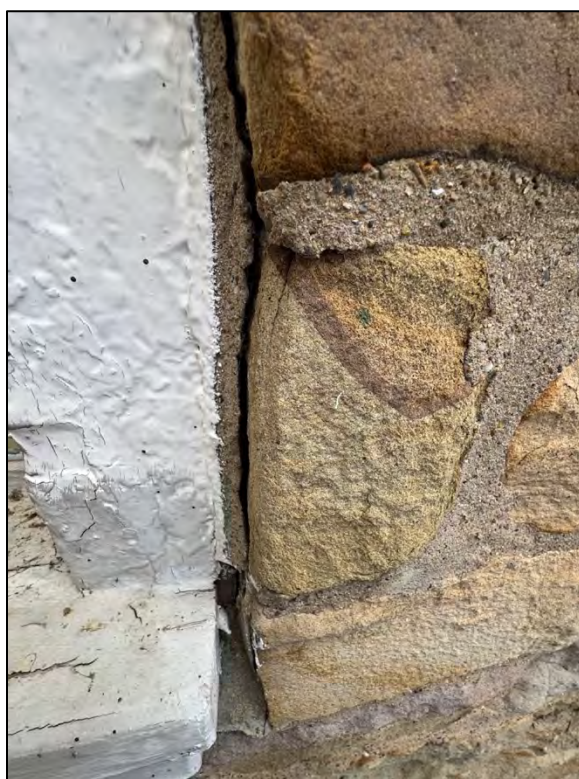
*Plate 35. West side of window, north elevation of historic tavern/tot room. Note the space between the mortar and stone.*

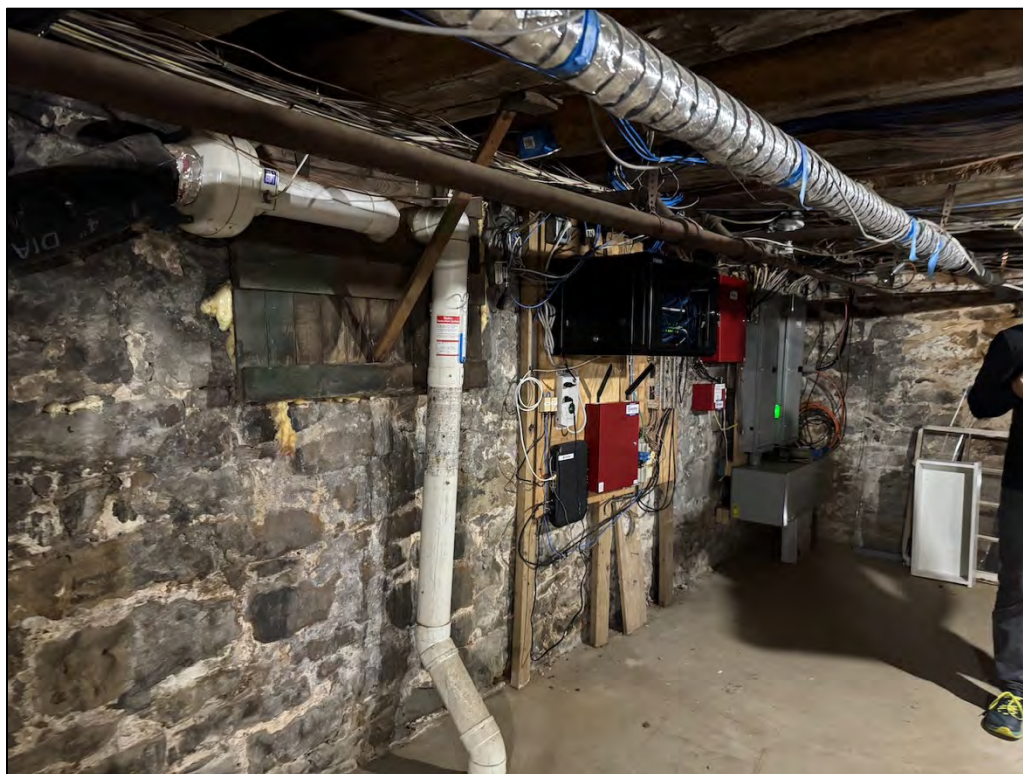
Several historic window/vent openings are located on the east elevation within the foundation which appear to be covered over with plexiglass or wood planking. These window openings are likely not weathertight and should be evaluated. Minor voids around several ground-level window openings may permit small animals or pests to enter the building. Occasional presence of vermin within the basement indicates that there may be minor openings or points of penetration in inaccessible areas. Further investigation is recommended, including selective probing, to determine the extent and location of potential breaches and confirm structural continuity under the additions.

*Plate 37. Foundation wall, facing southeast*

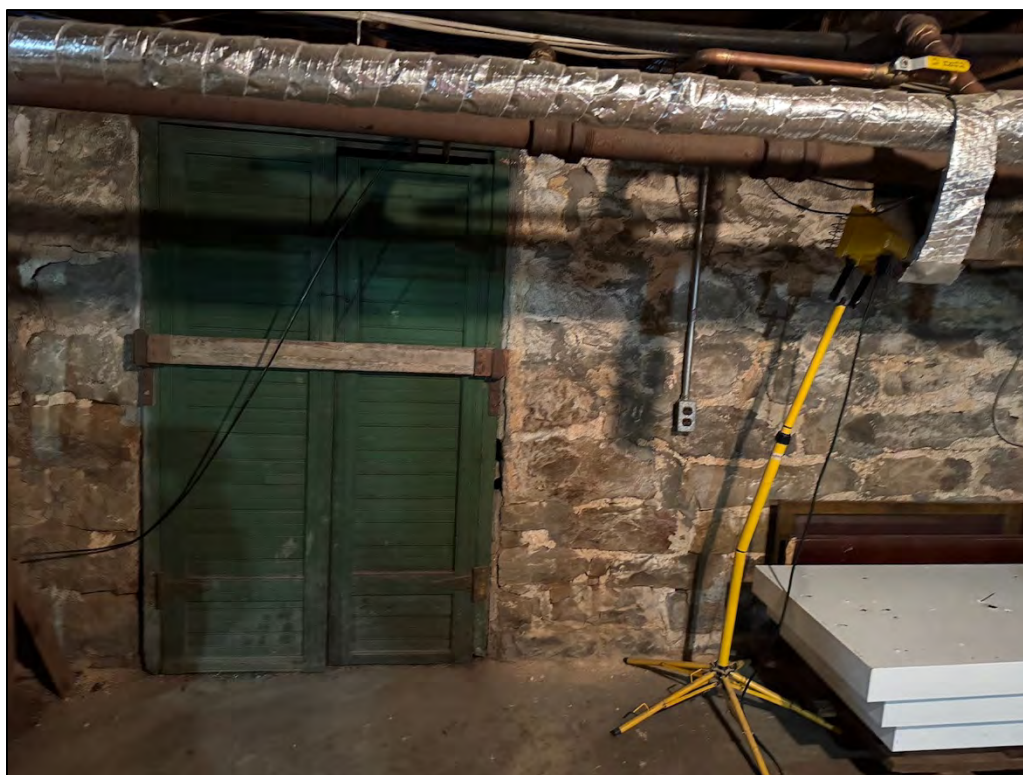
*Plate 38. Basement foundation, facing south*

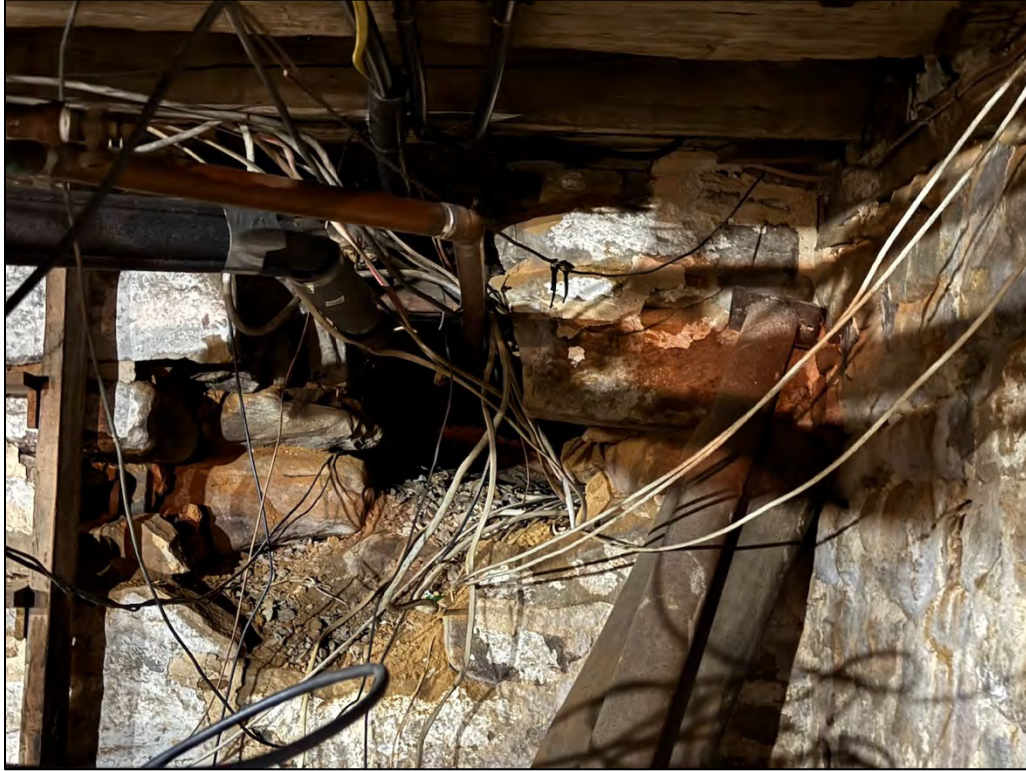
*Plate 39. Hole cut through south wall in foundation, facing south.*

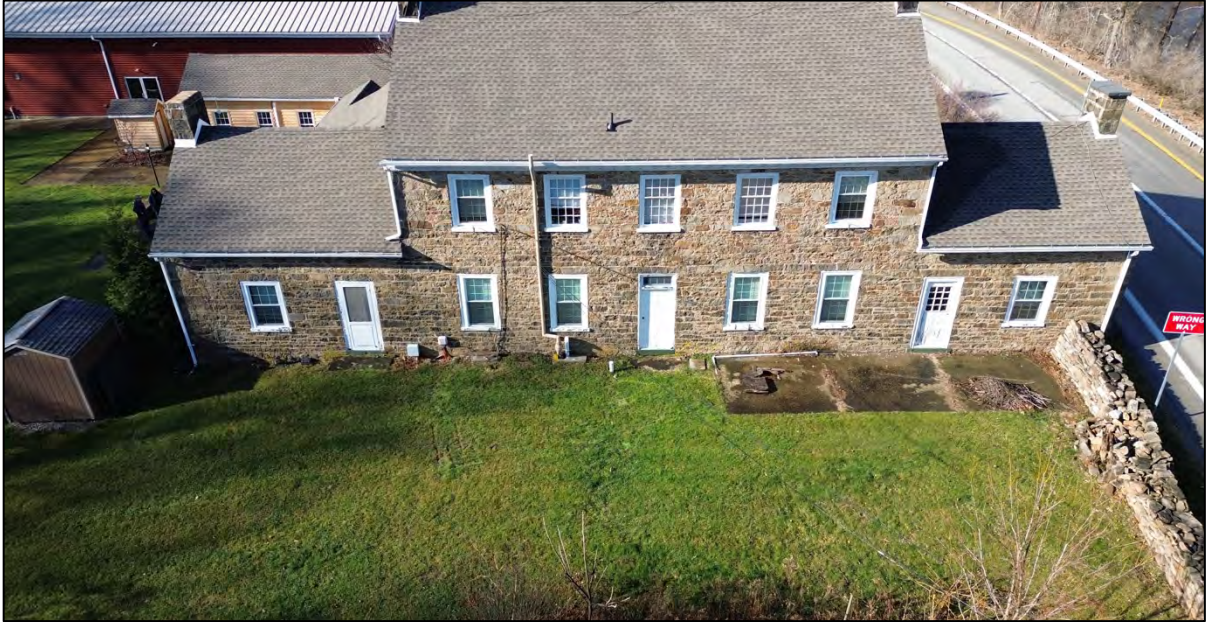
Given the size of the roof planes and the increasing intensity of regional storm events, the existing K-style gutters may be undersized for current drainage needs. Additionally, gaps between deteriorated gutters, fascia boards and stone walls may create entry points for moisture, small animals and pests.

*Plate 40. East elevation, facing west.*

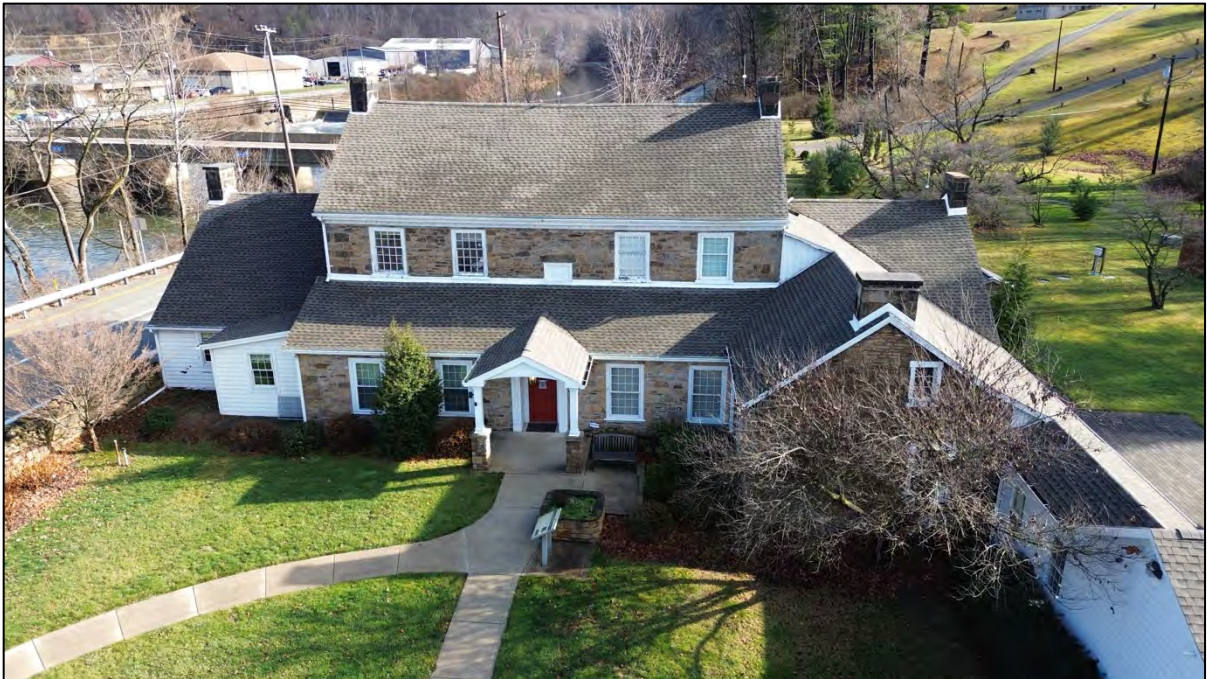
*Plate 41. West elevation, facing east.*

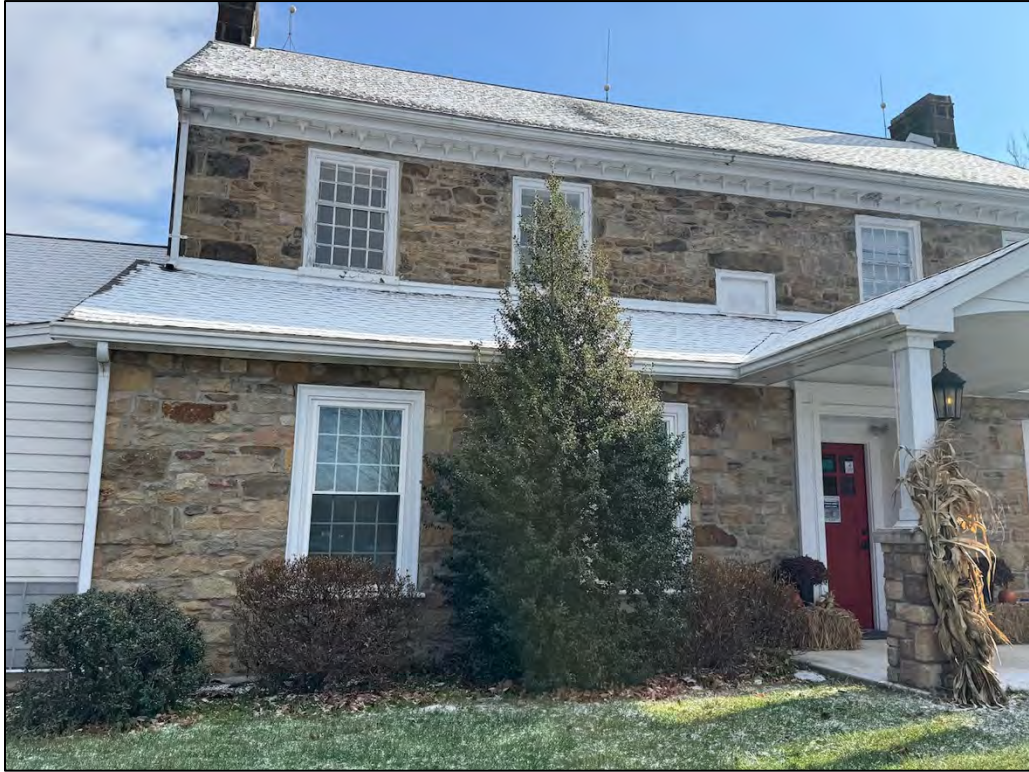
*Plate 42. West elevation, facing east. Typical gutter and downspout configuration.*

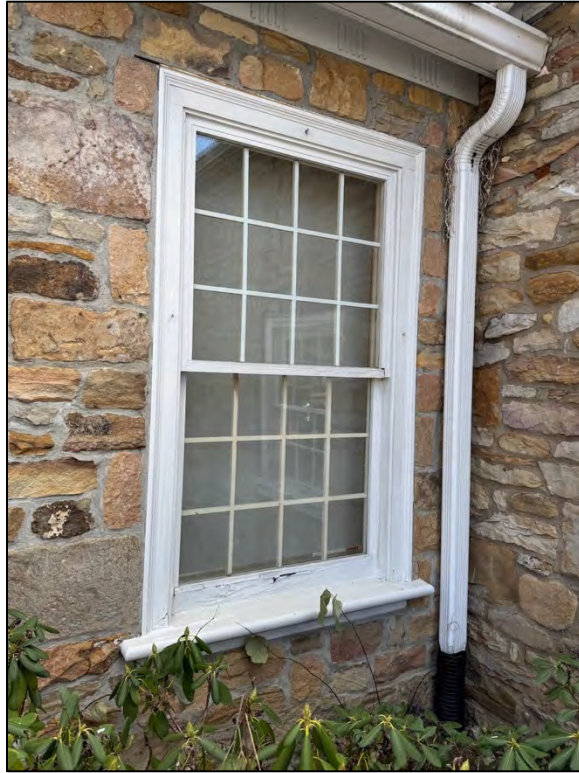
*Plate 43. West elevation (enclosed porch). Typical gutter and downspout. Note the bird nest against the house.*

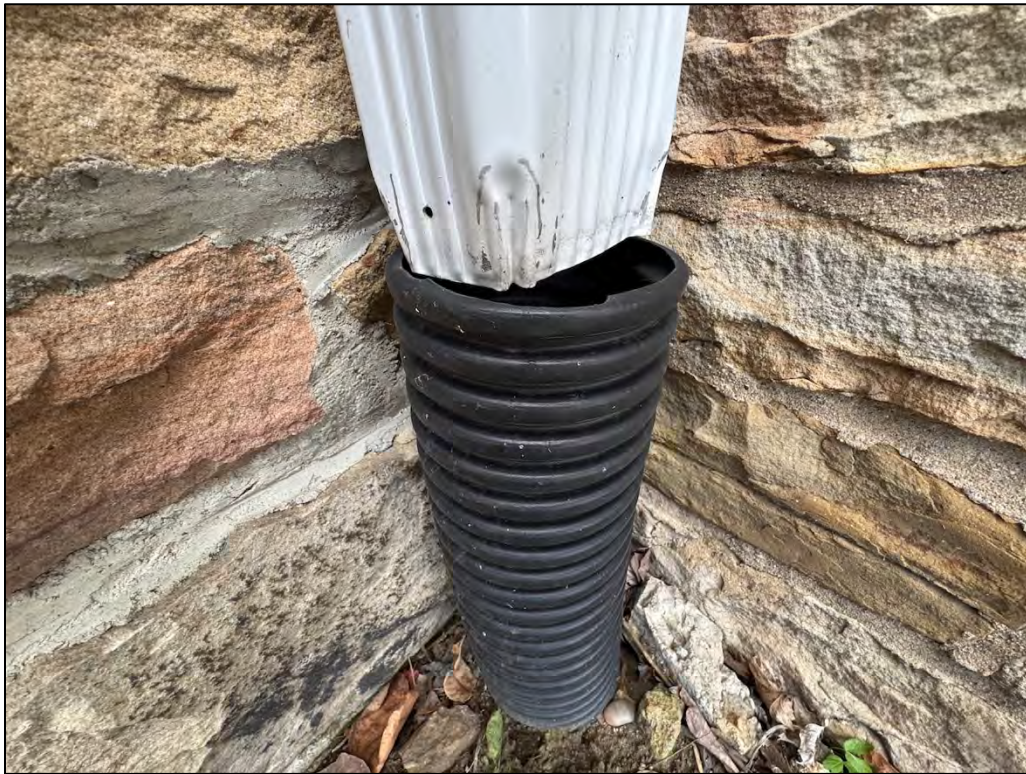
*Plate 44. Detail of downspout not directly connecting with drain. Splash back can erode surrounding stone more quickly.*

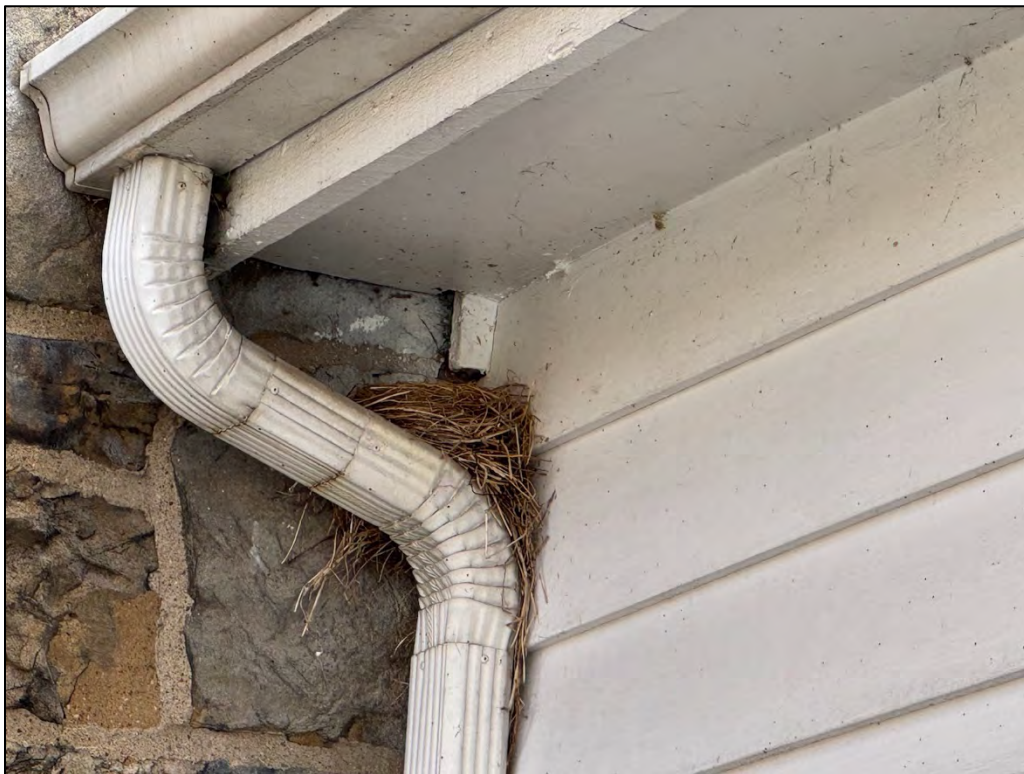
*Plate 46. Several downspouts provide structural support for bird nests.*

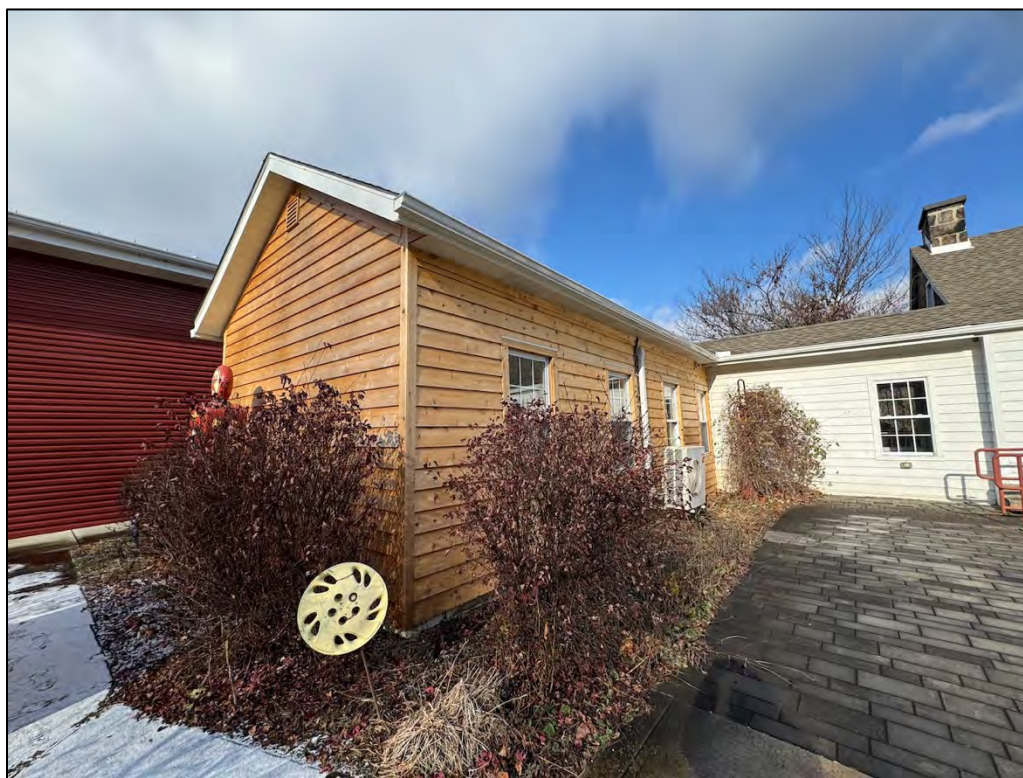
*Plate 49. Newly re-sided gallery with new gutters and downspouts.*

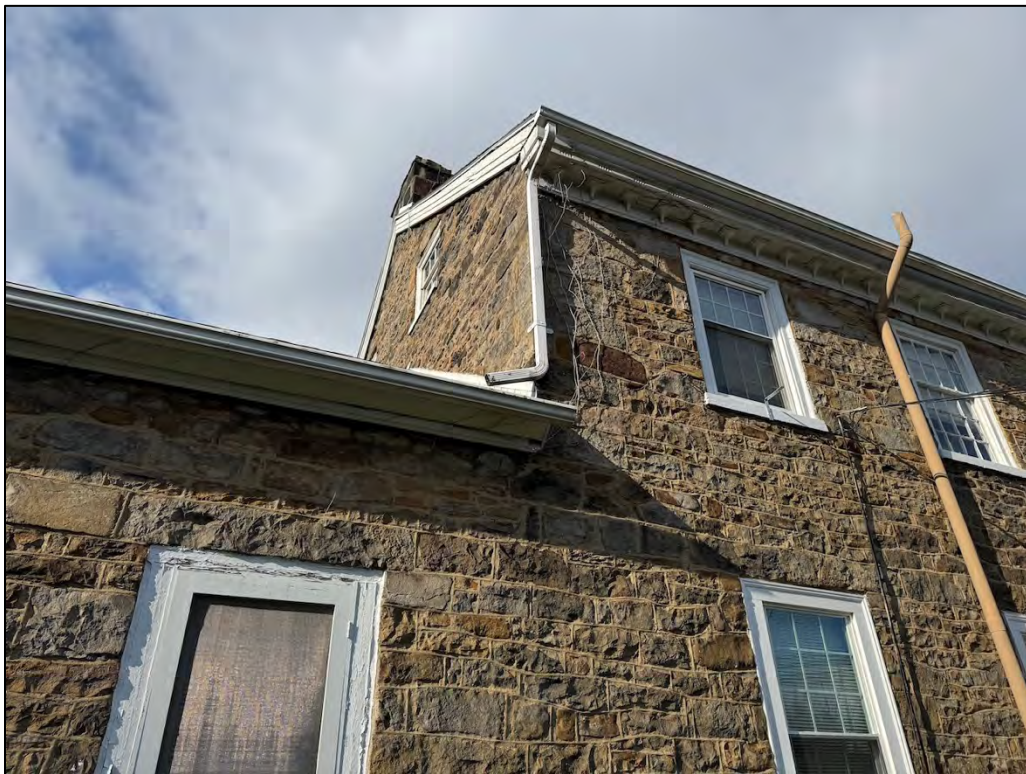
*Plate 52. Typical gutter and downspout on east elevation.*

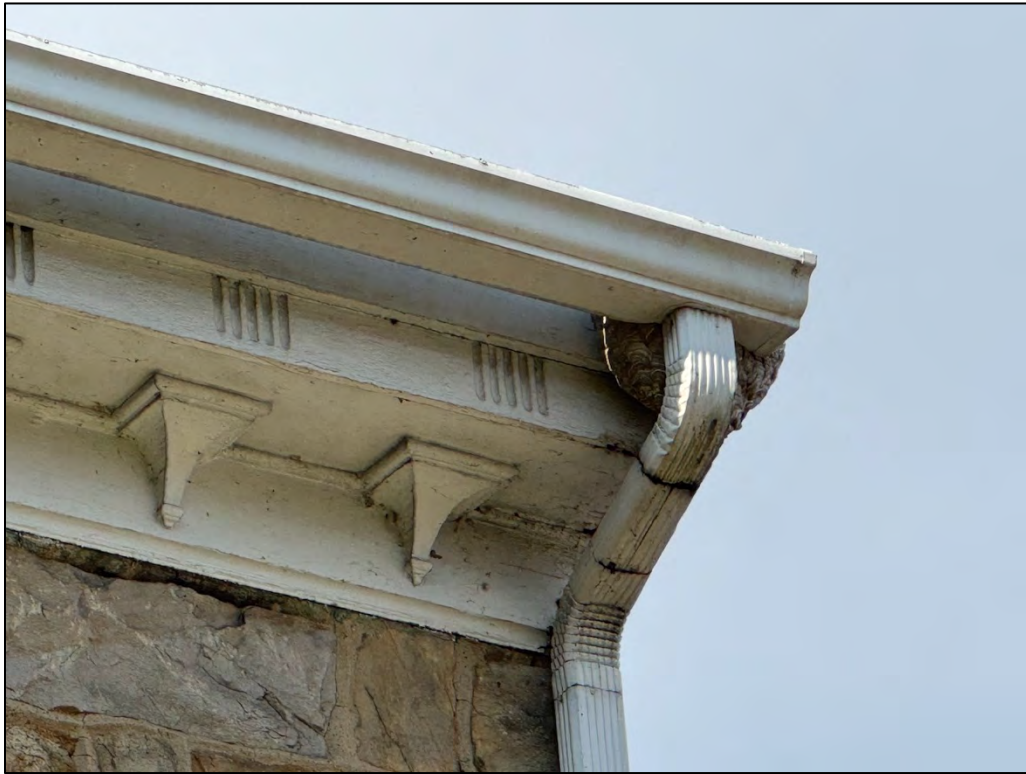
*Plate 53. Downspouts also provide support for bees' nests.*

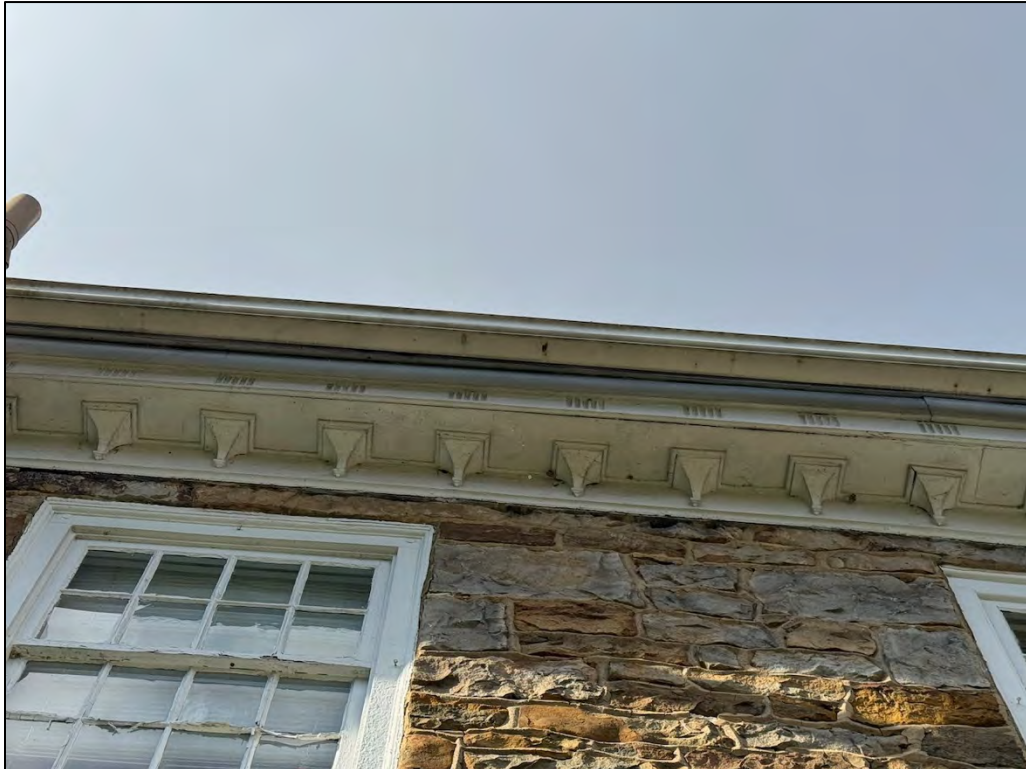
*Plate 54. Detail of rust spots and holes in the gutter, east elevation.*

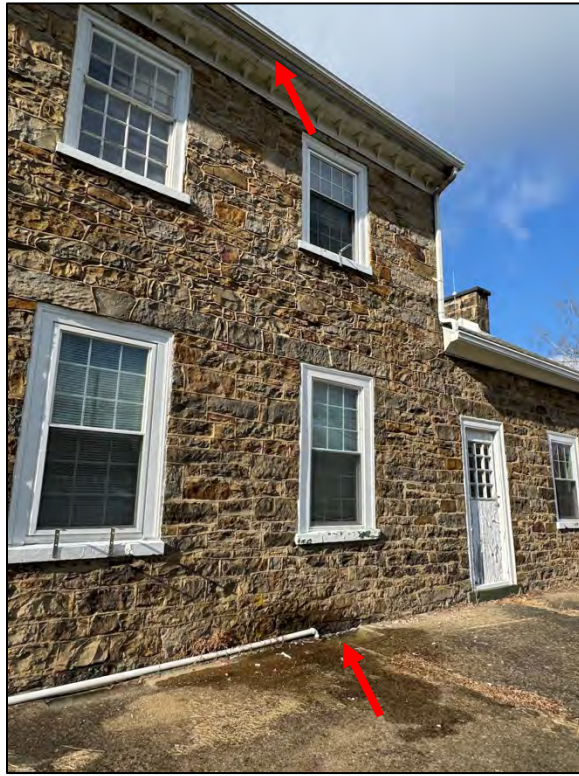
*Plate 55. Image depicting the moisture directed to the foundation from faulty gutter.*

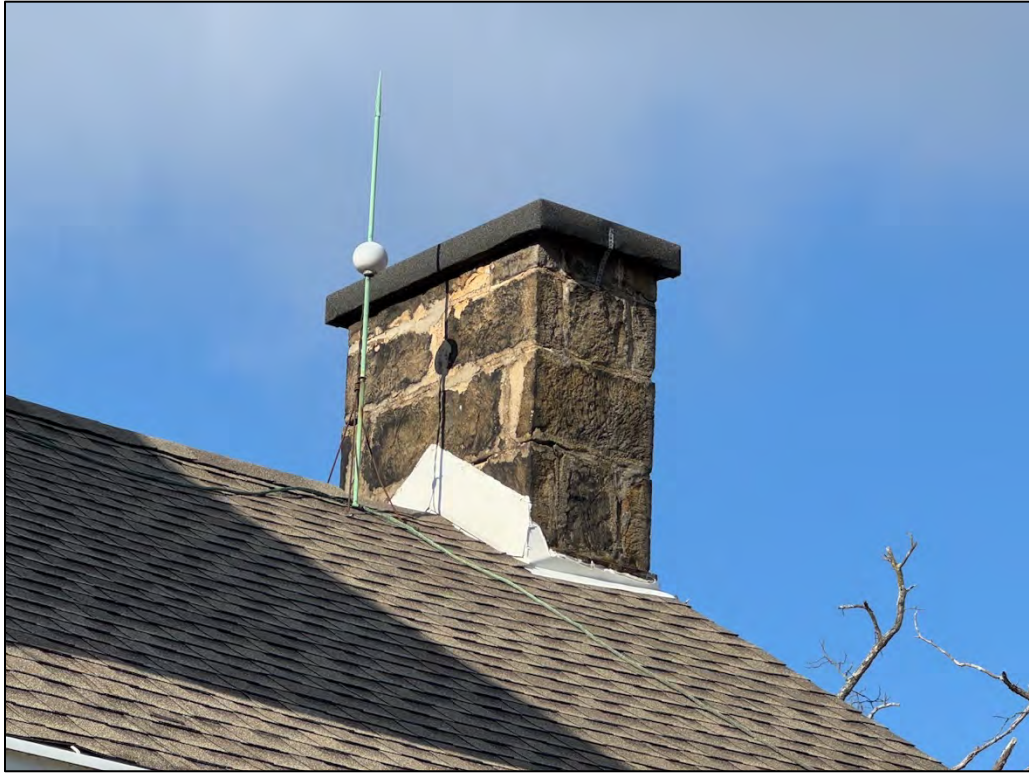
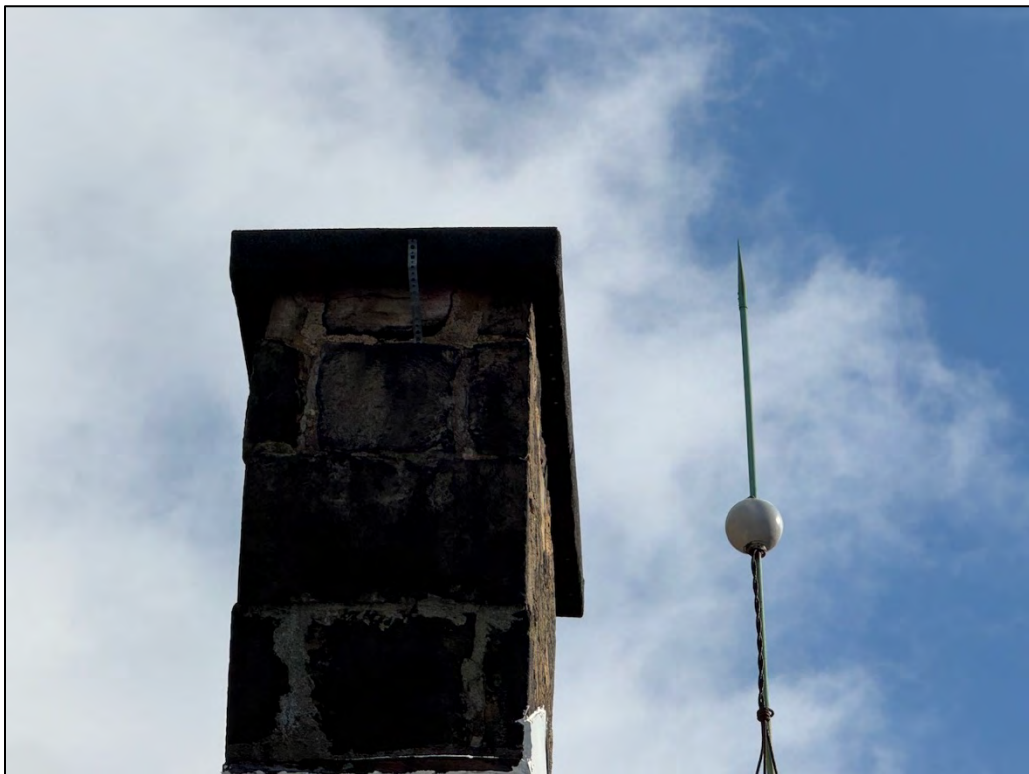
This gable-end stone chimney is located on the northern end of the northern wing of the building. The stack is covered with a wood-framed, tarpaper covered box, likely installed as a protective measure. The stack appears to have been repointed previously although the mortar does not appear to match the historic in composition or tooling. Cracks and voids are visible in the joints, suggesting mortar failure and possible moisture penetration.

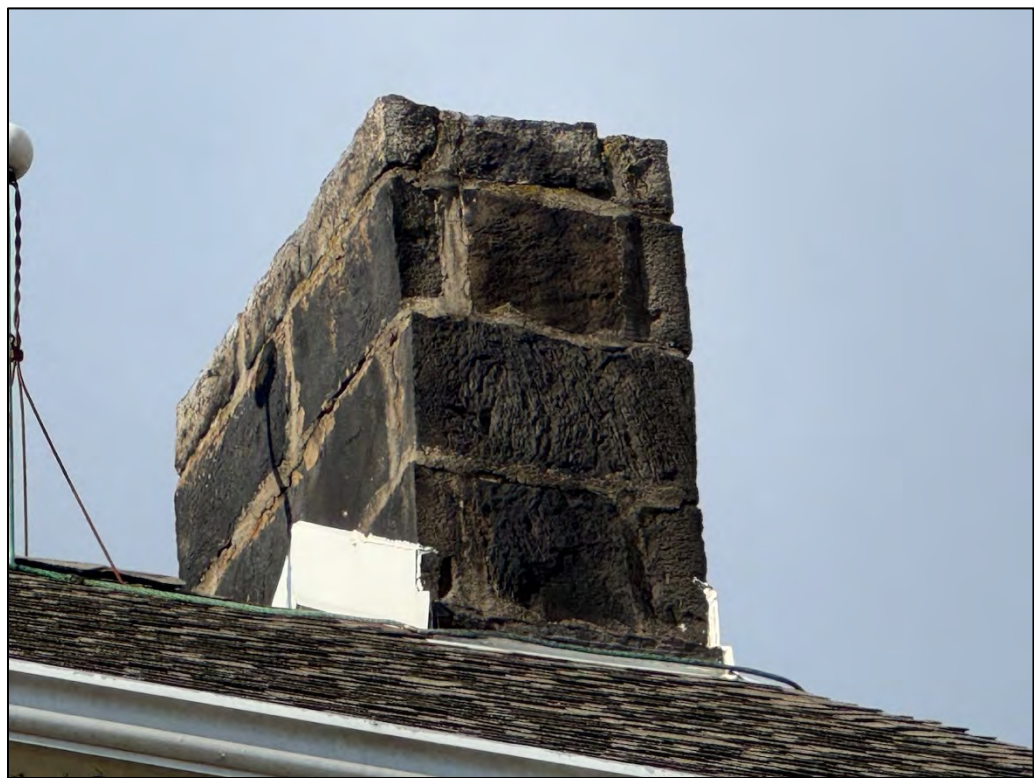
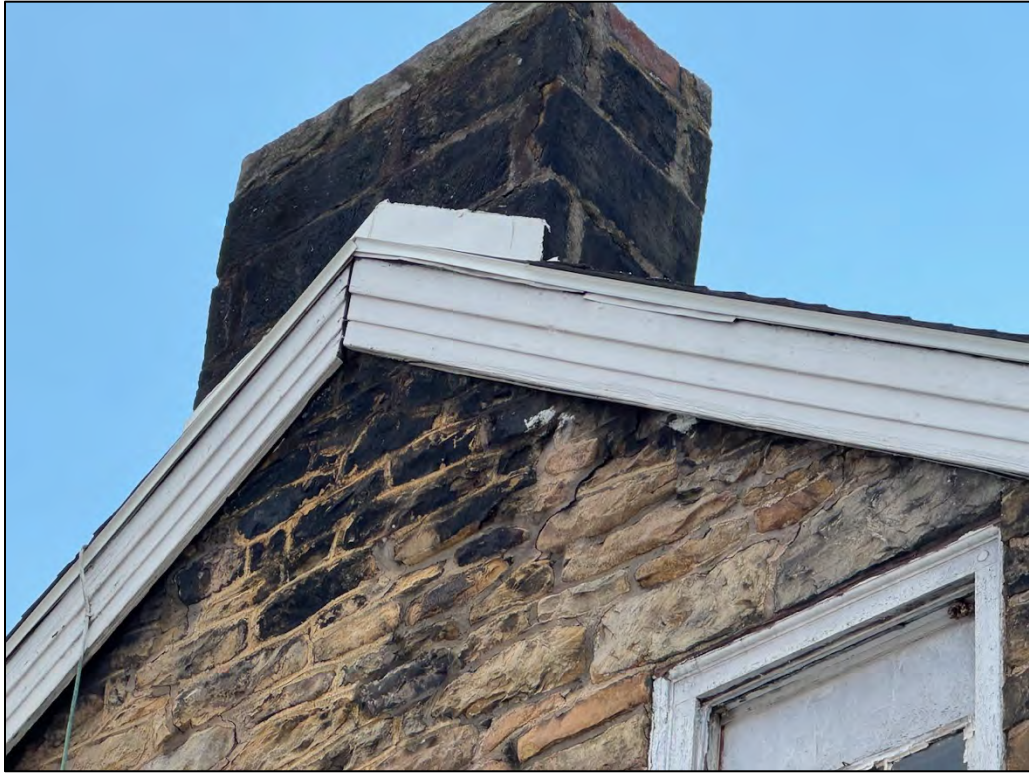
This stone chimney is on the north elevation of the main core of the building. This chimney stack is showing minor cracking and deterioration of its mortar. The stack is not covered by a cap, which increases vulnerability to water intrusion, freeze-thaw cycles, pest entry and interior flue degradation.

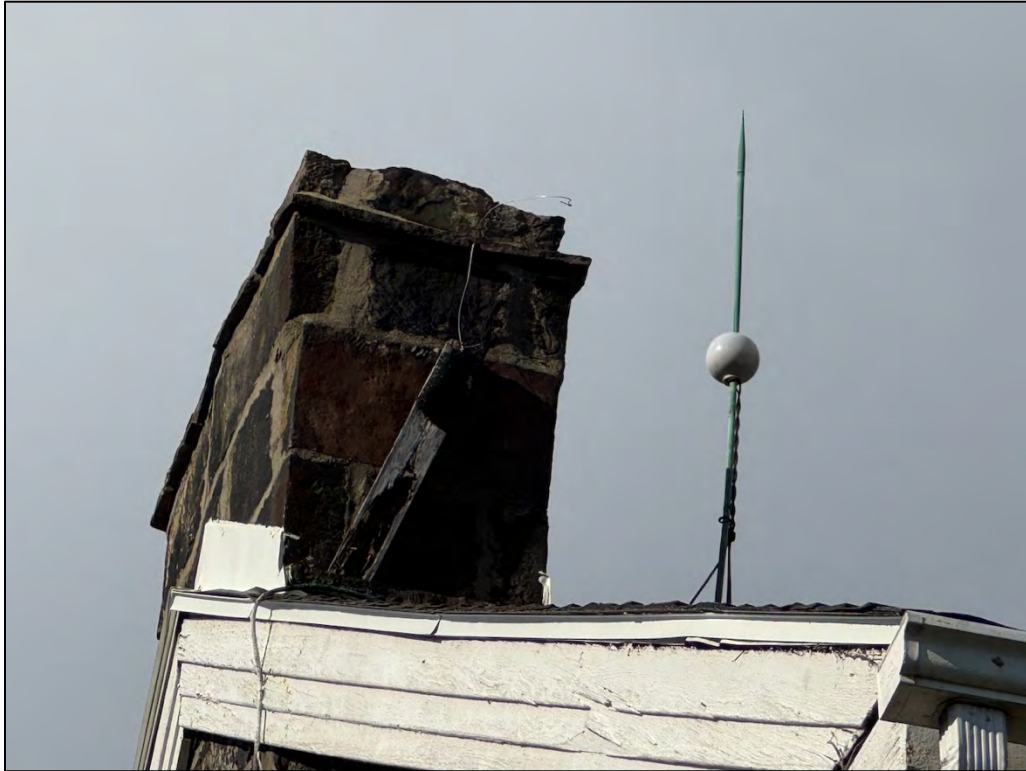
This uncovered stone chimney is located on the southern end of the main core of the building. This stack is also uncovered with a piece of wood and wire hanging from its east side, indicating the failure and loss of the original cap. This stack is at risk of moisture infiltration.

*Plate 65. Chimney 3, facing west. There is no cap on the chimney.*

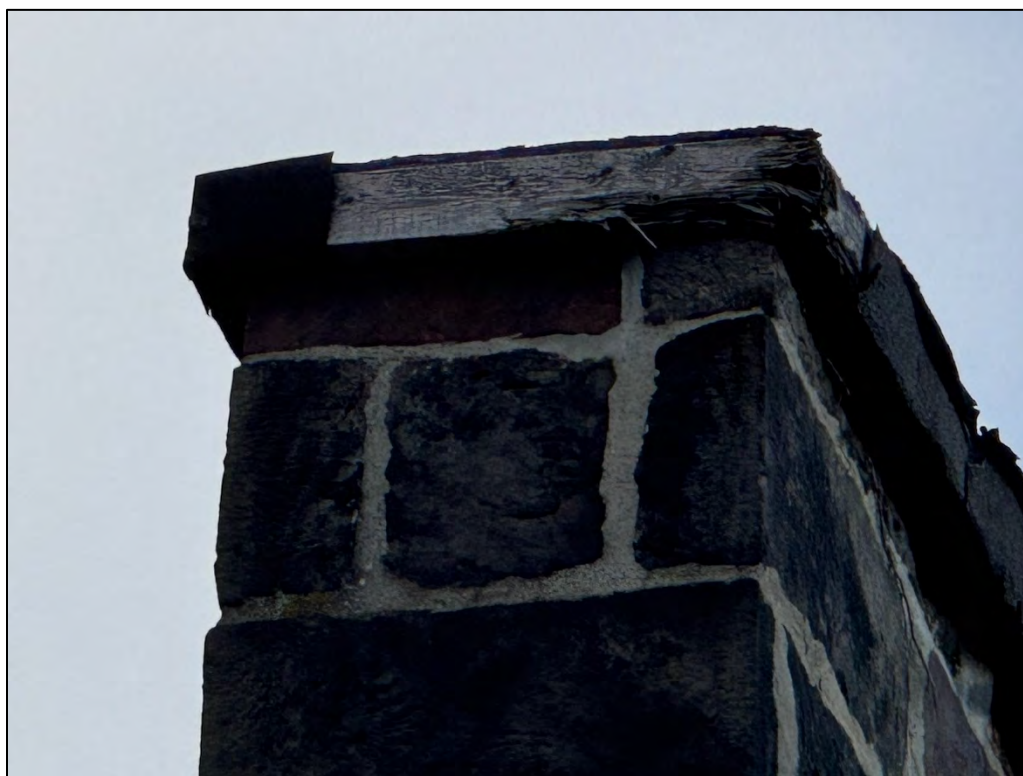
Located on the south elevation of the southernmost wing, this stone chimney historically had a beehive oven attached which was removed prior to 1930. This chimney appears to be in fair condition. A tar paper wrapped wood frame cap covers the top of the chimney, although it is likely not weathertight, allowing moisture inside of the building. Ghost marks of the original oven remain visible on the exterior masonry.

*Plate 68. Detail of Chimney 4. Note the cap is constructed of wood wrapped in tar paper. Facing northeast.*
