# CONDITION ASSESSMENT REPORT

## THE LINCOLN HIGHWAY HERITAGE CORRIDOR

3435 State Route 30 East  
Latrobe, Westmoreland County, Pennsylvania

Abbreviated  
Condition Assessment Report  
Alexander Johnston's "Kingston House"

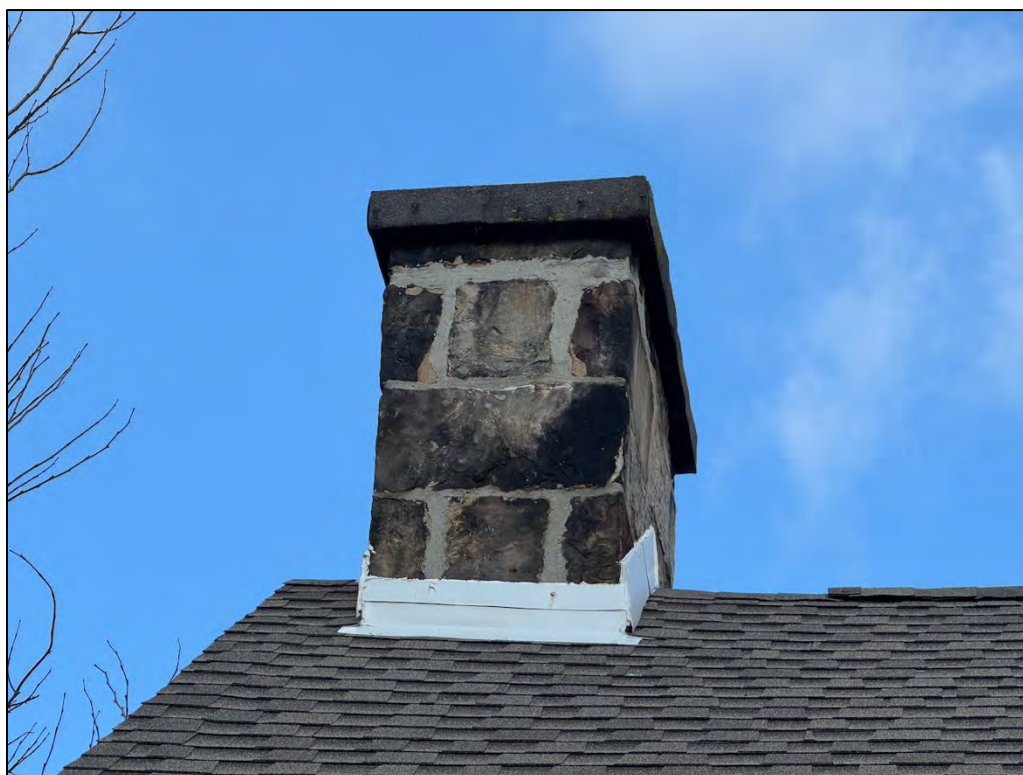
This chimney is located in the westernmost ell which historically served as the tavern but now serves as the Tot Room. This chimney appears to be in good condition although it has been repointed recently and appears to have a wider mortar joint than was historically appropriate. It is difficult to discern the mortar composition from ground level; however, the cap appears to be intact. According to historic drawings, this chimney also had a beehive oven attached to the ground level, similar to the south wing.

*Plate 72. Chimney 5 in Tavern/Tot Room. Facing north.*

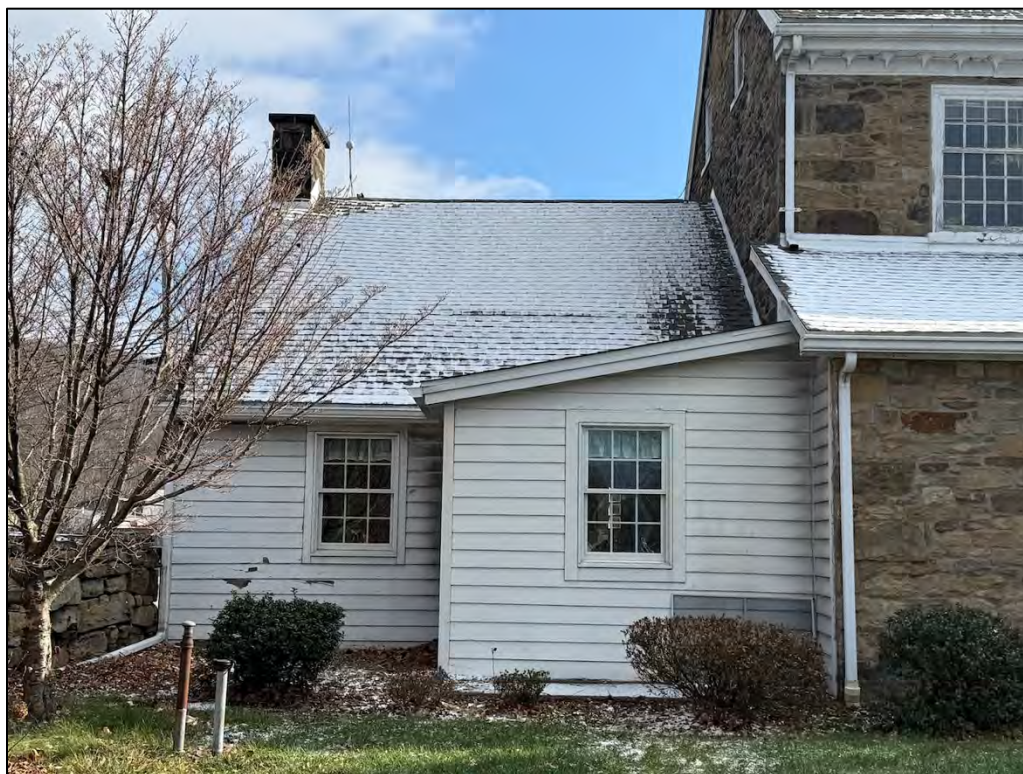
*Plate 74. West elevation, facing east. Note the flaking paint and sediment on the walls.*

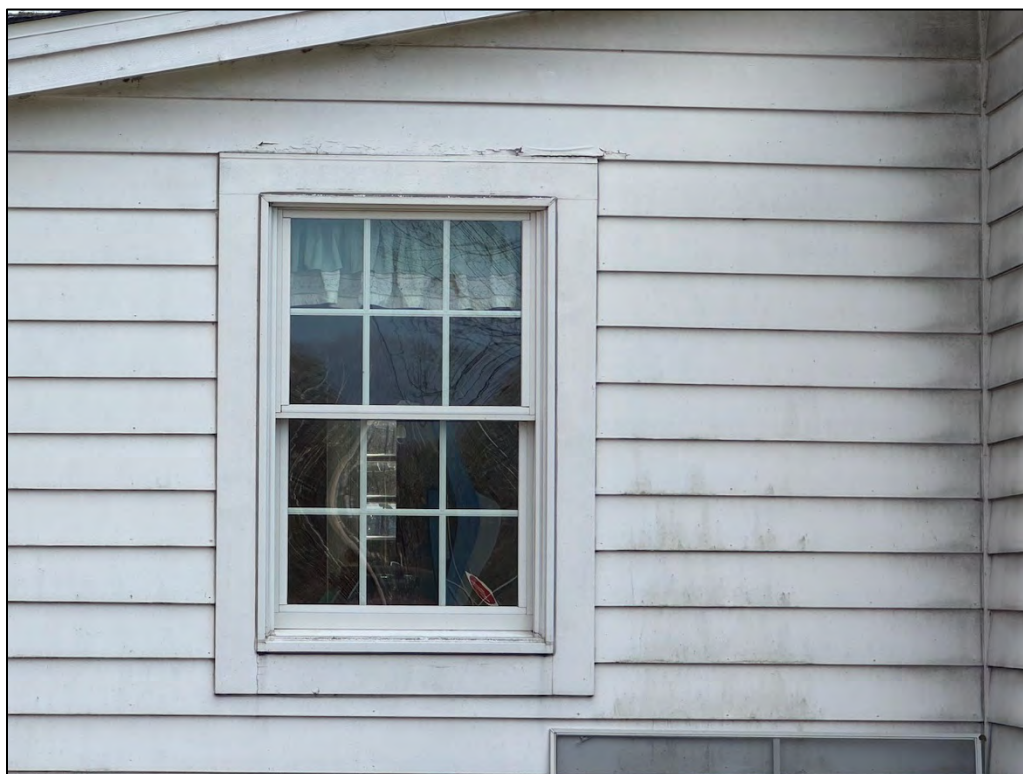
*Plate 75. West elevation, facing east. Note the flaking paint at the top of the window.*

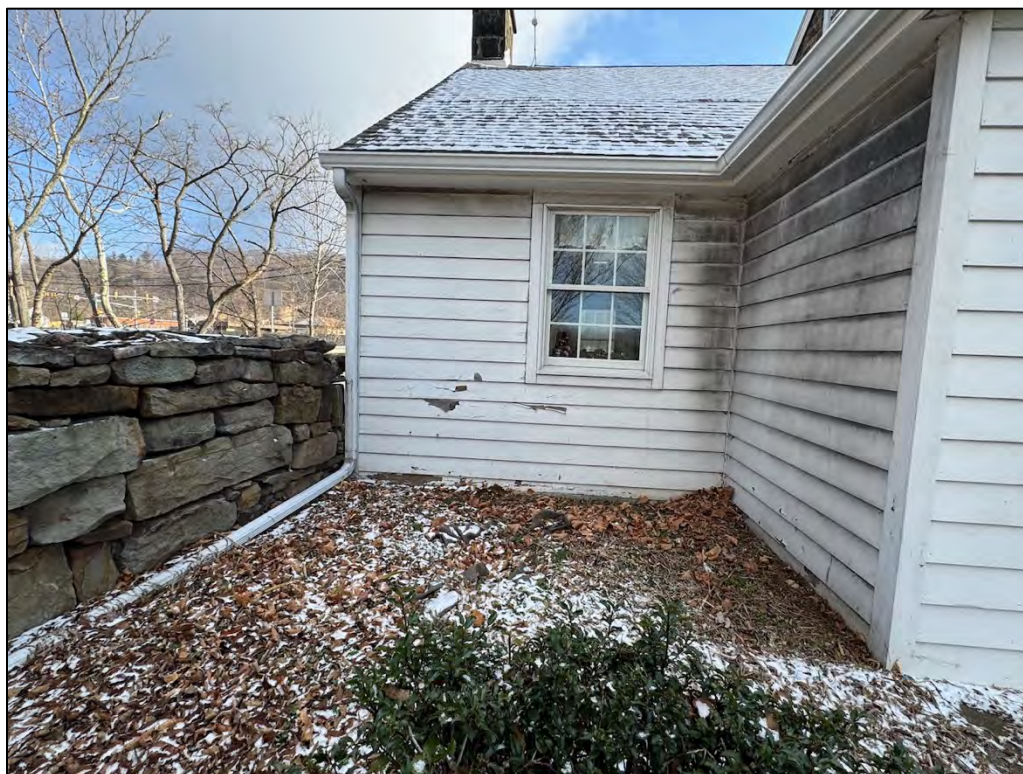
*Plate 76. West elevation, facing east. Note the flaking paint and sediment.*

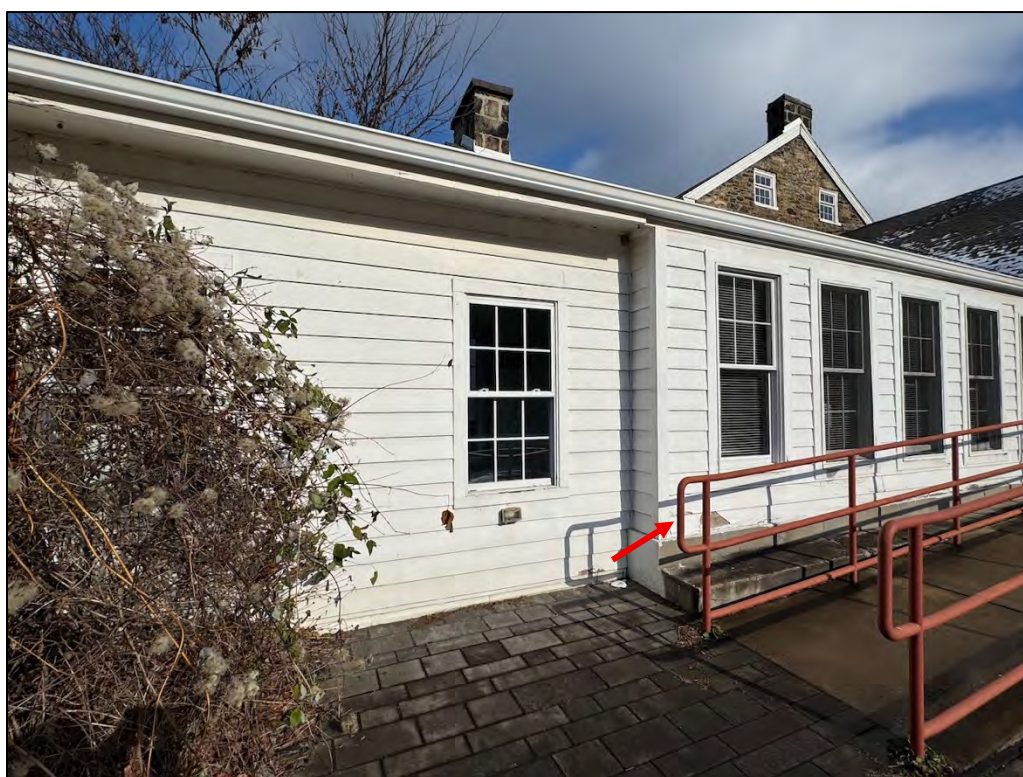
*Plate 79. South elevation, facing north. Note peeling paint.*

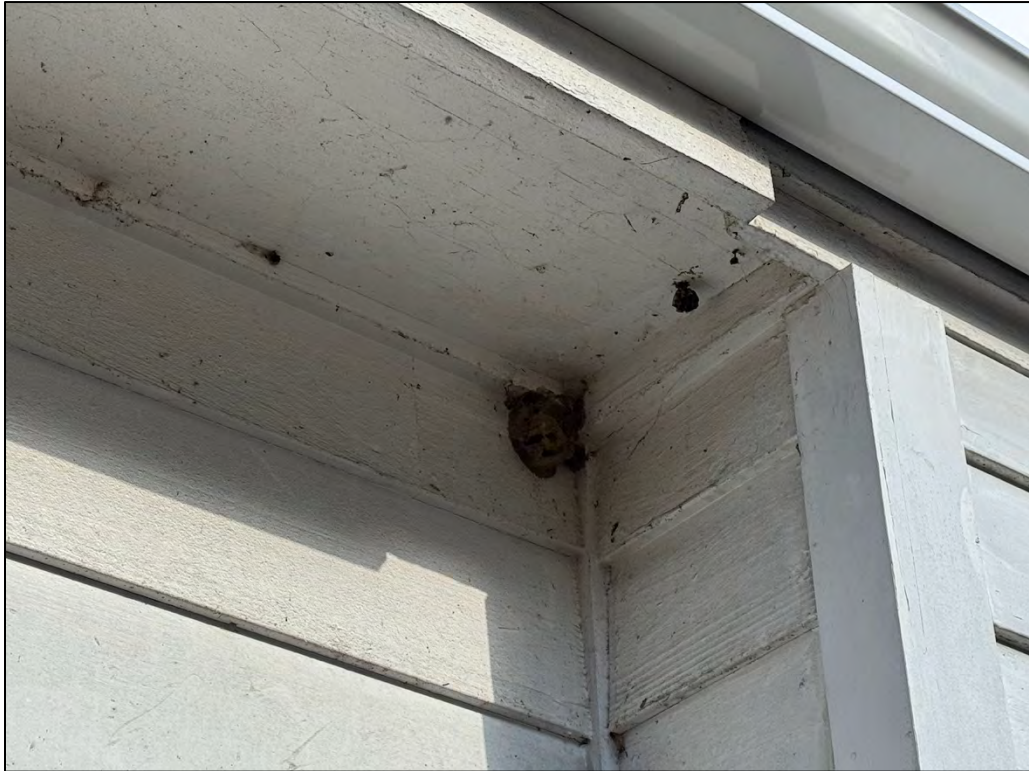
- Insect nests were observed beneath the eaves in several location, suggesting small gaps and sheltered conditions favorable to nesting.
- Deterioration at the eaves and soffit may indicate ongoing moisture issues associated with failing gutter systems.

*Plate 83. Insects building nests under eaves.*

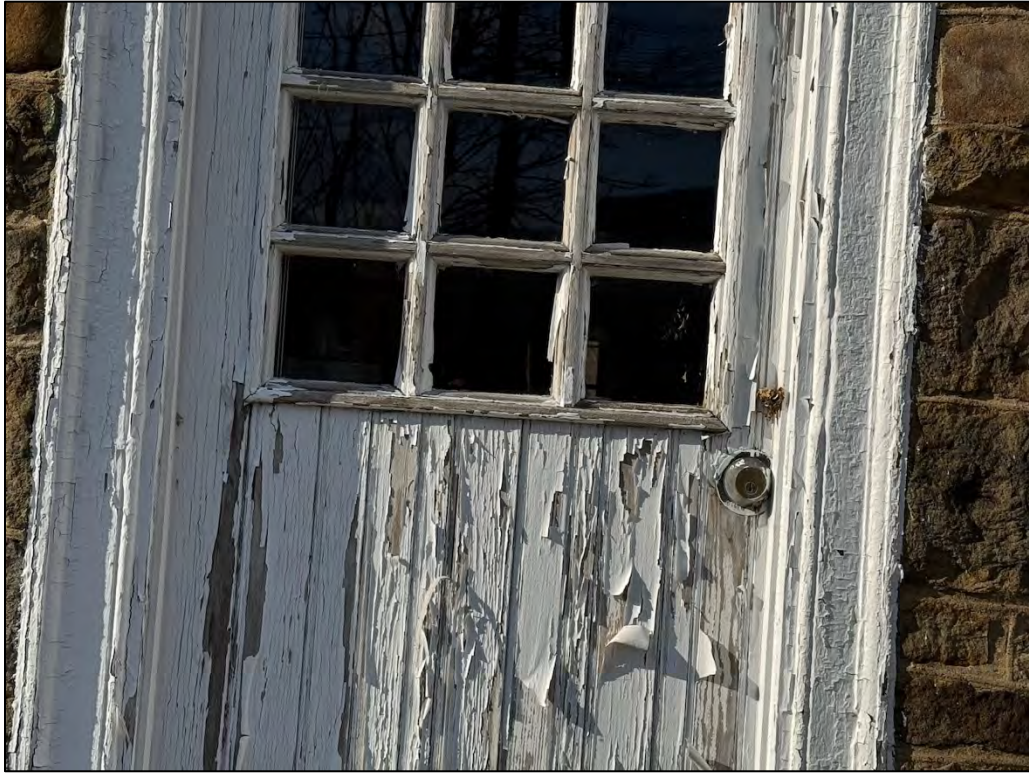
*Plate 87. Northernmost door on west elevation. The door handle has been replaced with a keyed lock.*

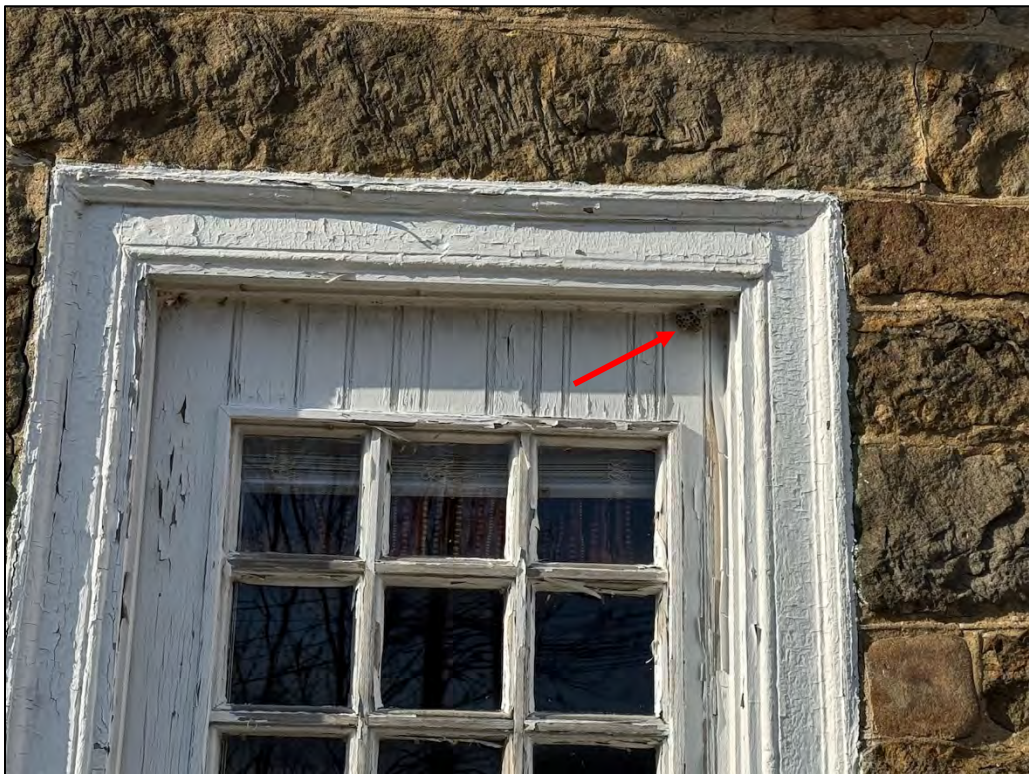
The exterior hardware has been replaced with a modern keyed lock, while an earlier box lock and key remain present on the interior, indicating alterations. Insect nesting was observed in the exterior upper corner of the door opening, contributing to staining and localized surface damage. The door is set on a painted stone threshold, which may also contribute to moisture

*Plate 88. Northernmost door on west elevation. Note the insect nest in the upper corner.*

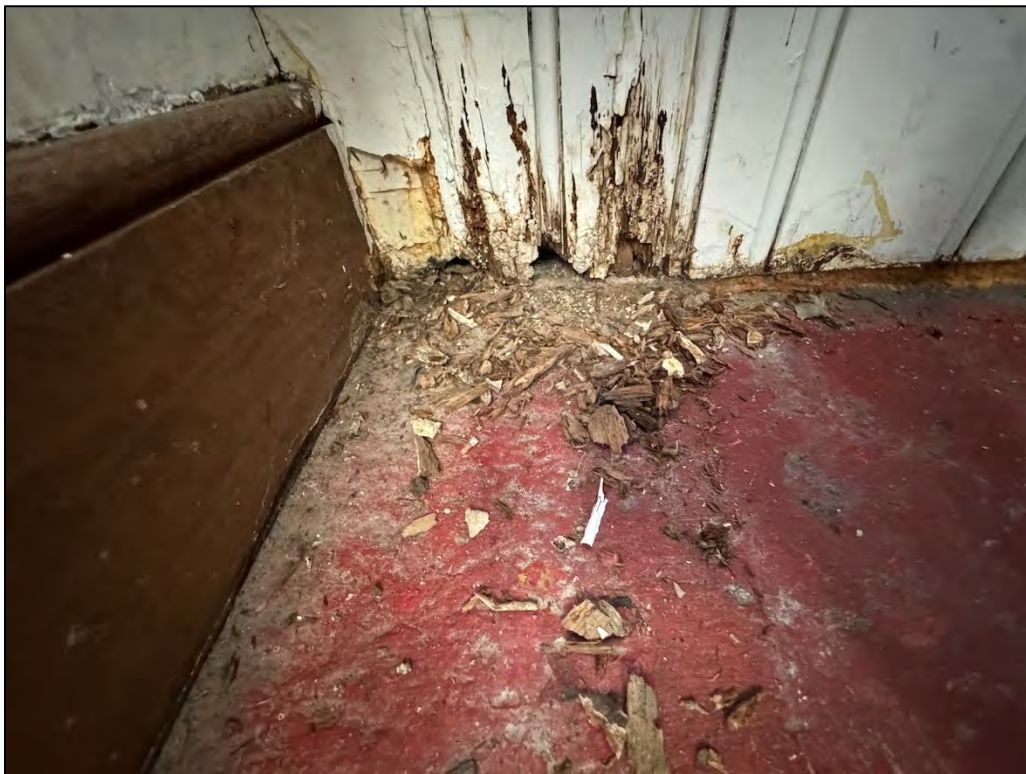
retention at the base of the wood components. The use of spray foam insulation may also be retaining moisture and encouraging decay.

*Plate 90. Bottom left corner (northernmost) of door. Note the deterioration of wood from moisture and insect activity.*

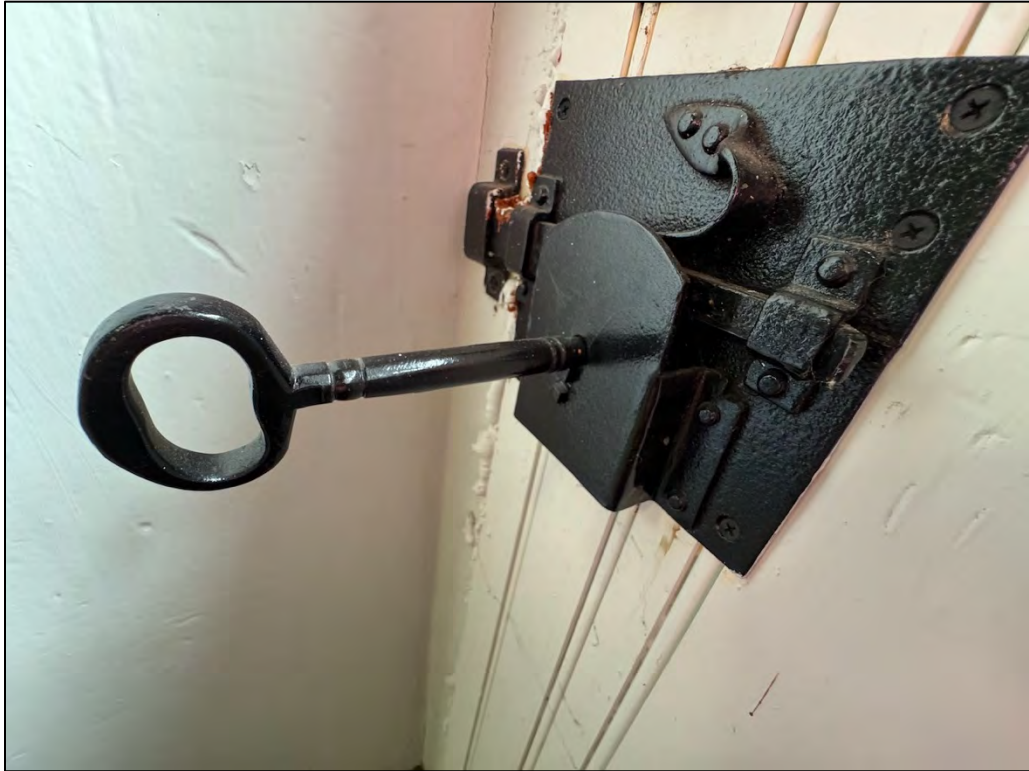
*Plate 91. Assumed original box lock and key (installed on a replacement door).*

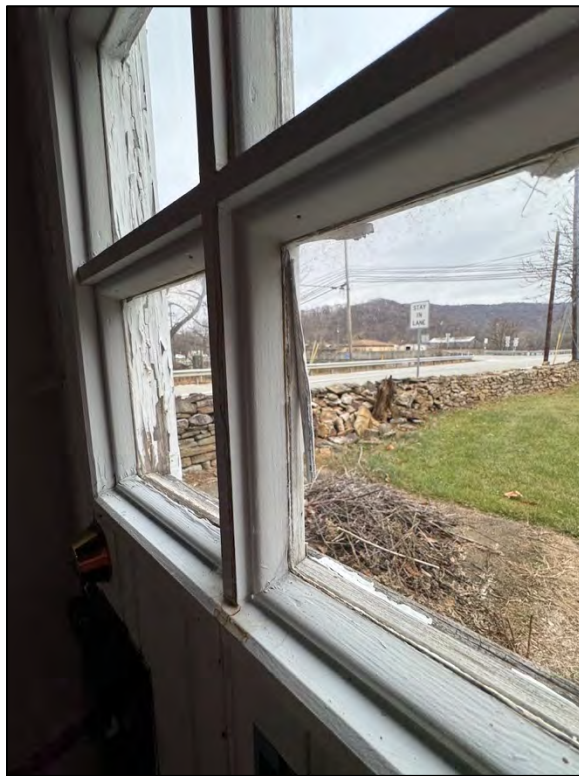
*Plate 92. Interior of window, showing the thickness of the muntins, facing northeast.*

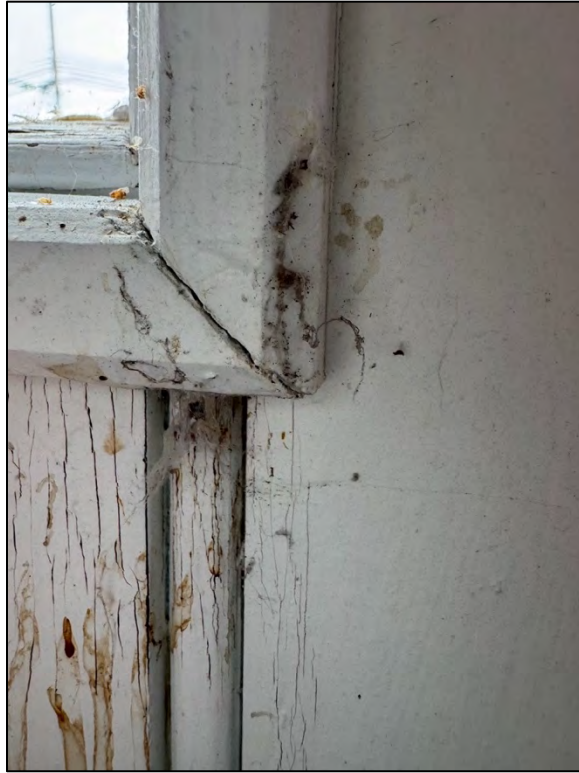
*Plate 93. Detail of southern corner of window in door, facing northeast. Note staining from insect activity.*

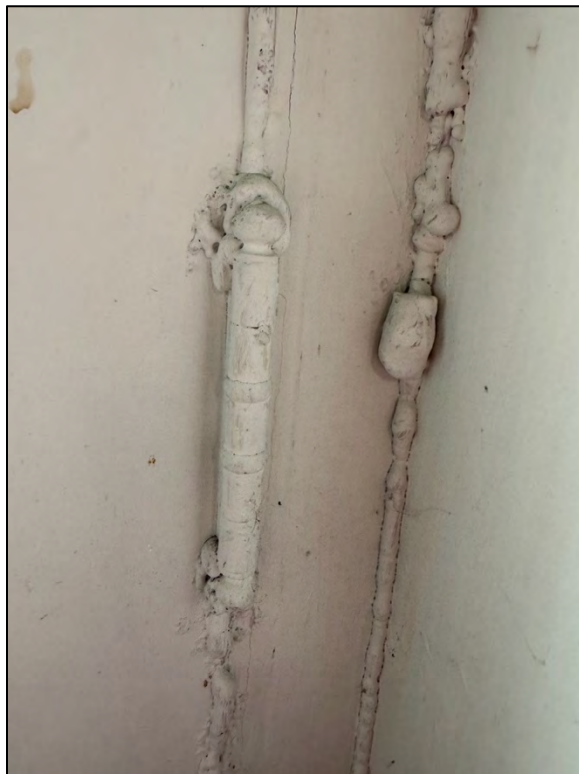
*Plate 94. Painted hardware and painted insulation near door*

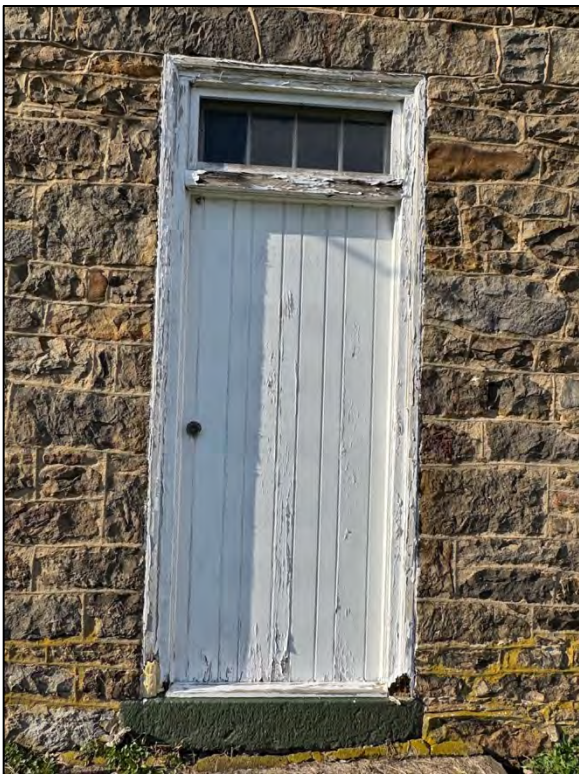
*Plate 95. The front door on the east elevation.*

Existing Condition: The door exhibits advanced deterioration due to prolonged weather exposure. Exterior paint failure is widespread, and the wood shows evidence of moisture-related damage. Both lower corners of the door have been previously repaired using spray foam. The southern corner retains exposed foam, while the northern corner appears to have lost the material, likely due to rodent activity and continued weathering.

The wood at the lower portions of the door is in poor condition, with pronounced vertical checking, splintering, and material loss. Remaining caulking between the wood casing and surrounding stone masonry is brittle and failing, leaving gaps that permit moisture infiltration and pest entry. The transom frame and screen insert also show peeling paint and weathering, indicating past deferred maintenance.

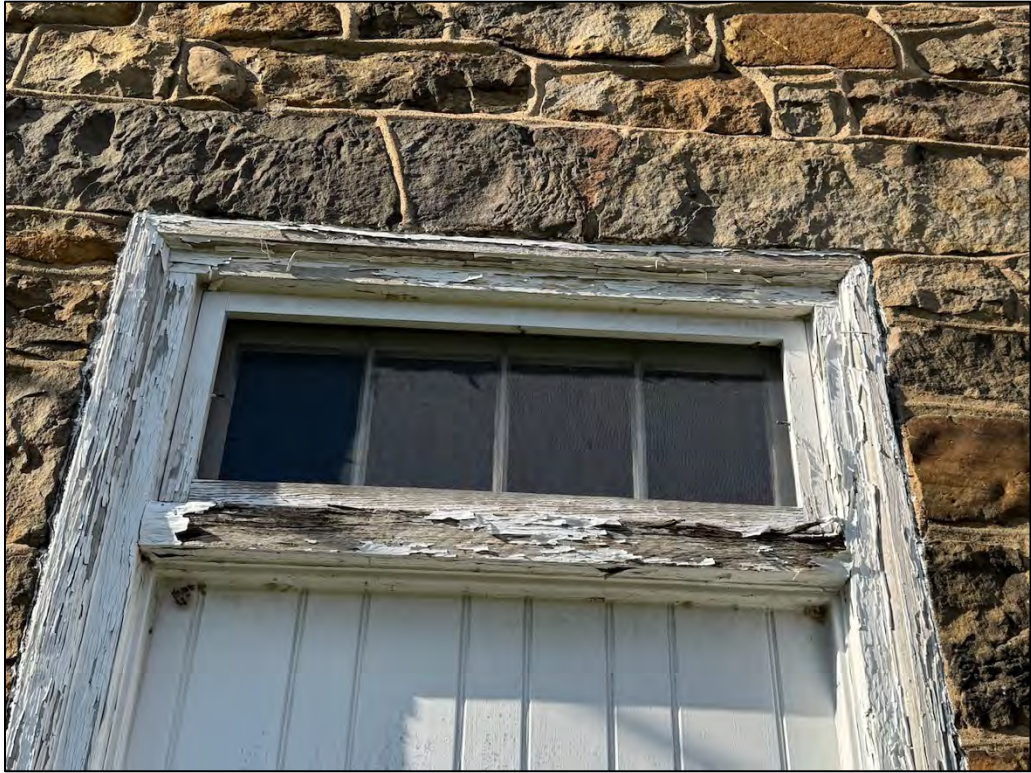
*Plate 99. The transom on the west elevation. Note the screen frame in transom and deteriorated paint.*

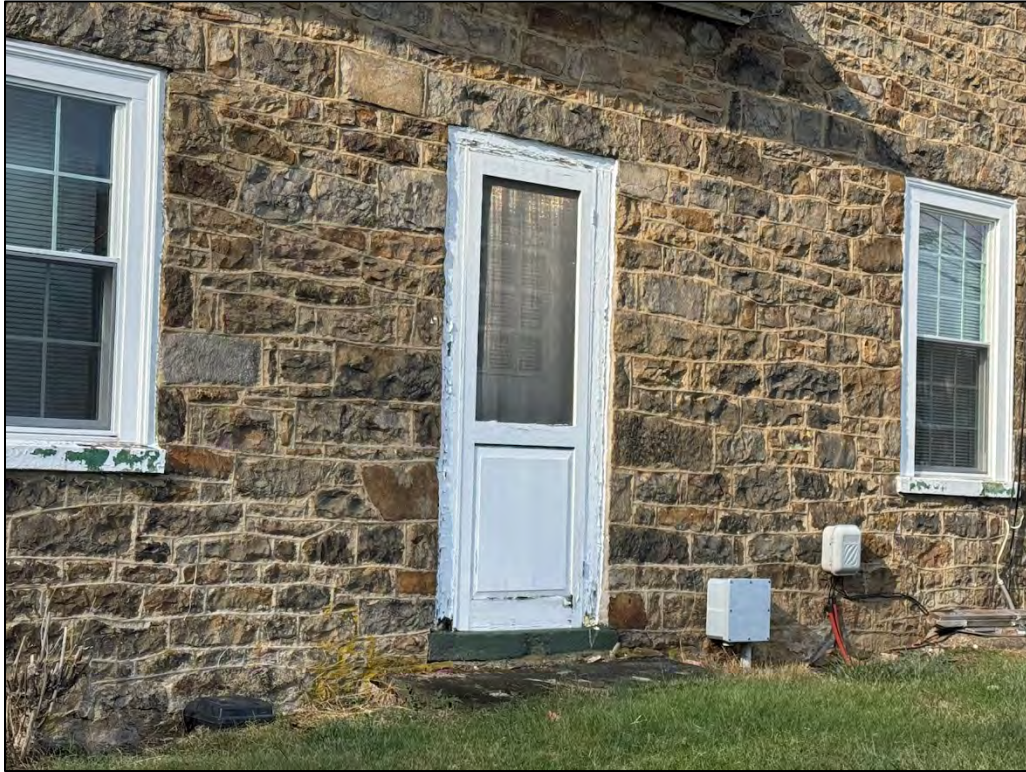
*Plate 102. Southernmost door on east elevation.*

**Existing Condition:** The door exhibits moderate deterioration due to prolonged weather exposure. Exterior paint failure is widespread, particularly along the lower portions of the screen door. The bottom left (southernmost) corner that appears to have been previously filled with spray foam; the material has since failed, leaving the wood vulnerable to moisture intrusion and pest activity. A similar repair is present at the bottom right corner, where the foam appears intact and present.

The surrounding screen door and frame also show signs of deterioration, including peeling and cracked paint, indicating deferred maintenance. The presence of spray foam repairs suggests repeated attempts to address localized decay rather than underlying moisture issues.

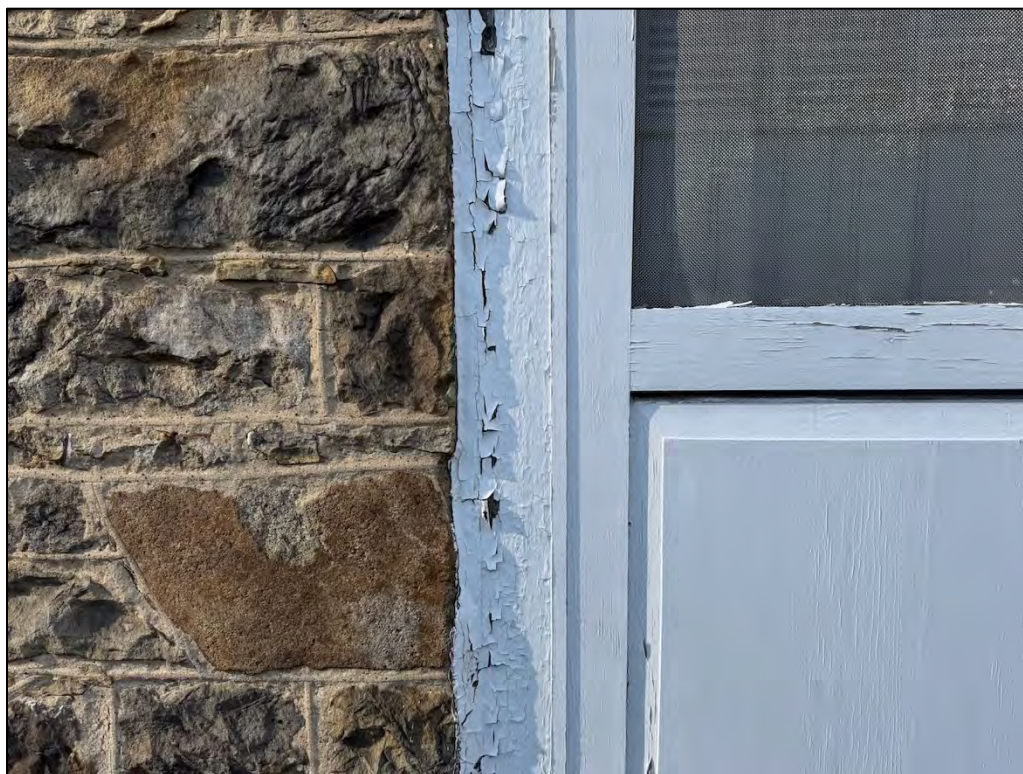
*Plate 105. Wood frame of screen door with flaked paint.*

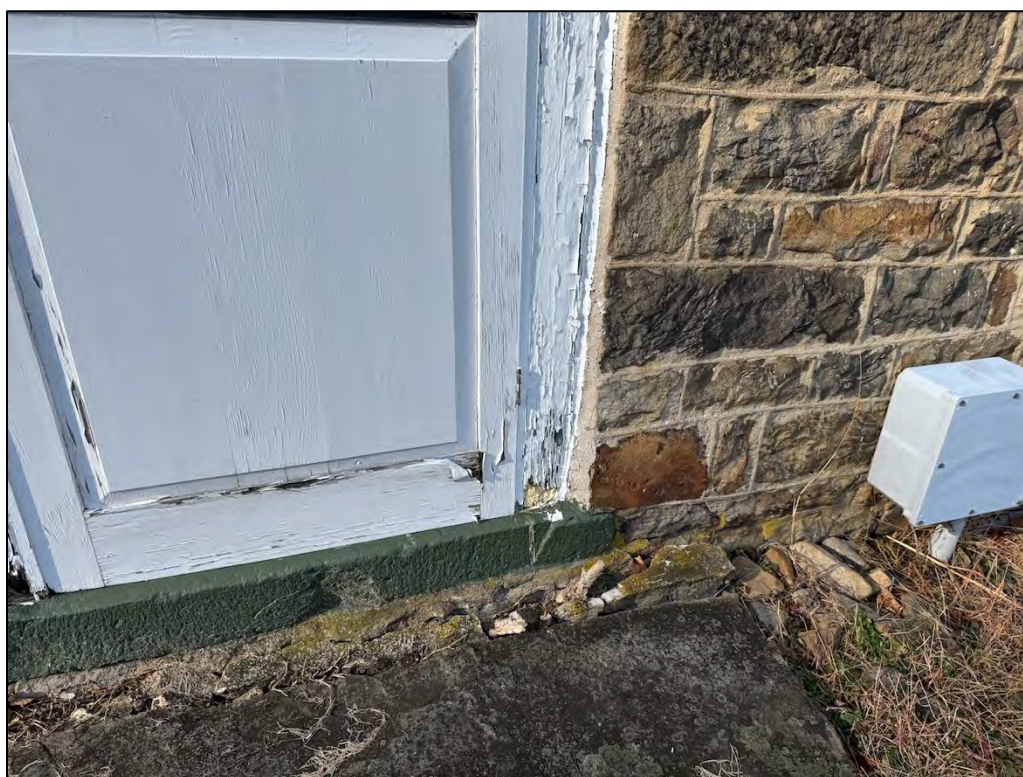
*Plate 106. Lower right (north) corner of door. Note flaked paint.*

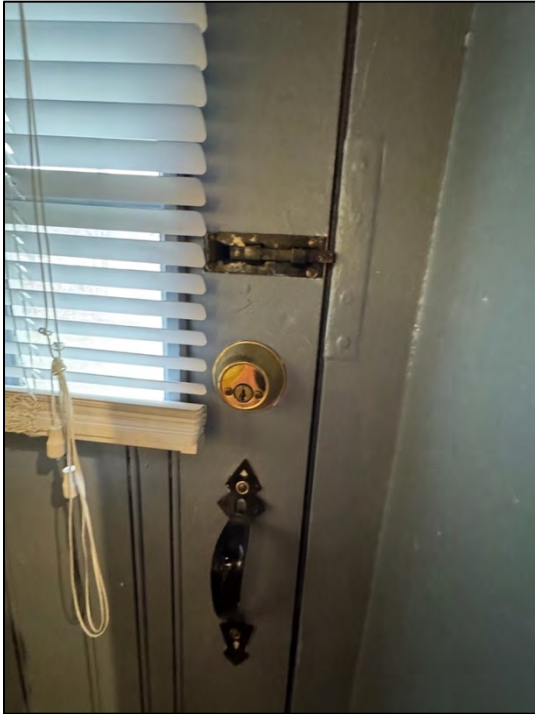
Interior hardware associated with this door include elements that may predate the current door assembly. A metal strap observed on the right side of the interior door may represent the original historic hardware. The hinge pin configuration appears consistent with a transitional hinge type, although further investigation would be required to determine whether these components are original to the building or salvaged from other, earlier doors.

*Plate 109. Detail of hardware, Ship Room, facing east.  
The strap on the right side of the door may be evidence of  
original hardware.*

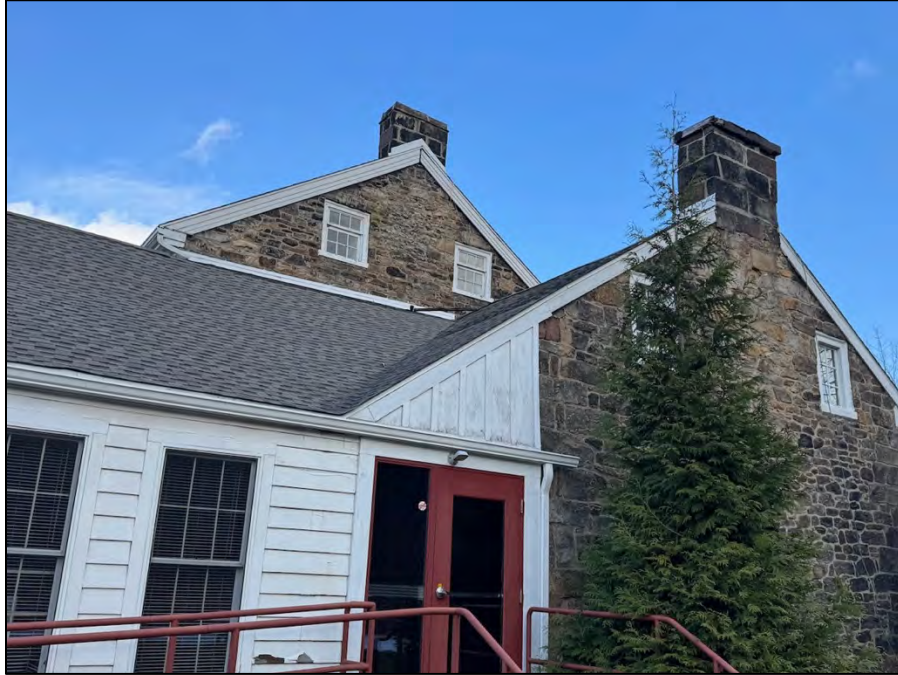
*Plate 112. View of the south elevation door.*

Existing Condition: This door is a modern, non-historic installation. It is in good condition and appears to be functioning as intended.

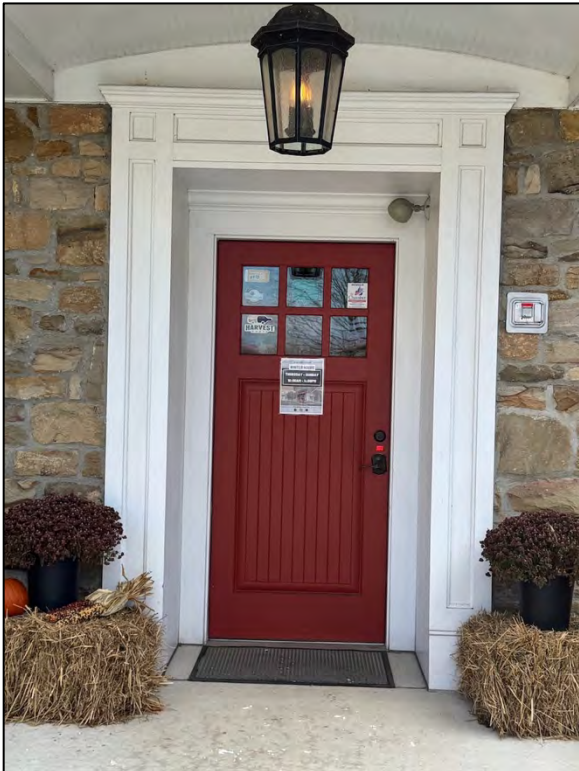
*Plate 114. Front entry on west elevation.*

Existing Condition: This door is a modern, non-historic installation framed by a paneled surround. It is in good condition and appears to be functioning as intended.

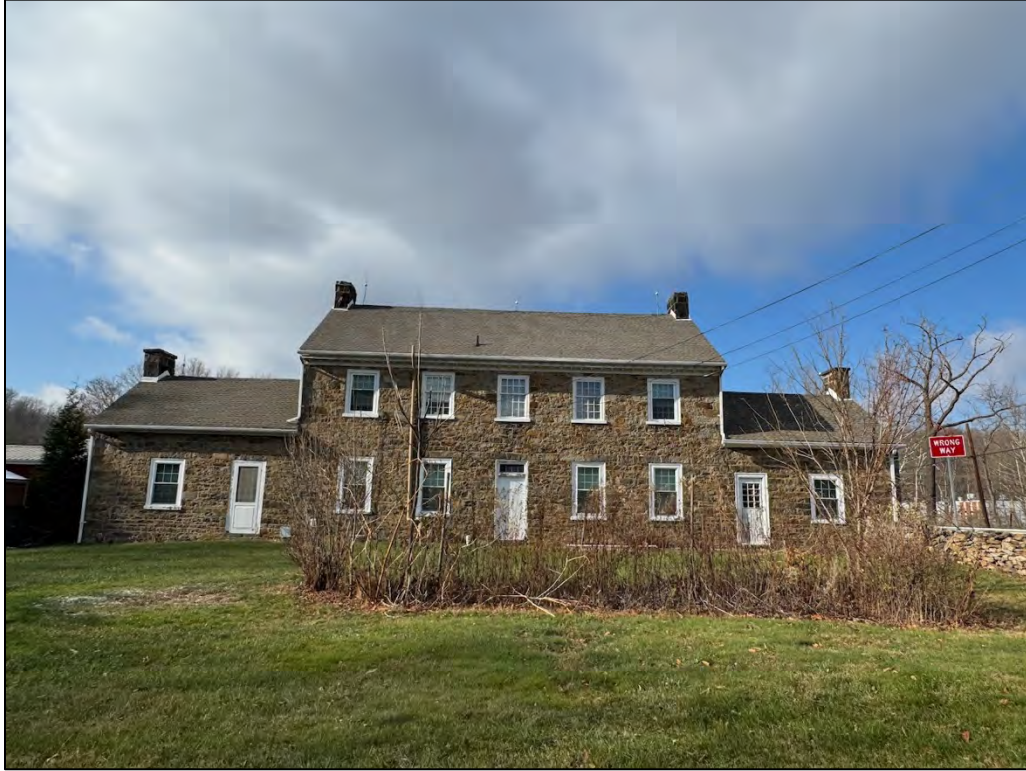
Existing Condition: The windows exhibit varying degrees of deterioration. The original and replacement wood windows are in severe need of rehabilitation as they appear to be allowing moisture infiltration into the building. The glazing compound has deteriorated on a number of the wood windows and paint failure is widespread. Several of the interior storm windows appear to have accelerated the deterioration of the wood windows by trapping moisture against the historic fabric. The vinyl windows appear to be in good condition as they are the most recent installations. These units feature faux muntins including an 8/12 glazing pattern on the east elevation, which differs from the documented historic sash configuration.

*Plate 116. Representative windows, east elevation. All first-floor windows are vinyl. The three central, second story windows are wood replacement units flanked by vinyl windows.*

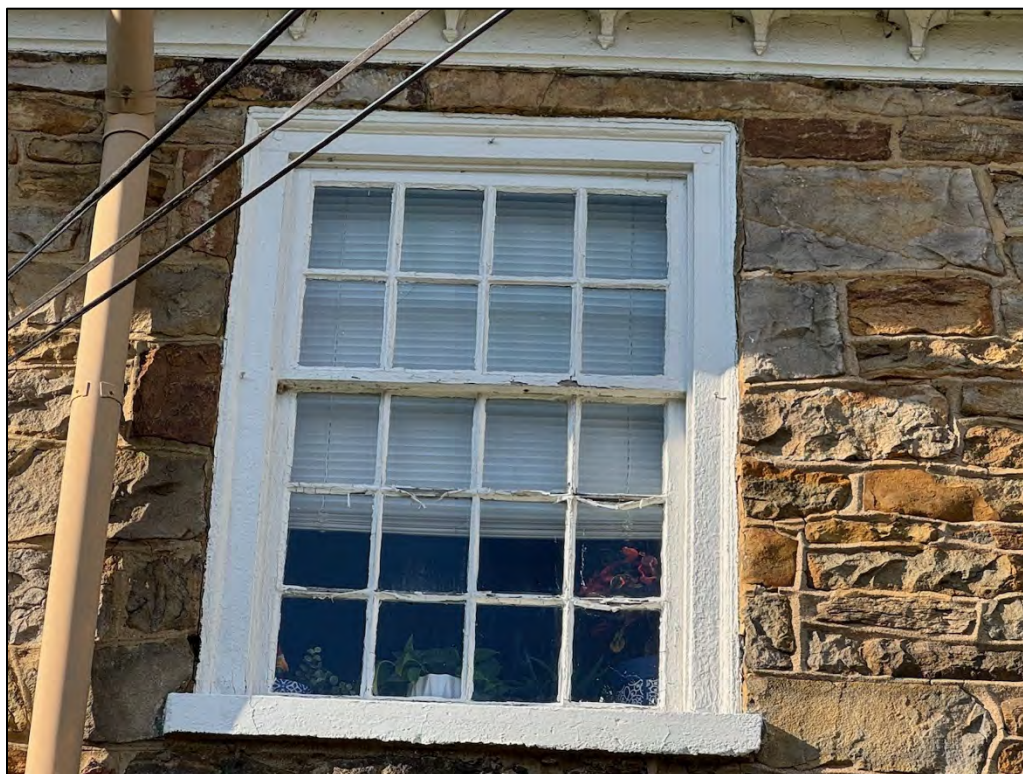
*Plate 118. Replacement wood window, east elevation (W2-9). Note the deterioration of the muntins and glazing.*

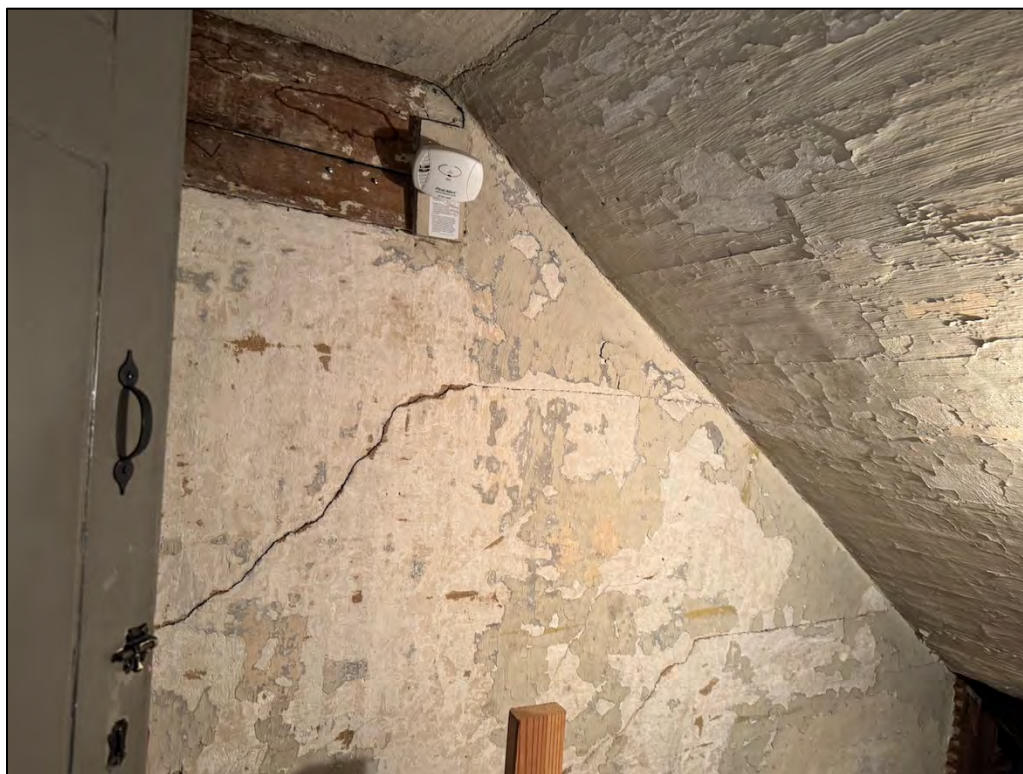
The stairwell ceiling and the west and north stairwell walls are finished in plaster over wood lath, exhibiting cracking at the upper landing. The south stairwell wall is covered with plaster over wood panels. The stair itself consists of open-faced wood treads with a simple 2x4 handrail.

*Plate 123. Room 1, basement entry, facing northwest. Note the crack in the plaster.*

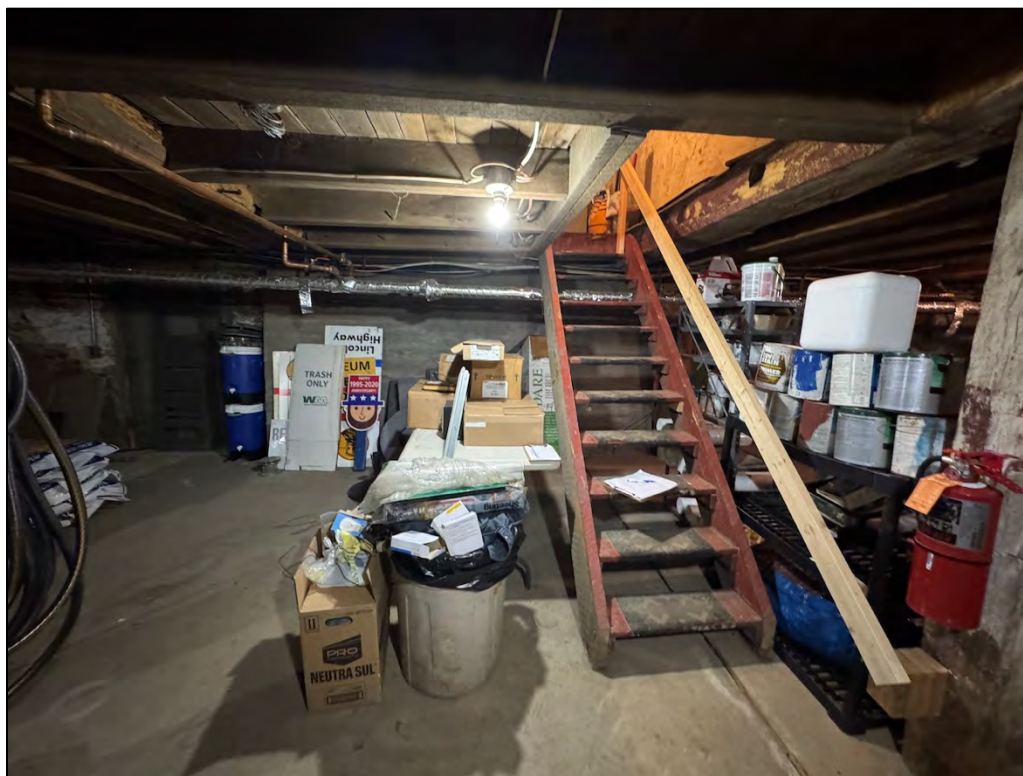
The main basement walls are constructed of cut stone and appear to be in good condition. Based on differences in joist types and framing, it is assumed that the interior stair access was added in the mid-to-late 19<sup>th</sup> century. Earlier access to the basement may have been provided by an exterior bulkhead door, trapdoor or ladder.

Plate 125. Room 1, facing west. The different type of support joist suggests this staircase was added later (mid-late 19<sup>th</sup> c.).

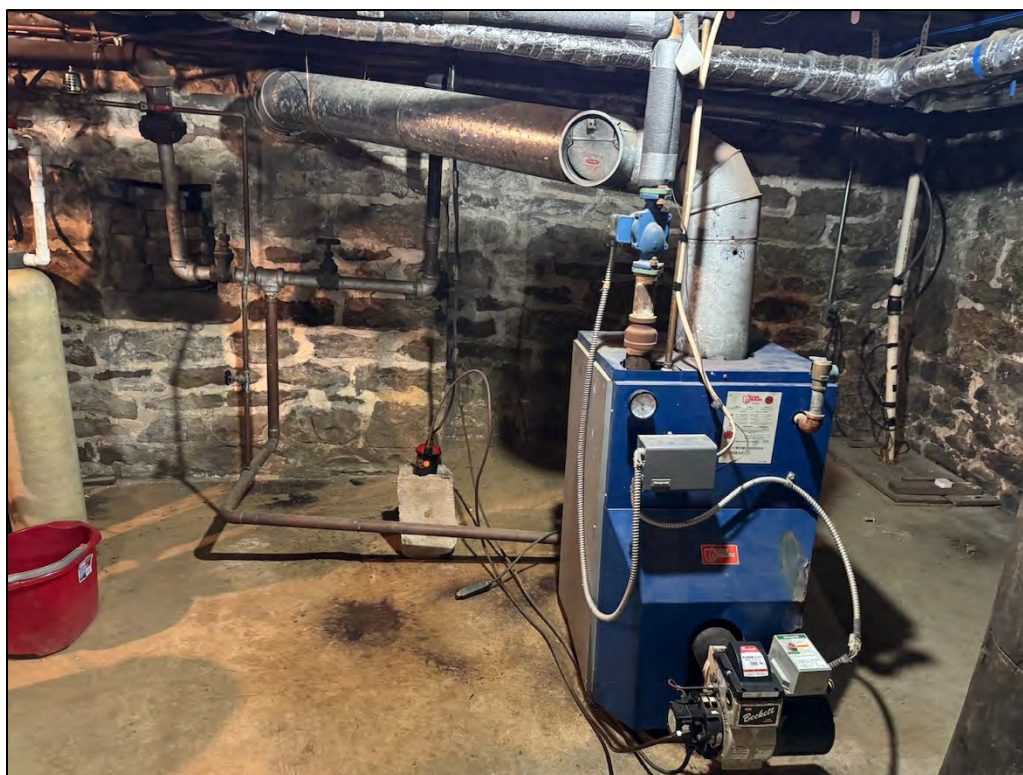
Existing Condition: Visual inspection indicates that the basement generally does not experience extreme water infiltration, except in unusual events. A sump pump intermittently discharges water to the exterior. At the time of the inspection (December 2024), the basement did not exhibit musty odors, visible biological growth or excessive moisture on stone surfaces exposed joists or the concrete floor. No biological growth was visible on the stones, exposed wood joists or flooring.

Plate 126. North wall, facing north. Note sump pump in the right corner.

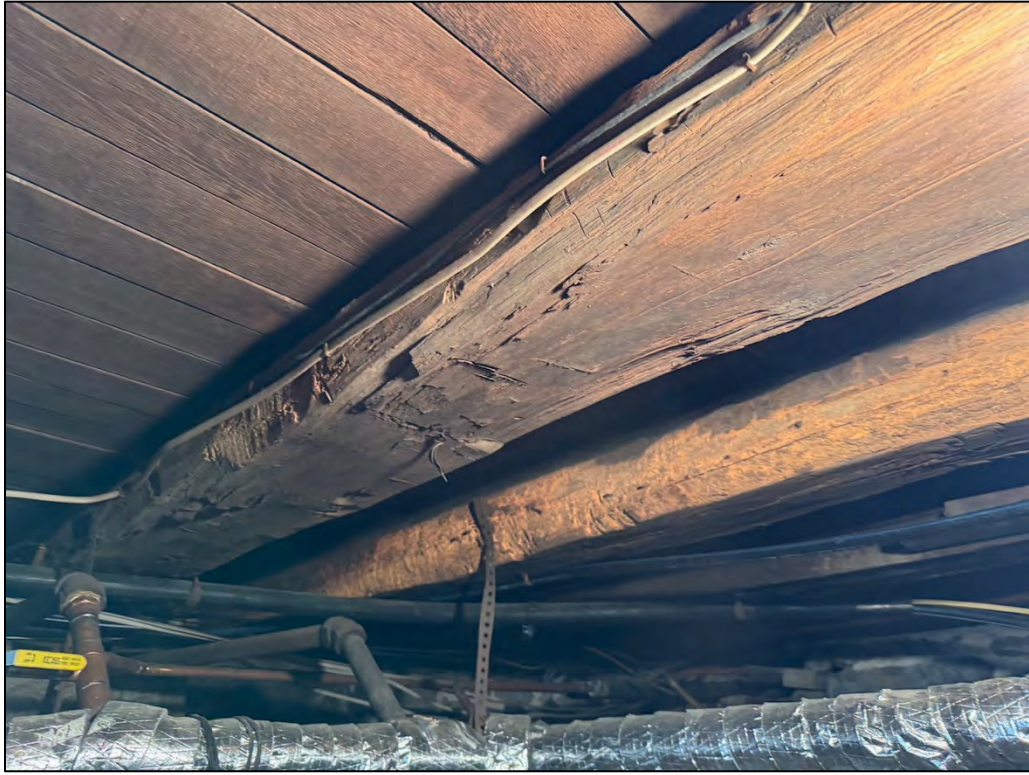
*Plate 129. Original beams, facing north.*

Original hewn timber joists (approx. 7 inches x 11 inches) are in very good condition and, in several locations, bear on timber beams that appear to be later additions. At least one beam shows evidence of prior insect activity; however, no active infestation was observed.

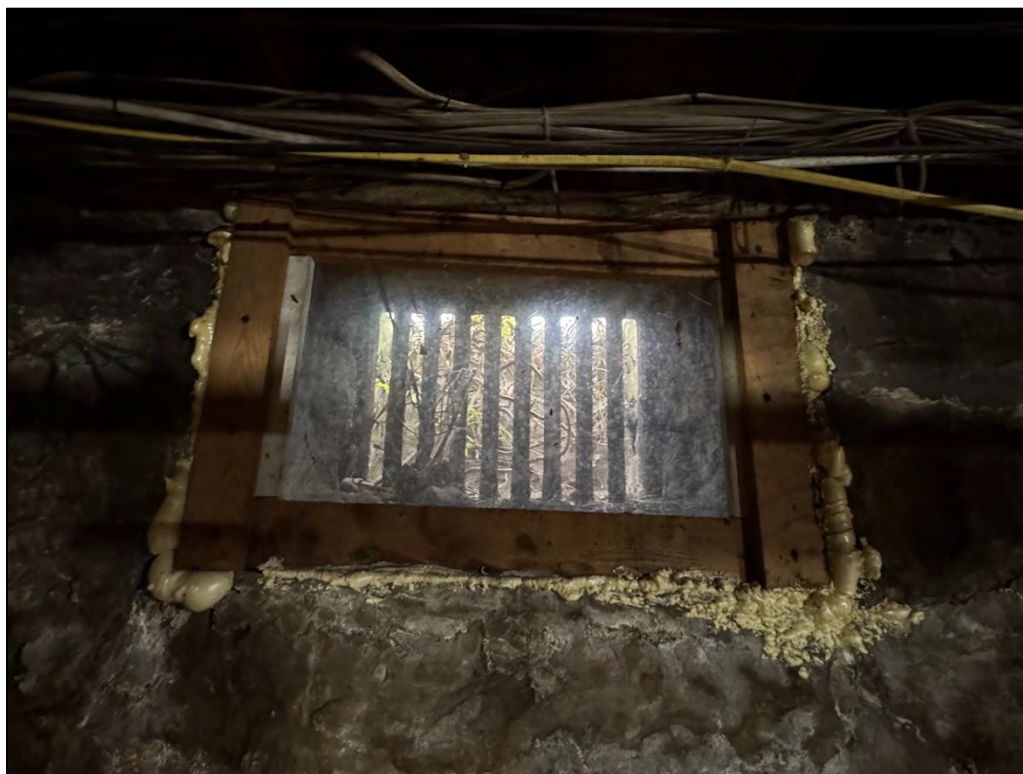
*Plate 131. Typical basement window, facing east.*

Three basement window openings have been partially enclosed using plywood, plexiglass, spray-foam or wood frames. A snakeskin was observed near one window opening indicating a potential entry point for vermin and suggests gaps in the building envelope.
