# CONDITION ASSESSMENT REPORT

## THE LINCOLN HIGHWAY HERITAGE CORRIDOR

3435 State Route 30 East  
Latrobe, Westmoreland County, Pennsylvania

Abbreviated  
Condition Assessment Report  
Alexander Johnston's "Kingston House"

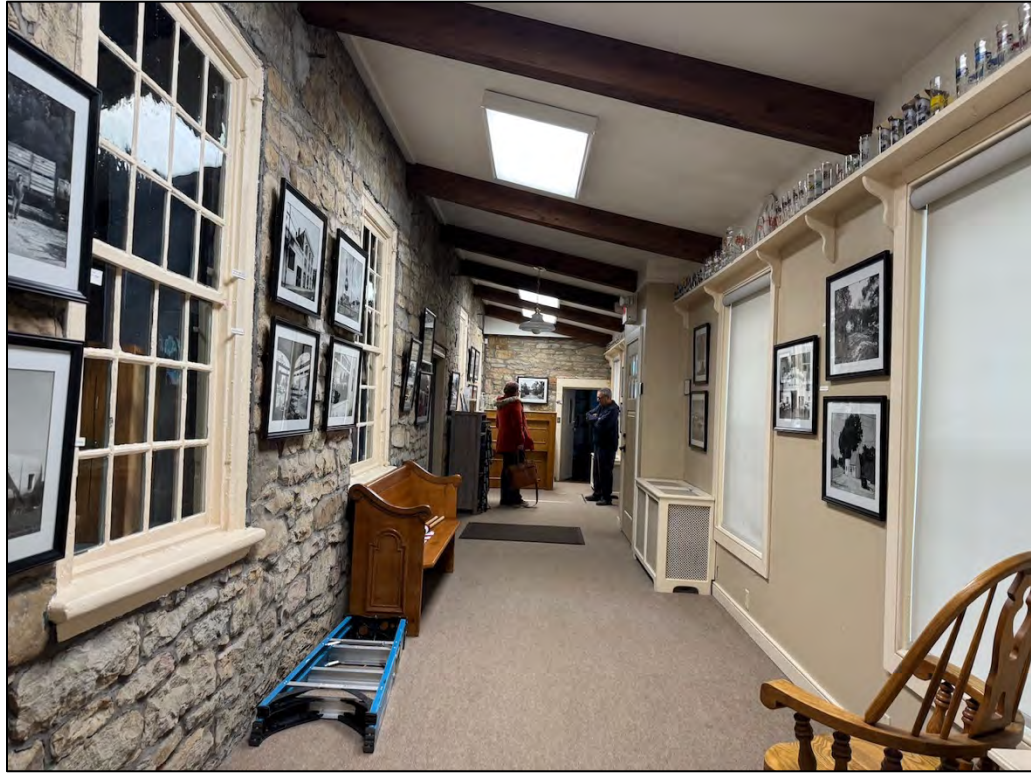
*Plate 135. Enclosed porch/Lobby, facing south.*

Existing Condition: Overall, the lobby is in good condition. The west elevation windows exhibit signs of deterioration and portion of the drywall require minor patching and repair. The east elevation stone wall has been repointed with a mortar that appears to contain Portland cement, which is harder than the surrounding stone. Because the space is conditioned, this mortar is less likely to accelerate stone deterioration than it would be in an exterior condition; however, any future repointing should use a compatible, lime-based mortar with a historically appropriate joint profile. Historic photos suggest that this wall may have been whitewashed historically, a finish that is no longer evident. The junction between the lobby ceiling and the Tot Room wall has been infilled with spray foam, a non-historic material that obscures original construction and may complicate future investigation or treatment.

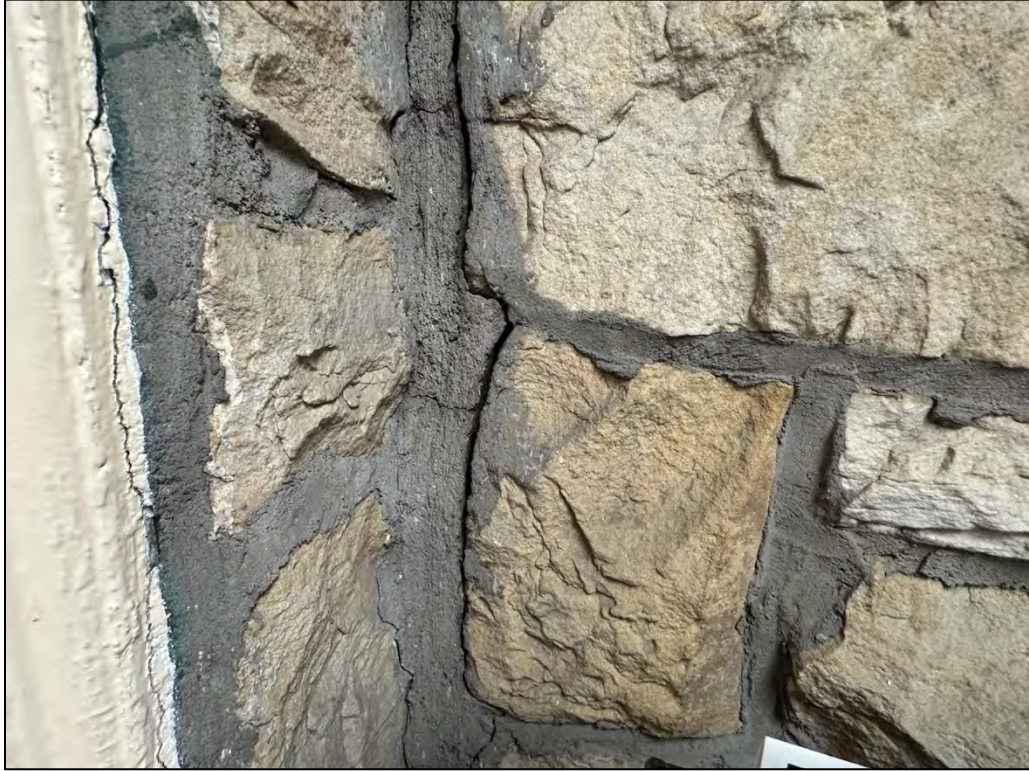
*Plate 139. Cracked mortar, facing southeast.*

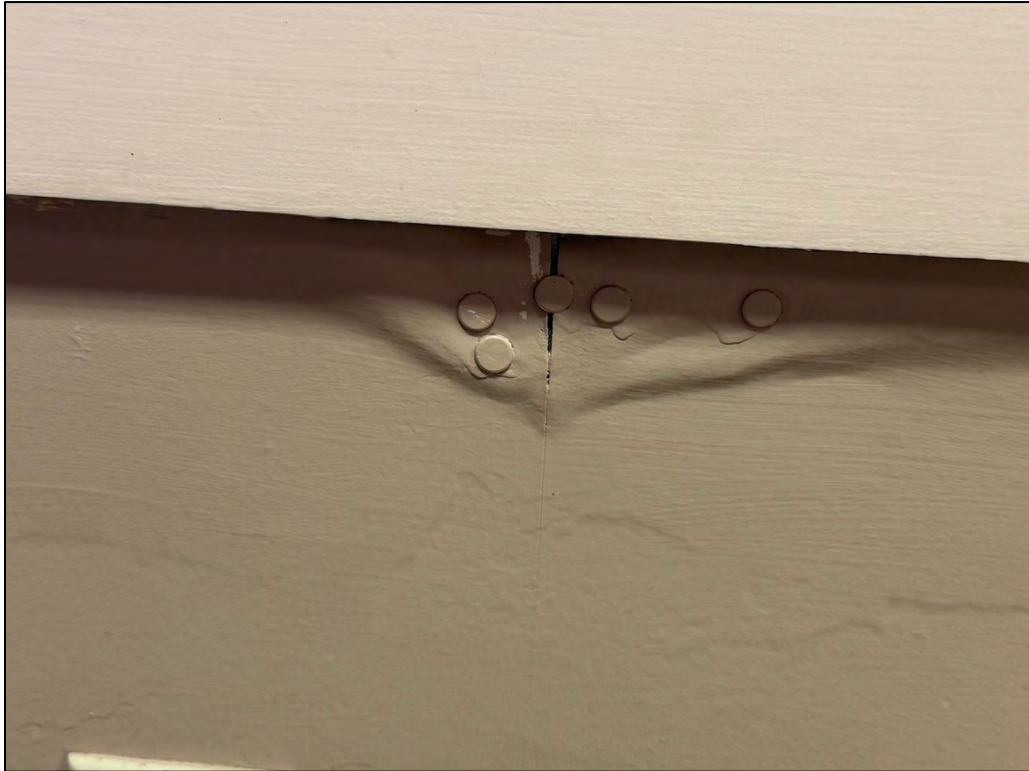
*Plate 142. Evidence of water infiltration beneath replacement vinyl window.*

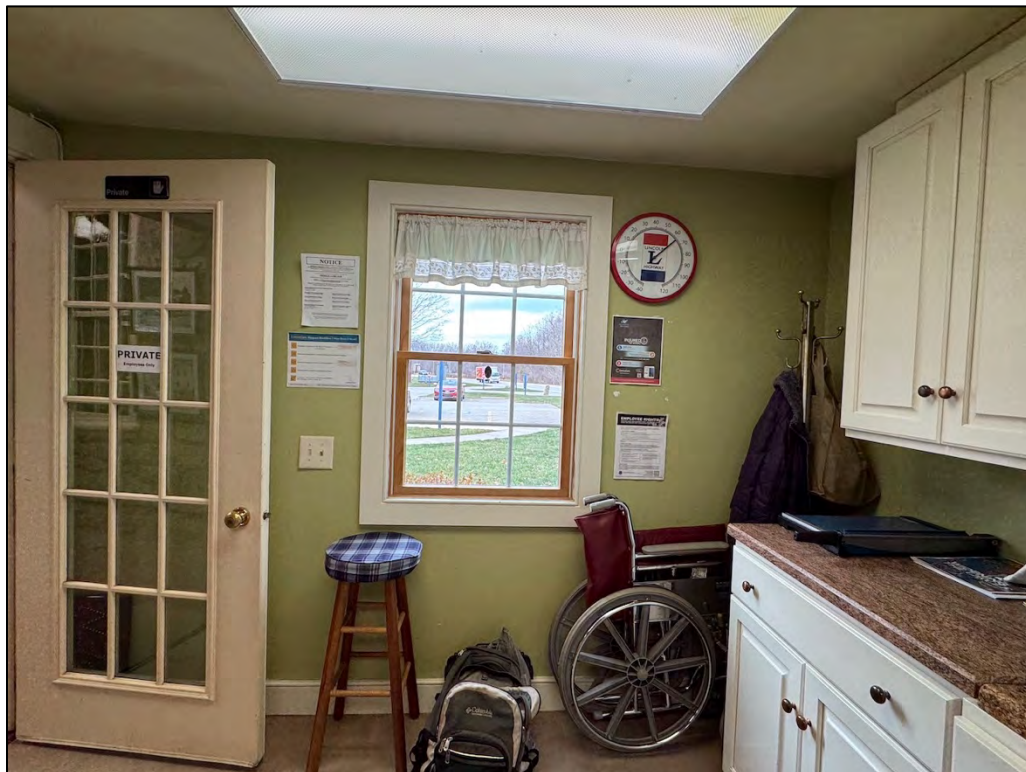
*Plate 143. Room 3 (Office #1), facing west.*

**Existing Condition:** Overall, this room appears to be in good condition. The vinyl replacement vinyl windows appear to be in good repair, and the wall finishes are generally intact. The ceiling exhibits staining consistent with a previous roof leak; however, no active moisture intrusion was observed at the time of inspection, and the condition appears to have been addressed following roof replacement.

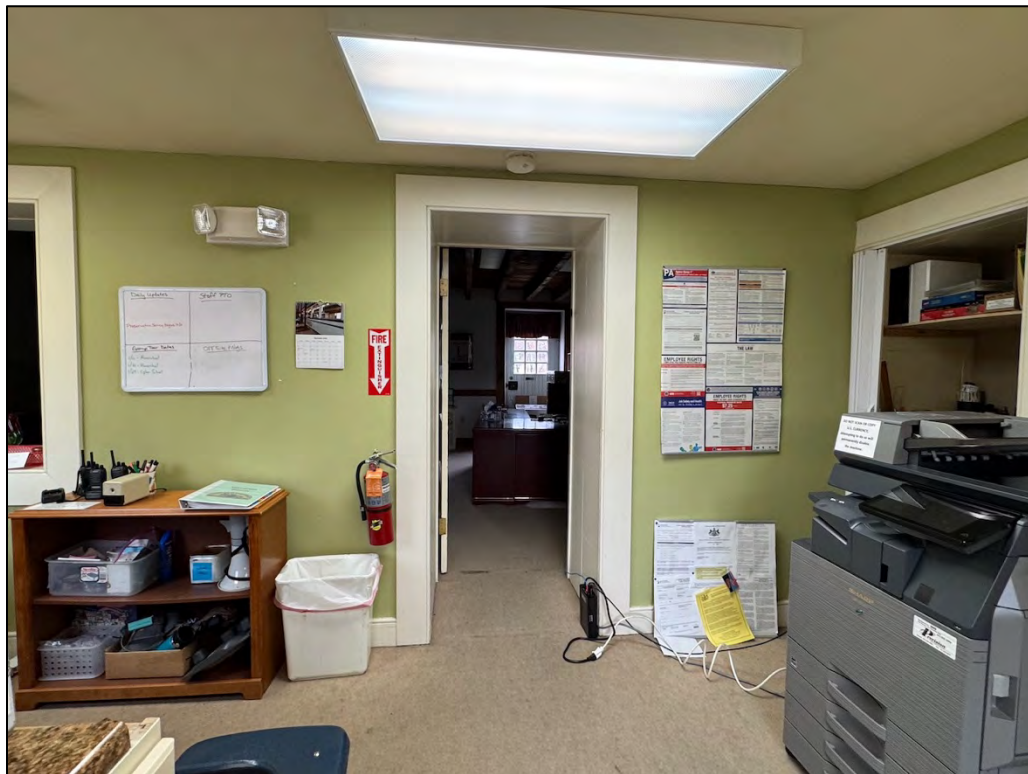
Openings in the framed east wall reveal portions of the adjacent wing and provide visual evidence of the thickness of the original stone construction, offering insight into the building's earlier fabric and configuration.

Plate 145. Room 3, facing east. Note the thickness of the walls.

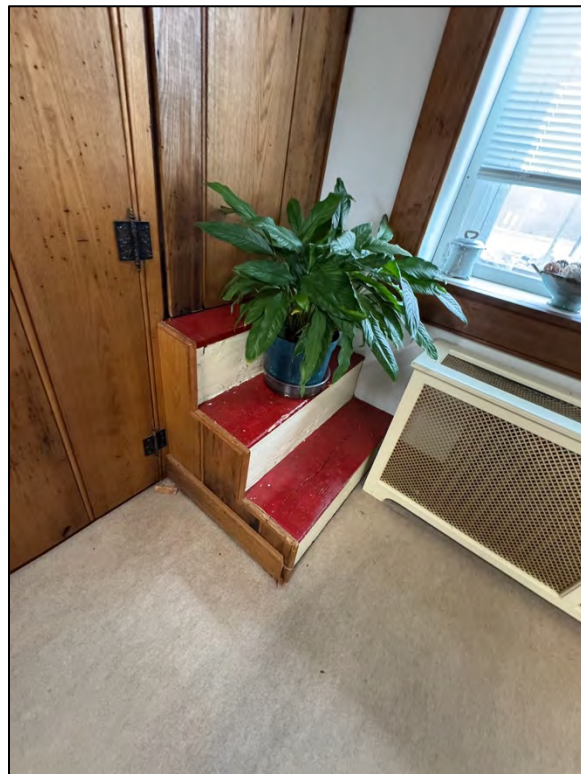
The steps leading up to a concealed storage area appear to be in good condition, although it is unclear if they were replaced during the ca. 1980 renovation or are original. The stairs are part of a winder staircase to the second story gabled attic space (Room 13).

*Plate 154. Detailed image of the stairs, facing northeast.*

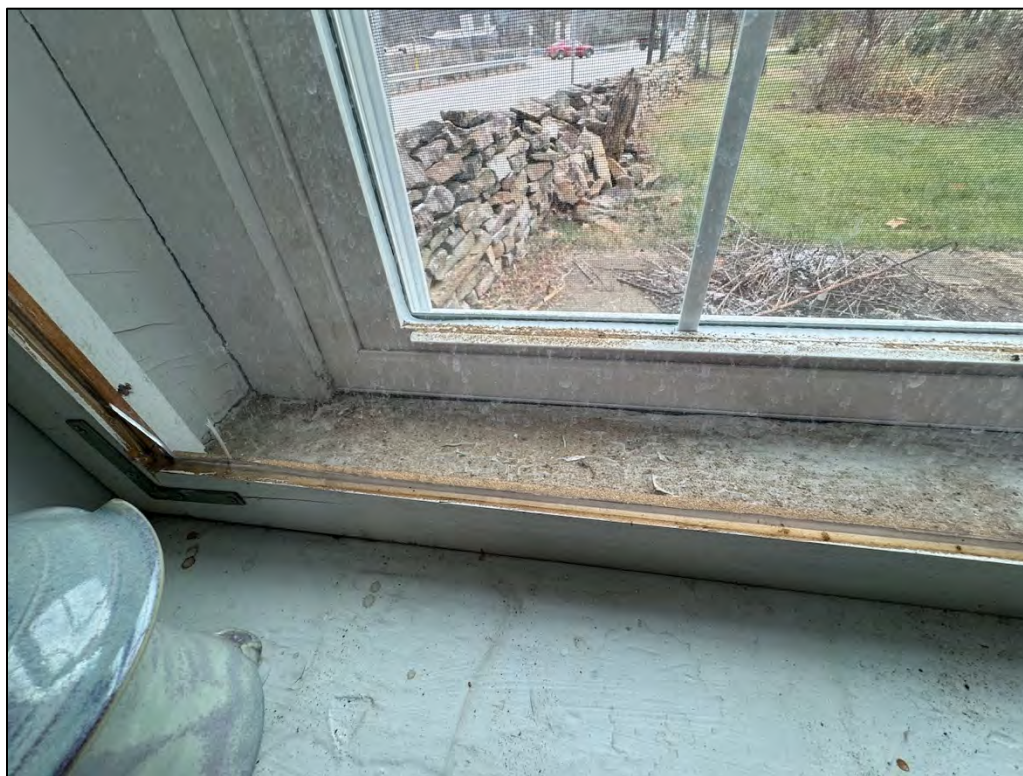
The vinyl window on the east wall is in fair condition; however, it is paired with a deteriorated wood storm window. Evidence of trapped moisture and insect activity was observed, indicating that the window assembly is not properly sealed. Continued moisture entrapment is likely accelerating deterioration of the surrounding wood fabric.

*Plate 155. Room 4, Detail of the window debris, facing east. Note the broken wood storm window, separation between the window frame and the wall and the insect staining.*

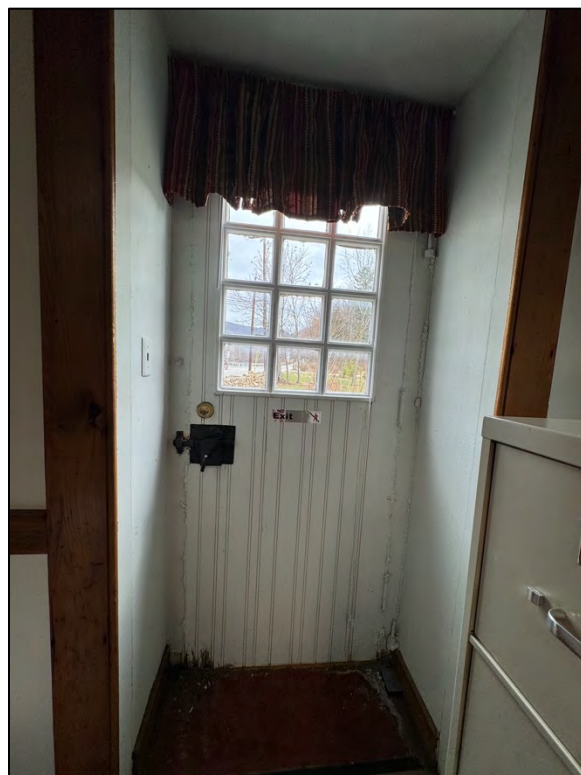
The wood door on the east elevation, likely was installed during the ca. 1980 renovation, is in poor condition, exhibiting rot, cracking, and flaking paint and insect damage. Water infiltration is evident at the base of the door, suggesting inadequate sealing. The door surround is infilled with spray foam, which also may be trapping moisture against historic materials. While the door retains some period-appropriate (although not necessarily original) hardware, rehabilitation will be necessary to prevent further deterioration and potential loss.

*Plate 156. Detail of the door, facing east. Note deterioration on the lower portion of the door.*

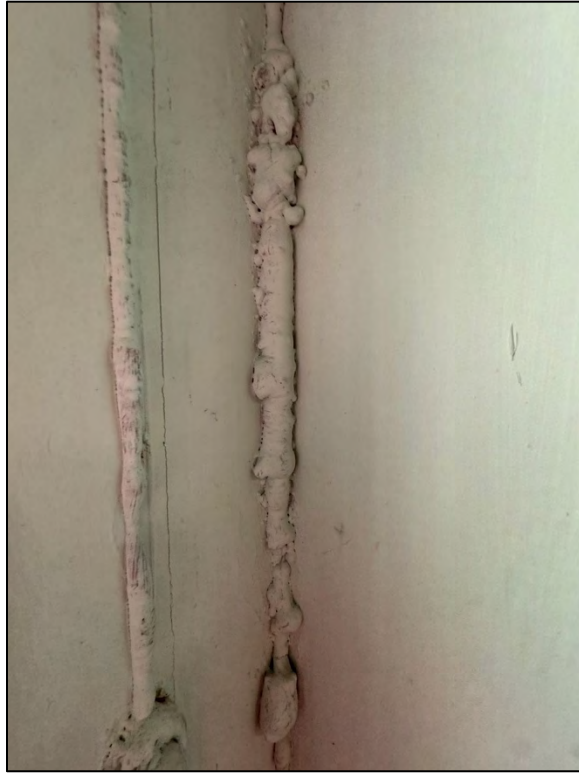
*Plate 159. Painted spray foam residue, facing east.*

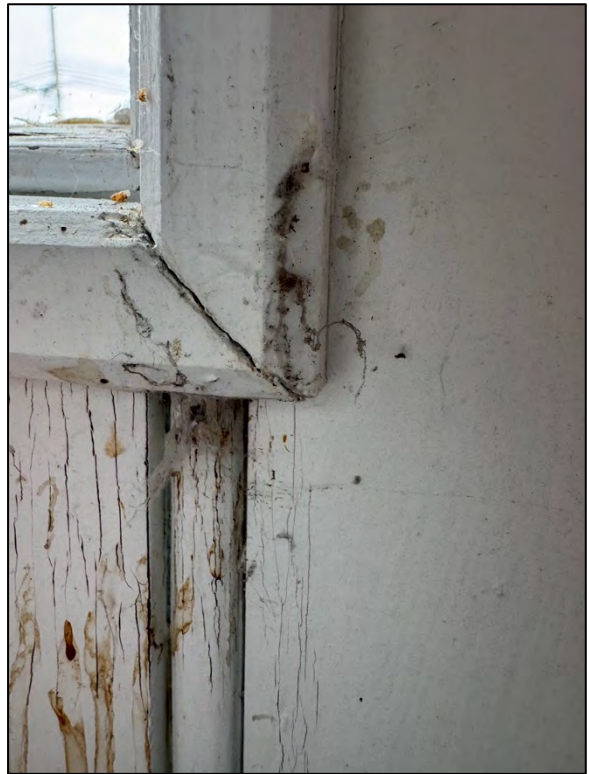
*Plate 161. Note deterioration in door, including insect debris and staining. Facing east.*

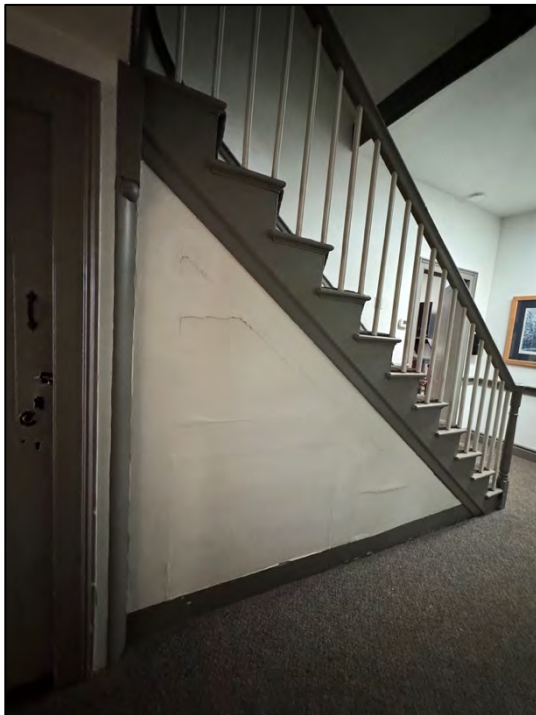
The under-stair wall has been altered and clad with wood paneling; portions of this wall are visible from the basement. Adjacent plaster finishes show cracking and bubbling, particularly along transition areas.

*Plate 179. Stair wall, facing northeast. Note the deterioration of the plaster on wood.*

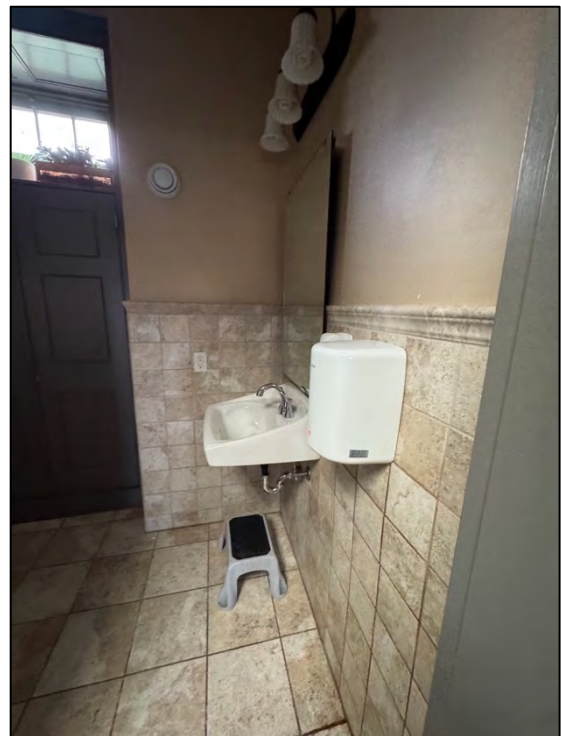
*Plate 191. First floor bathroom, facing east.*

**Existing Condition:** The bathroom is generally in good condition. Minor chipping and cracking of plaster were observed along portions of the walls. The travertine tile flooring appears to be in good repair, with no visible signs of cracking, loose tiles, or significant grout deterioration noted at the time of the inspection.

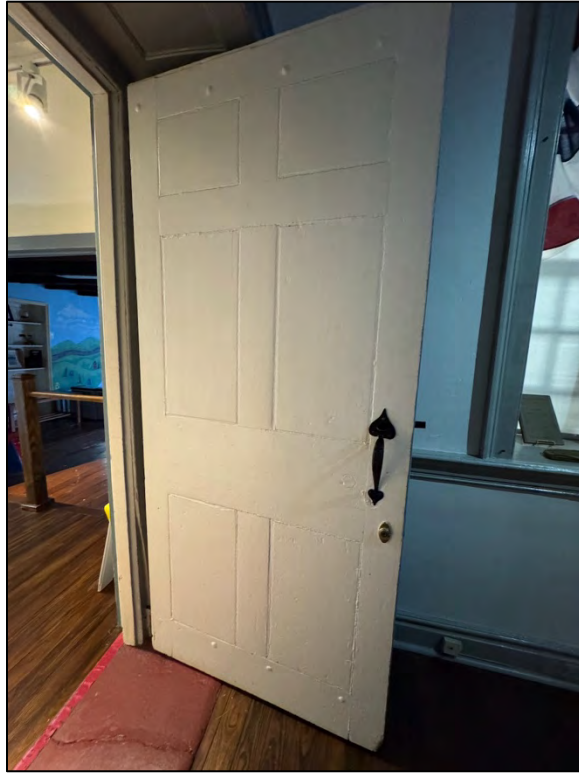
*Plate 197. Door from Convoy Room to hallway, facing west. Note the rivets at the top and bottom of the door.*

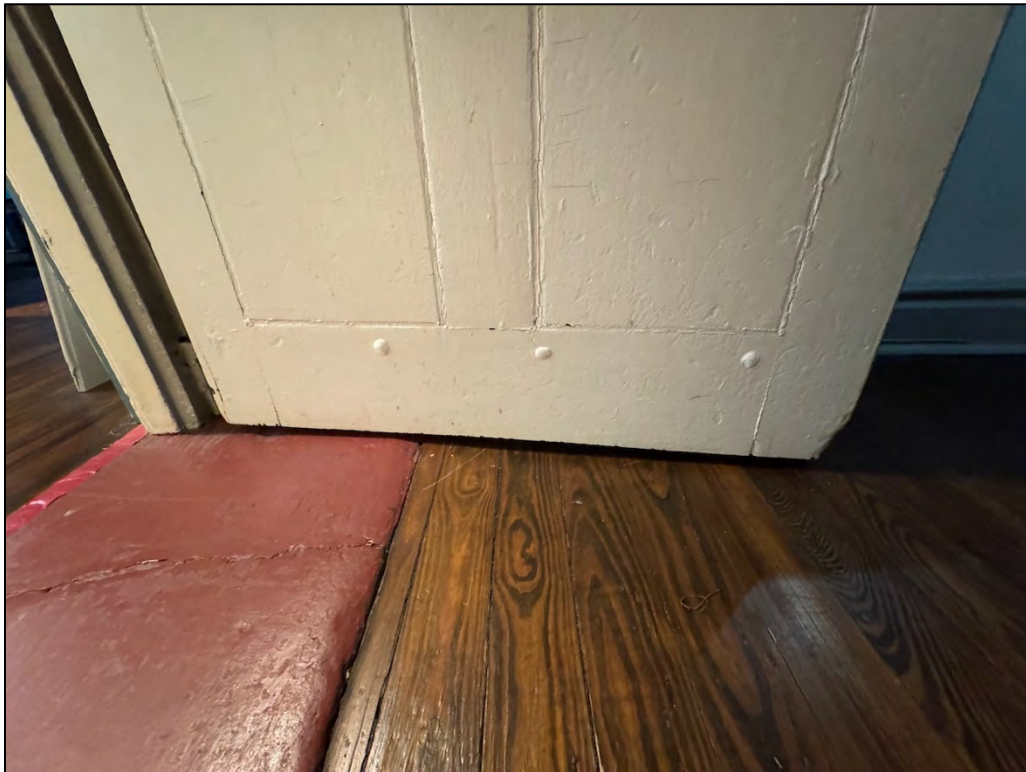
The south elevation door appears to be original and retains period hardware, including visible rivets and is set over a stone threshold. A boxed freestanding radiator is located along the west elevation adjacent to a boxed utility chase.

*Plate 198. South elevation door, note the rivets at the bottom of the door.*

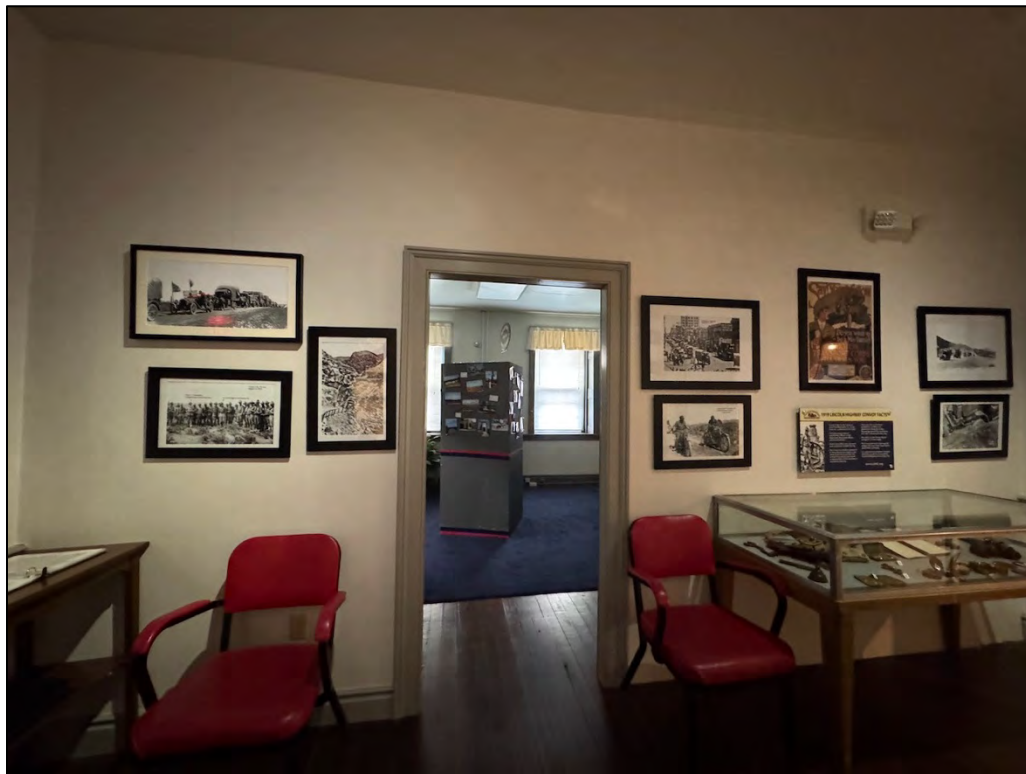
*Plate 200. Convoy Room, facing east toward "Bike" room. Note the lack of a chair rail on this modern wall.*

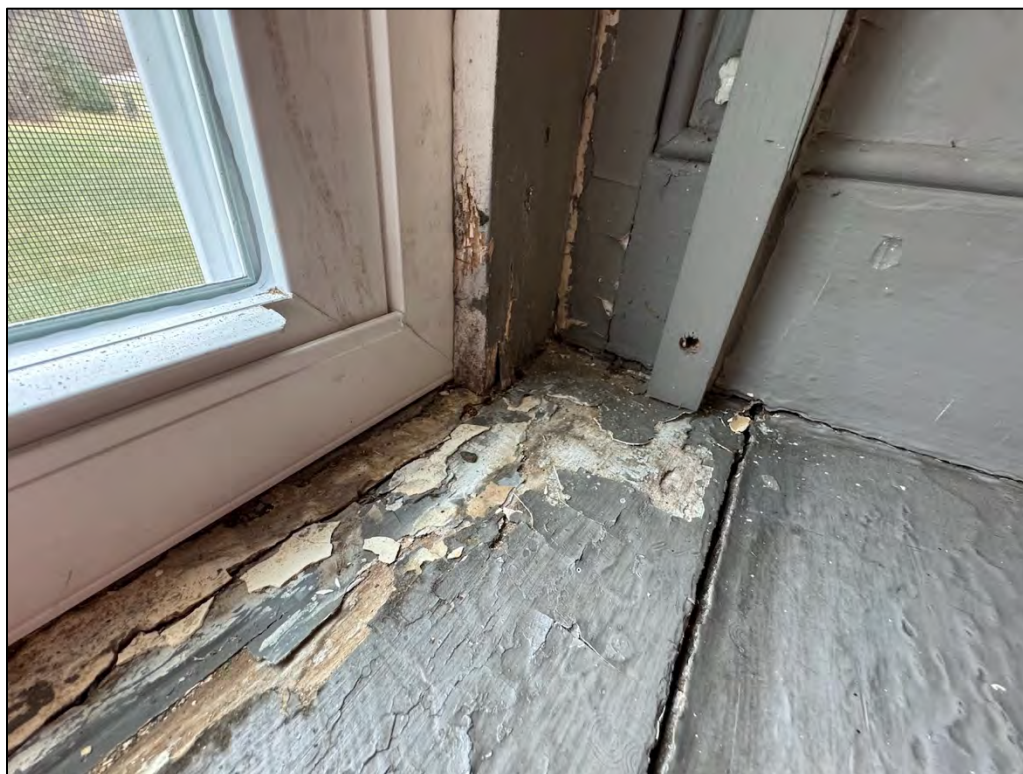
The window aprons exhibit evidence of moisture infiltration, including peeling, cracking and alligating paint. Interior storm windows may have been installed in the past, potentially trapping moisture and contributing to localized deterioration of surrounding wood elements, including the pocket shutters.

*Plate 208. Window 1-16, detail of water damage, facing southeast.*

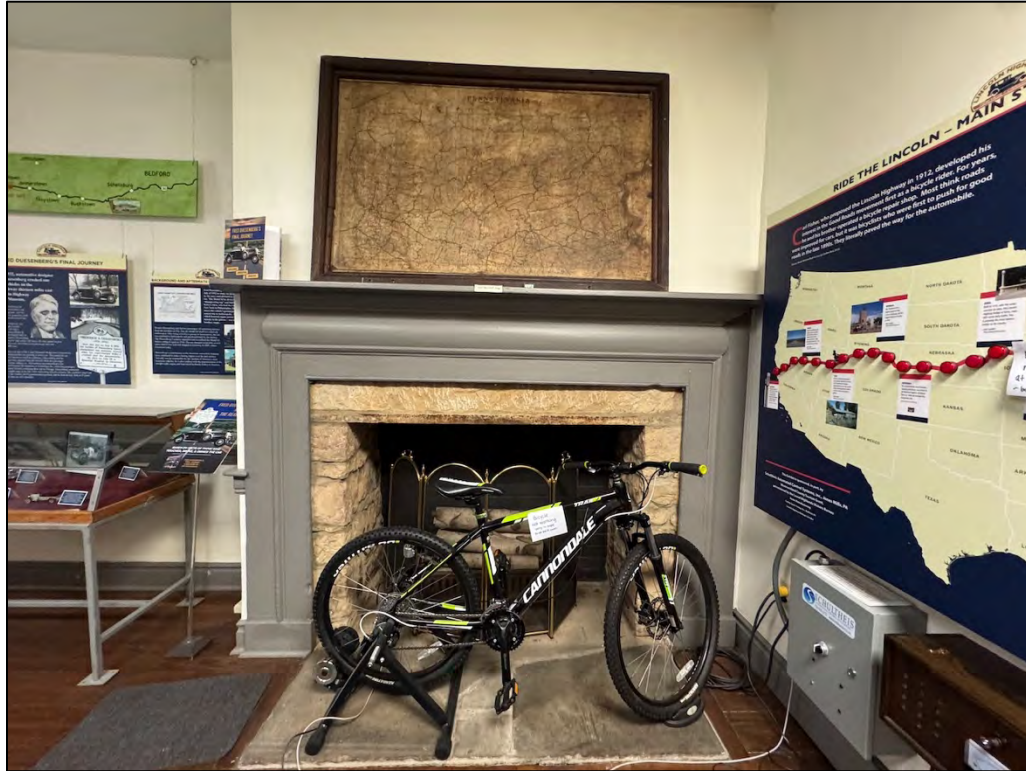
Lighting is provided by two rectangular fluorescent fixtures supplied via exposed external conduit. A freestanding steam radiator is located on the east elevation, with exposed supply and return piping. The fireplace and mantel appear to be original to the room; however, the firebox may have been infilled at an unknown date.

Plate 210. Fireplace, facing south.

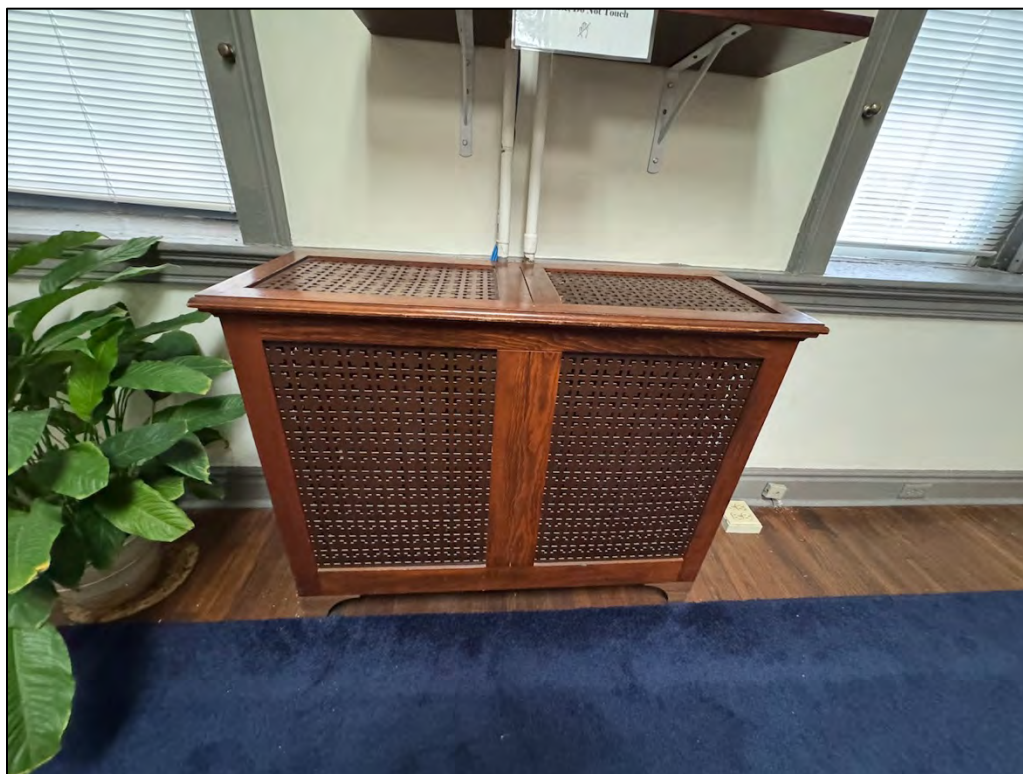
*Plate 212. Freestanding radiator and cover, facing east.*

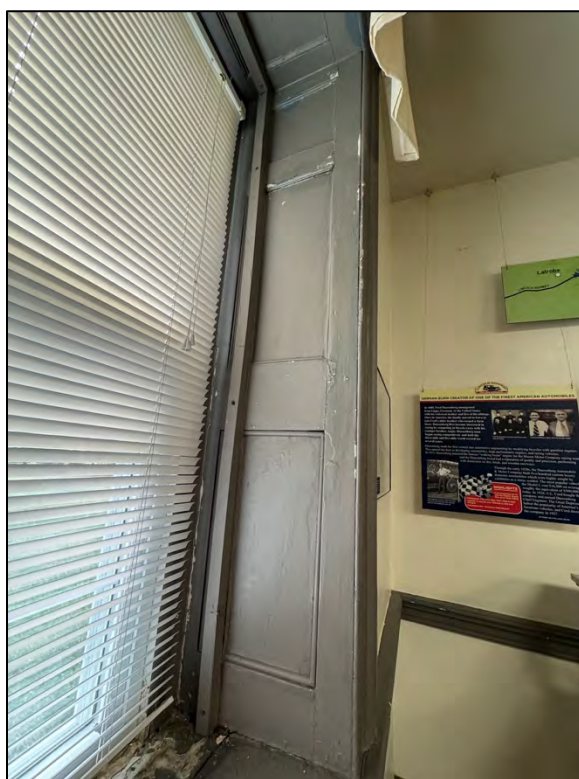
*Plate 213. Deteriorated shutter on window 1-16, facing southeast.*

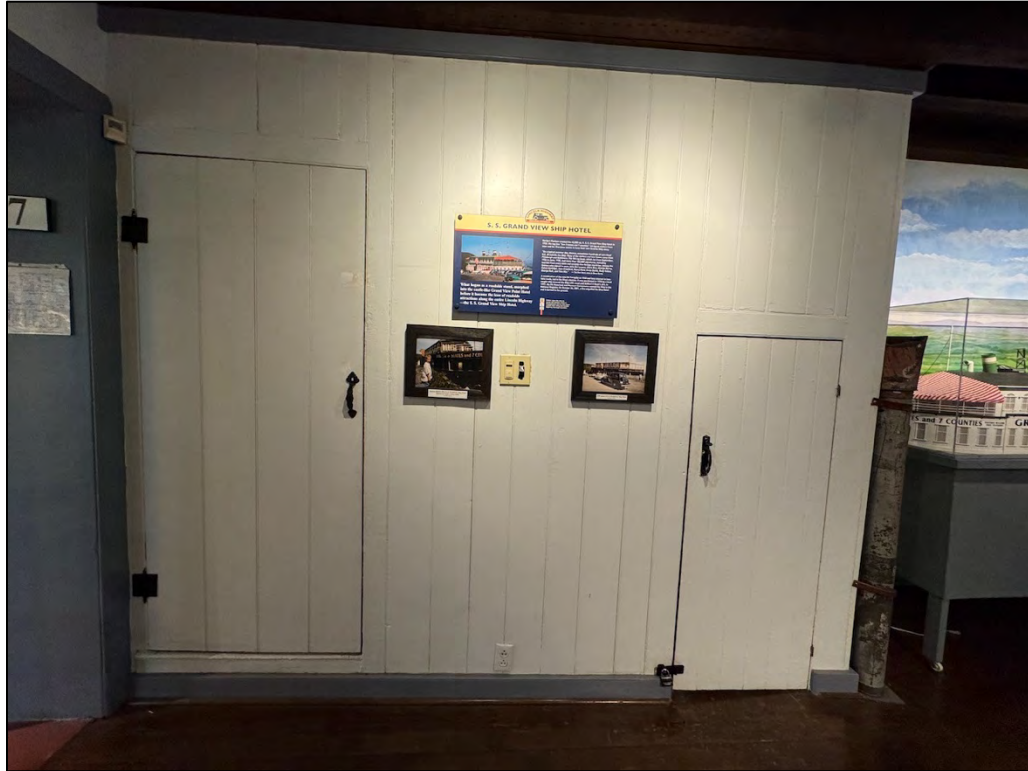
*Plate 221. Ship Room, facing north. Note the hidden staircase behind the door to the left.*

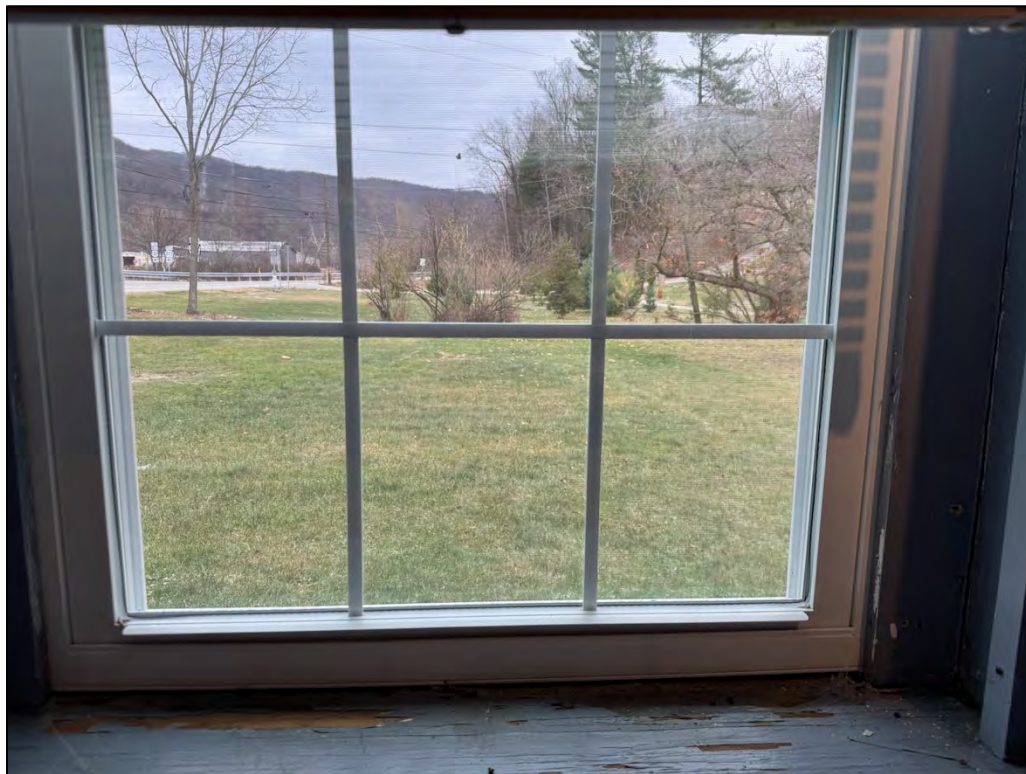
*Plate 224. Replacement window in the Ship Room. Note the water damage to the sill and frame, facing east.*

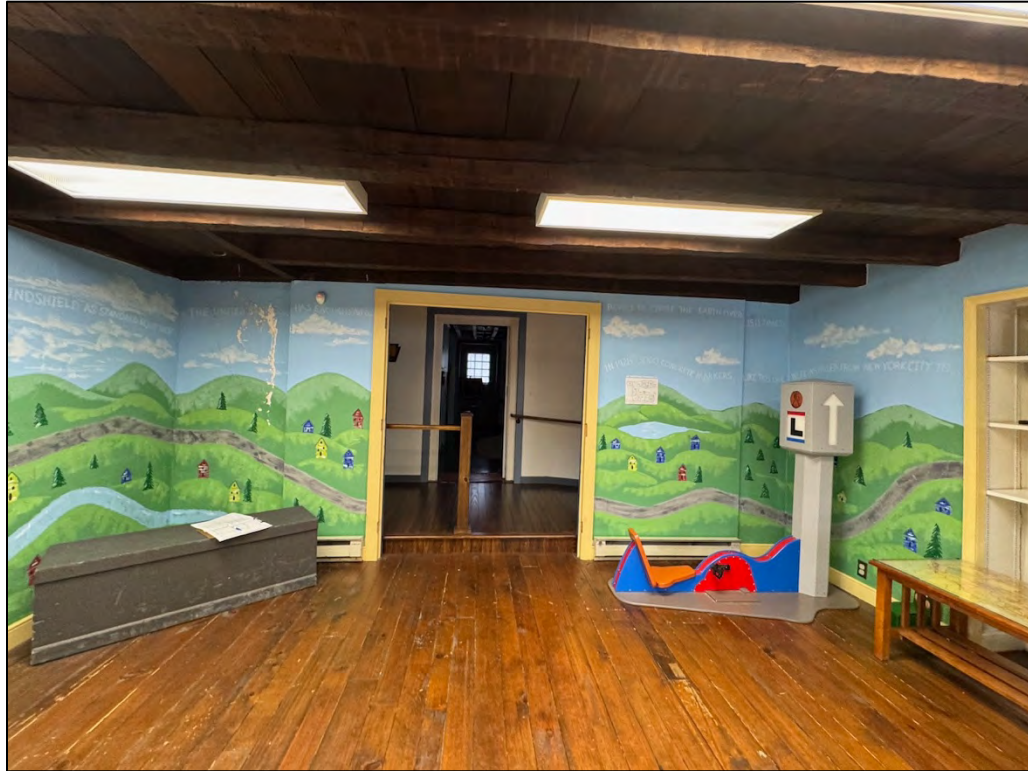
The plaster walls are generally in good condition, and are notably painted with murals, however, visible water-related deterioration is present in the northeast corner of the room. This condition is likely associated with past moisture infiltration at the roof junction between the original structure and the Tot Room, possibly due to earlier flashing failure. Although the roof and associated flashing were reportedly replaced ca. 2023, the flashing does not appear to extend fully along the uphill slope, which may allow moisture to enter behind the existing siding. At the time of the site visit, a moisture meter did not indicate active moisture behind the bubbling plaster; nevertheless, this area should continue to be monitored.

*Plate 232. Tot Room, facing east. Note water damage to the left of the cased opening.*

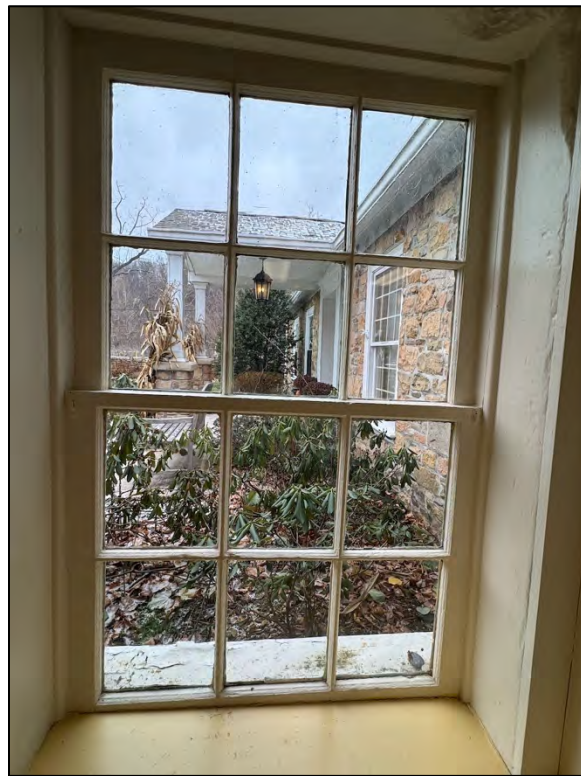
*Plate 235. Wood window, facing north. Note the scratch in the glass.*

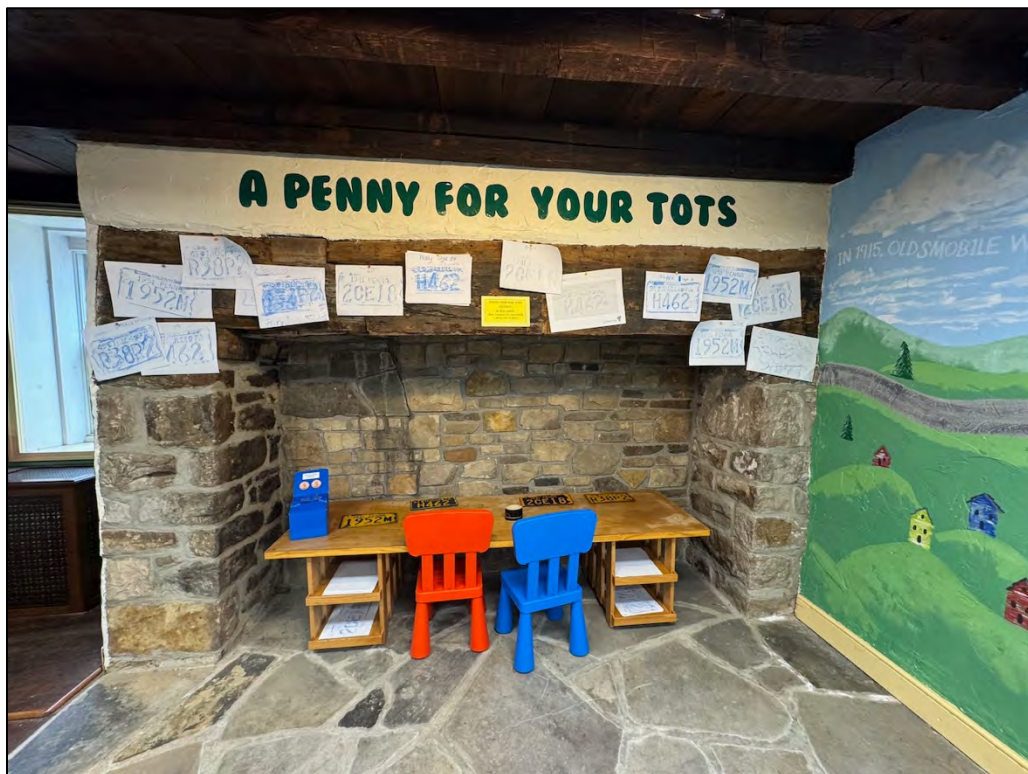
The large stone fireplace dominates the west elevation wall space. A substantial wood beam spans the mantel. The firebox opening measures approximately 8 feet 2 inches wide and originally contained a beehive oven. The rear wall of the firebox has been altered and made shallower through the addition of a false wall, obscuring the original oven features.

Plate 237. Fireplace in Tot Room, facing west. Note the hearth and fireback wall alterations.

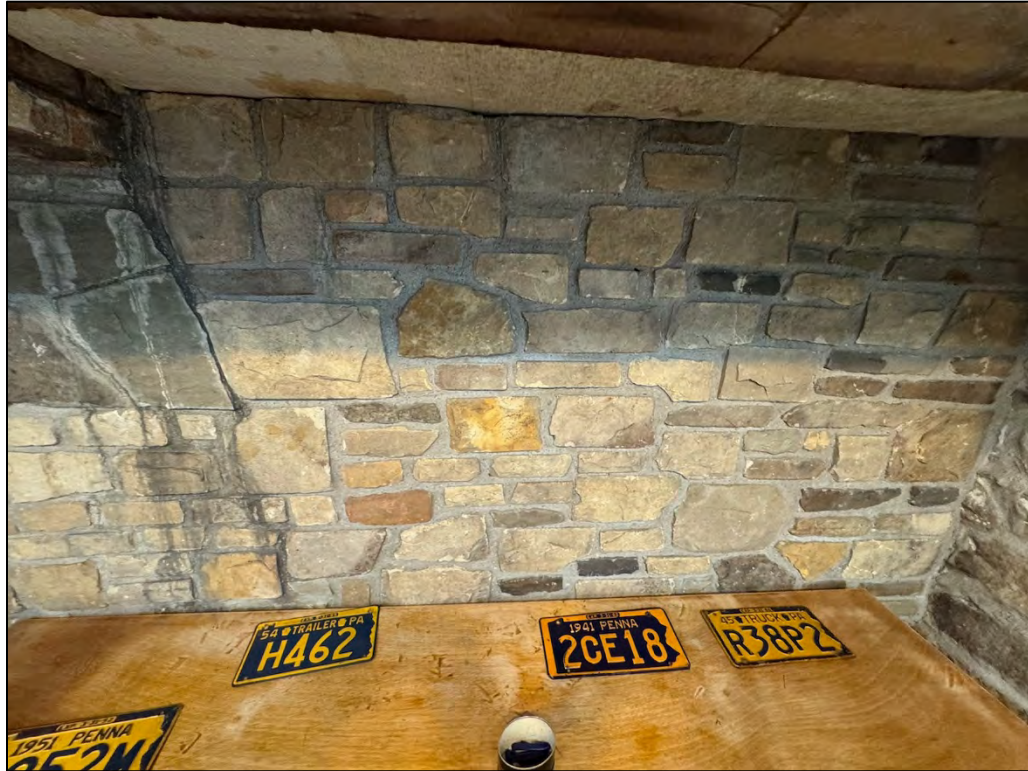
Plate 238. Replaced fireback obscures original beehive oven ghost marks, facing west. Note the insulation covering the chimney.

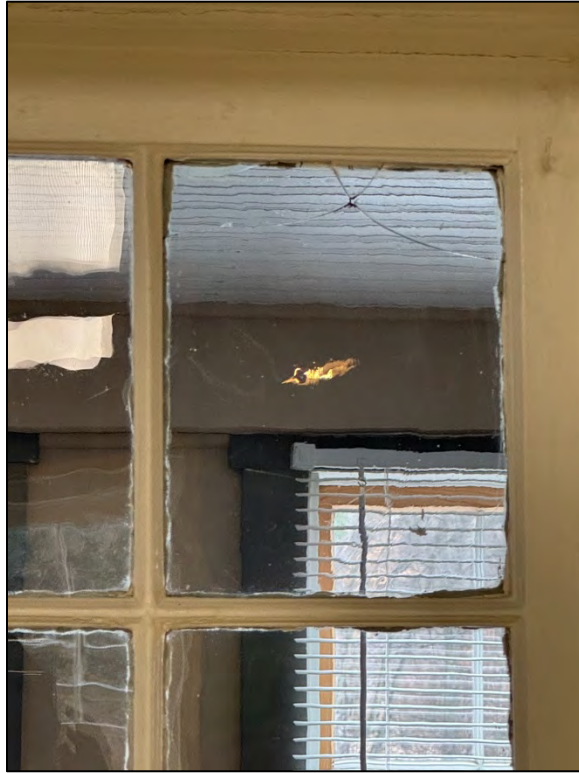
Fenestration within the Tot Room includes three different window types. W1-18, located on the south wall overlooking the Postcard Corridor, is a 6/6 double hung sash wood window and is likely the oldest existing window in this room. Two cracked panes are present in the upper sash and no hardware is visible. Window W1-19, located on the west elevation, is a 1/1 double hung sash vinyl replacement window and appears to be in good condition. Window W1-20, located on the north elevation, is a 6/6 double hung sash wood window with a cracked pane in the upper sash, chipped paint and evidence of past water damage: this window most likely dates to the ca. 1980 remodel or later.

*Plate 240. Example of cracked glass in upper sash, facing south.*

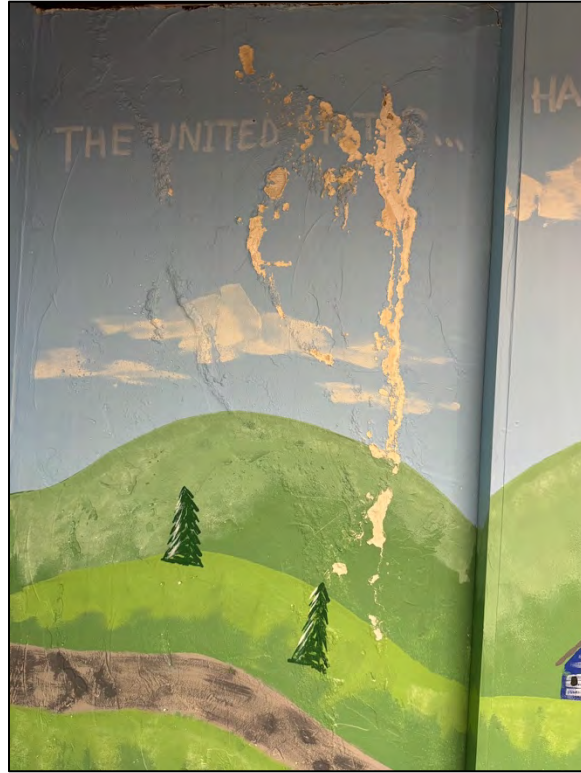
Plate 246. Deterioration due to moisture on plaster wall, facing east.

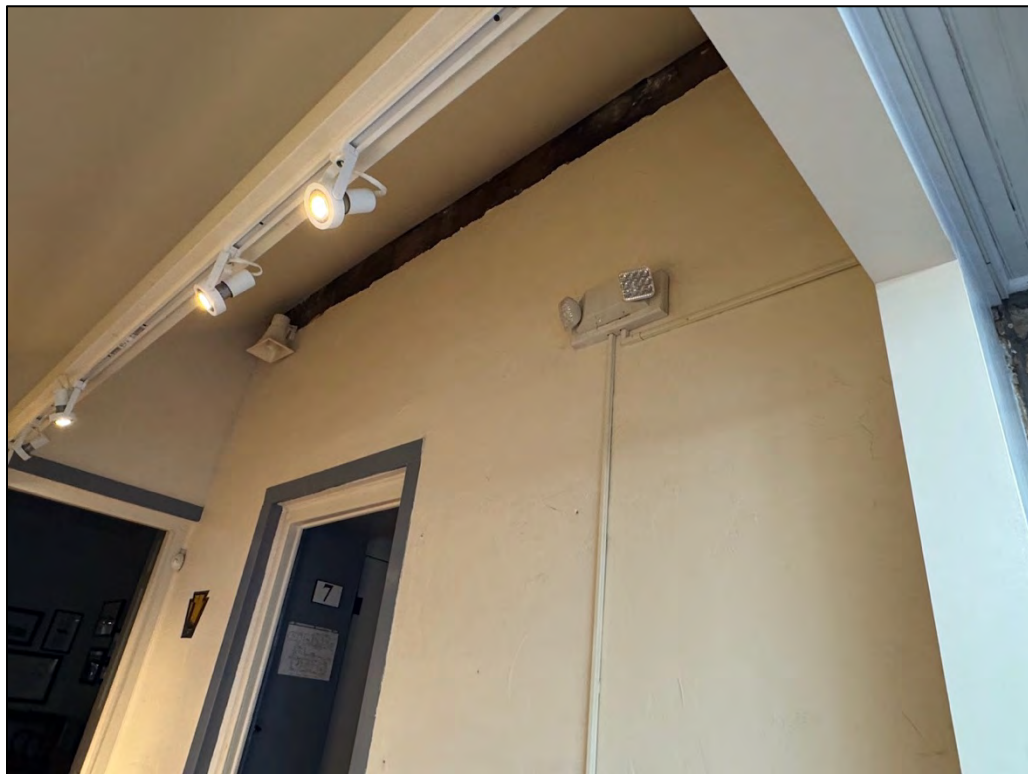
*Plate 250. Ceiling in hallway outside of Ship Room, note exposed wood.*

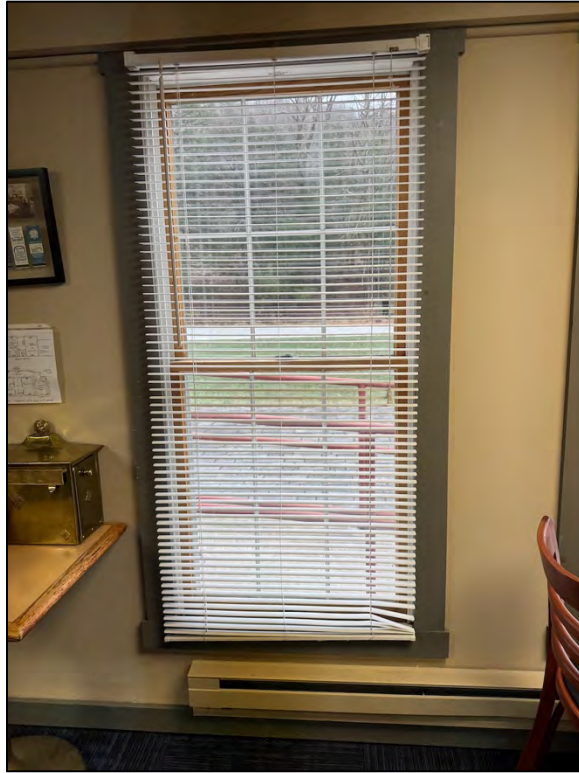
The fenestration in the corridor includes two, historic wood windows, which were previously discussed in their respective room sections. Additionally, five additional 1/1 double hung sash wood windows were installed on the south elevation wall. These windows are modern replacement windows; however, they show early signs of deterioration. At minimum, the caulking around the window frames is failing.

Plate 253. Typical modern wood replacement window, facing south.

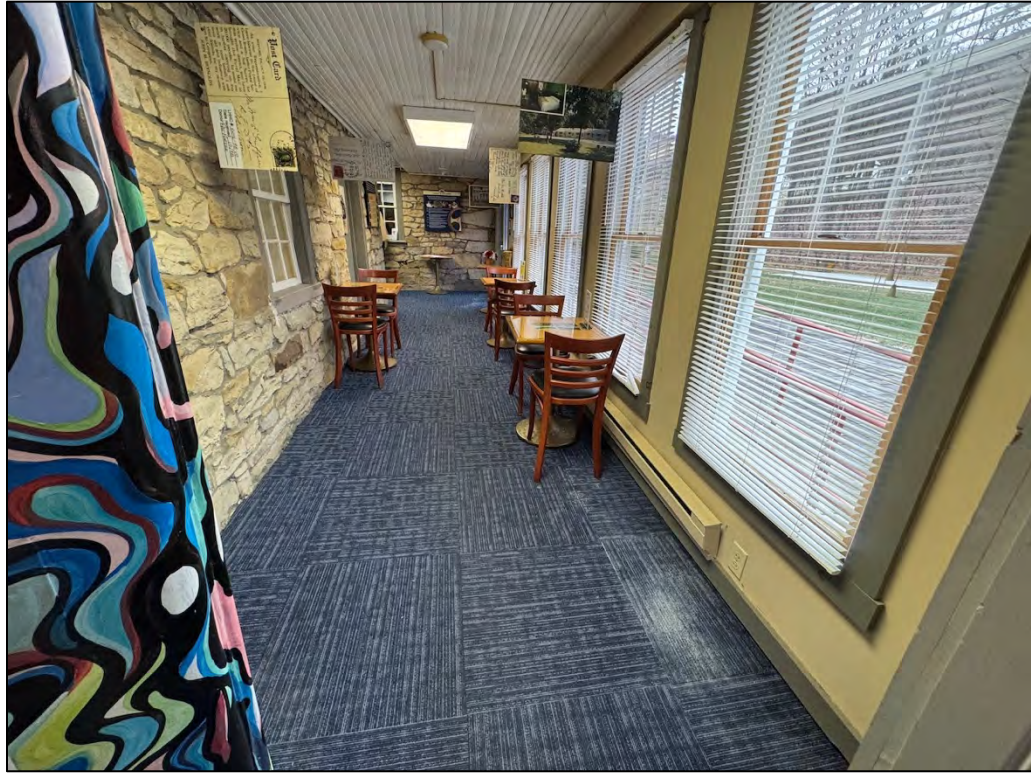
The original floor in this portion of the building consists of poured concrete, which was most likely installed in the early 20<sup>th</sup> century and is visible in the Stoltz photographs. Carpet tiles appear to have been installed directly over the existing concrete pad without a vapor barrier, allowing moisture to migrate upward. Evidence of efflorescence- visible as white staining on the carpet- confirms this condition. Moisture meter readings verified elevated moisture levels in this area, identifying the floor assembly as a significant point of moisture intrusion.

*Plate 255. Postcard Corridor, facing east. Note efflorescence on carpet.*
