# CONDITION ASSESSMENT REPORT

## THE LINCOLN HIGHWAY HERITAGE CORRIDOR

3435 State Route 30 East  
Latrobe, Westmoreland County, Pennsylvania

Abbreviated  
Condition Assessment Report  
Alexander Johnston's "Kingston House"

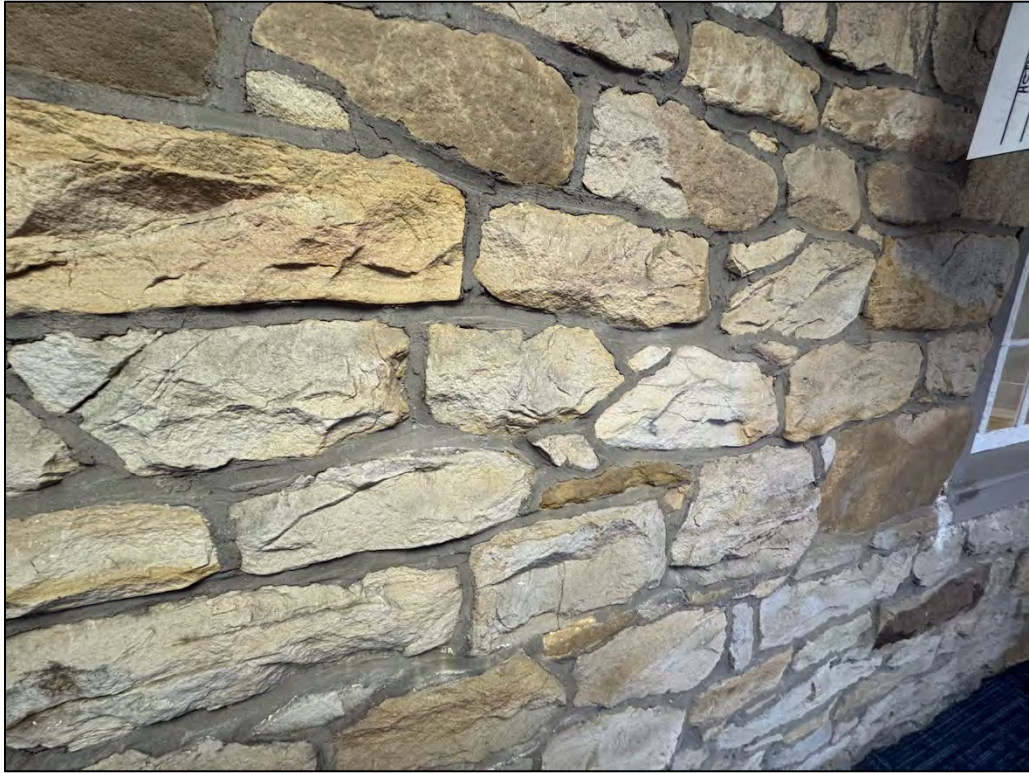
The easternmost wall on the postcard corridor is coated in a thick stucco or plaster finish that does not match the historic plaster profile of the original building. The drywall on the south elevation appears to be in good condition. The stone masonry forming the northern wall appears to have been repointed with an inappropriate mortar, that does not match the historic mortar in composition, texture or tooling. Although this repointing occurs within a conditioned interior space and therefore may not result in the same degree of deterioration as exterior repointing, a Portland cement-based mortar- if present- has a higher strength ratio than the resulting stone and may contribute to long-term masonry damage.

*Plate 257. Typical repointing job in Postcard Corridor, facing north.*

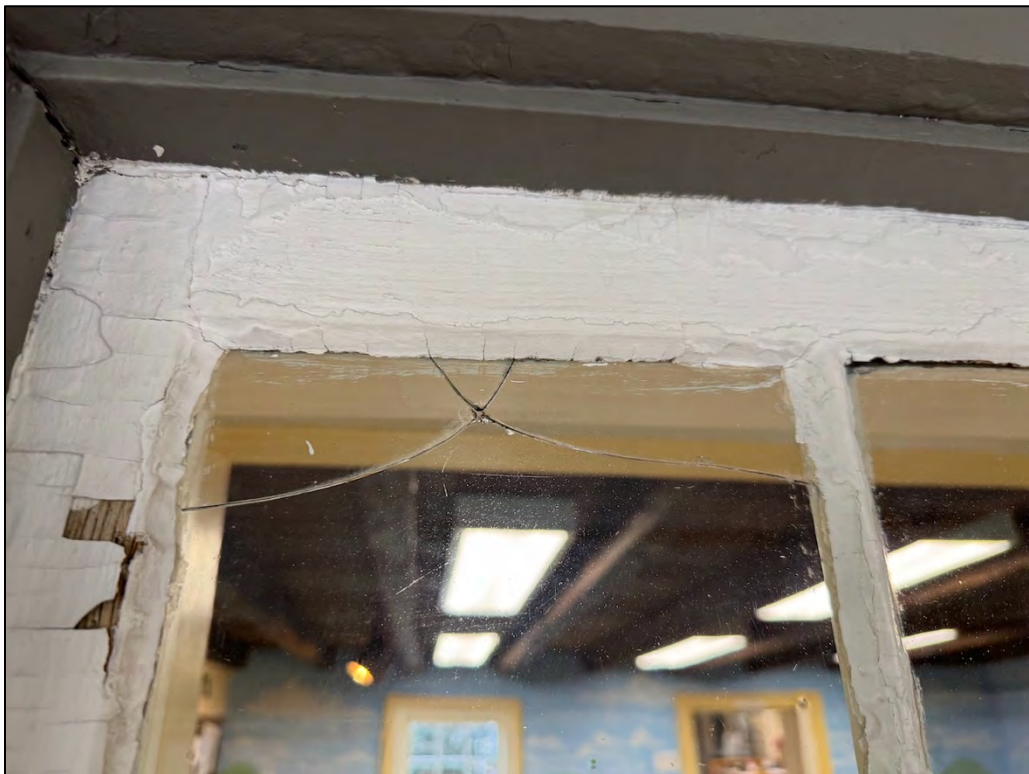
The fenestration in the corridor includes two, historic wood windows, which were previously discussed in their respective room sections. Additionally, five additional 1/1 double hung sash wood windows were installed on the south elevation wall. These windows are modern replacement windows; however, they show early signs of deterioration. At minimum, the caulking around the window frames is failing.

*Plate 258. Typical condition of historic window, facing north.*

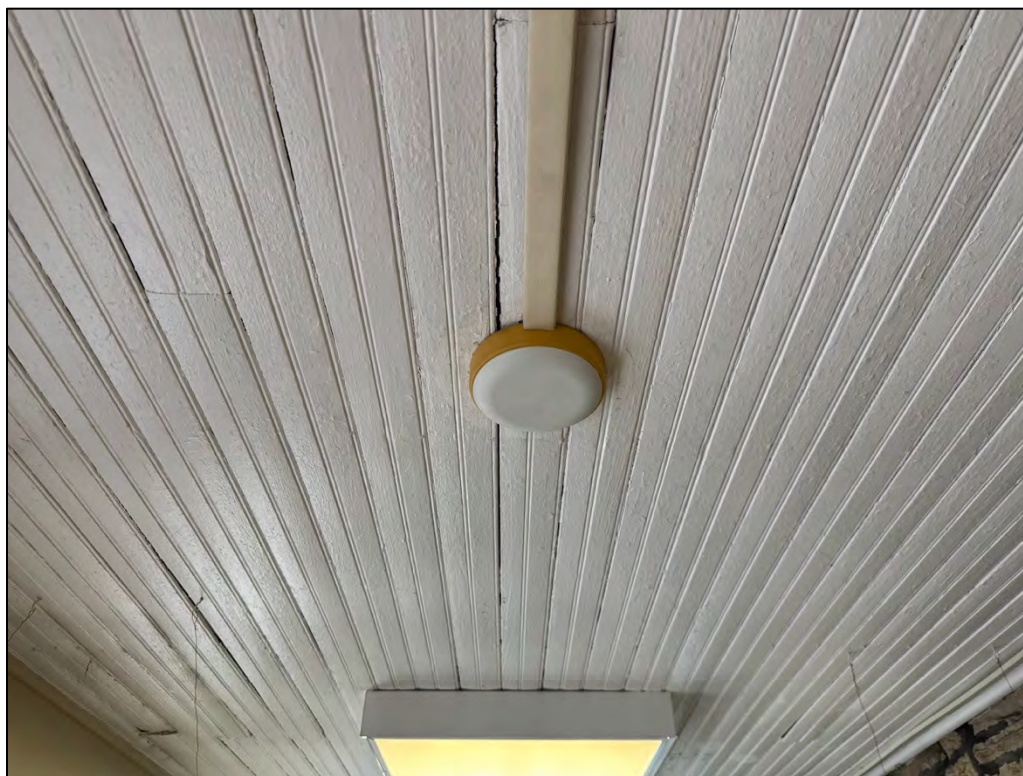
The beadboard ceiling, likely dating to the early 20<sup>th</sup> century, appears to be separating in several locations. While not visually confirmed, insects or vermin may be accessing the concealed space above the ceiling, with detritus and debris potentially falling through the gaps between the boards. This ceiling system likely requires further investigations and repair.

*Plate 259. Typical beadboard ceiling in Postcard Corridor.*

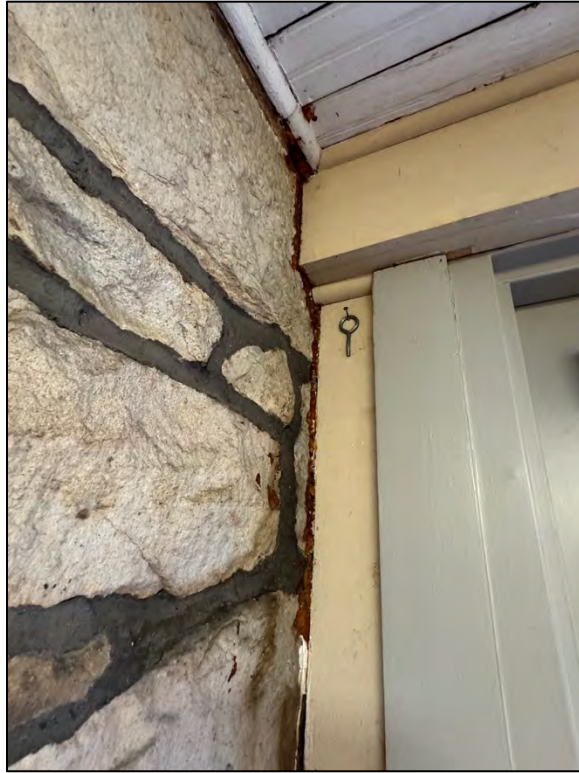
Additionally, junctions between the main building and later additions appear to be inadequately sealed. Spray foam was observed at the connection between Postcard Corridor and the main building and there is concern that flashing between the sections is not properly secured, potentially contributing to ongoing moisture infiltration. \*\*\*See addendum.\*\*\*

*Plate 261. Spray foam in between exit door and stone wall, facing southwest.*

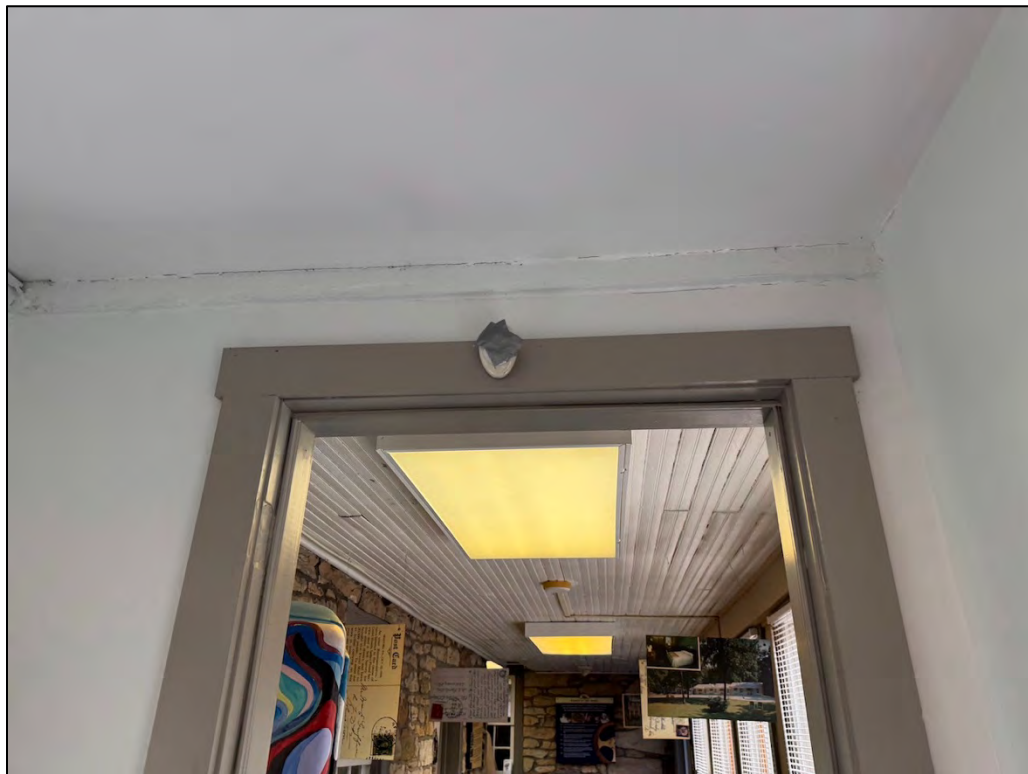
**Existing Condition:** Due to the numerous alterations and junctions between construction phases, the Postcard Corridor continues to experience moisture related issues. While the space visually appears well maintained, closer inspection reveals several areas of concern.

*Plate 264. Detail view of ceiling wall connection, moisture damage, facing east.*

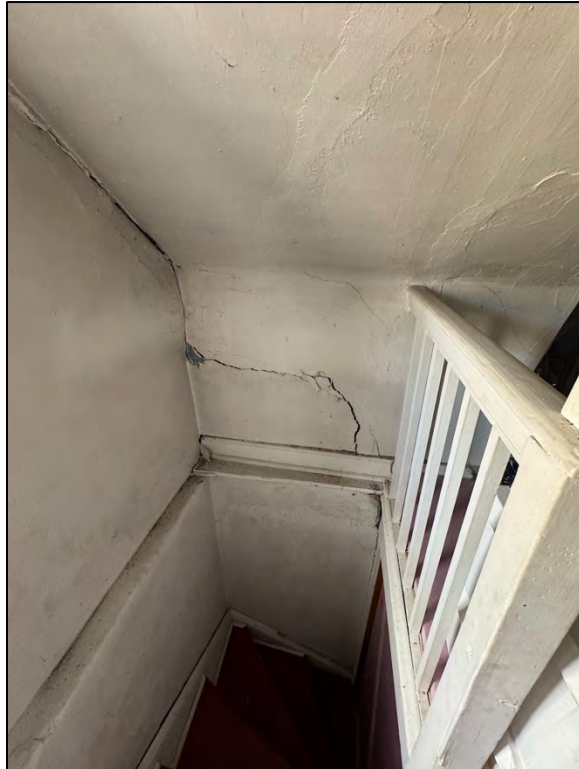
*Plate 270. Room 13, facing east. Note the major crack in the wall.*

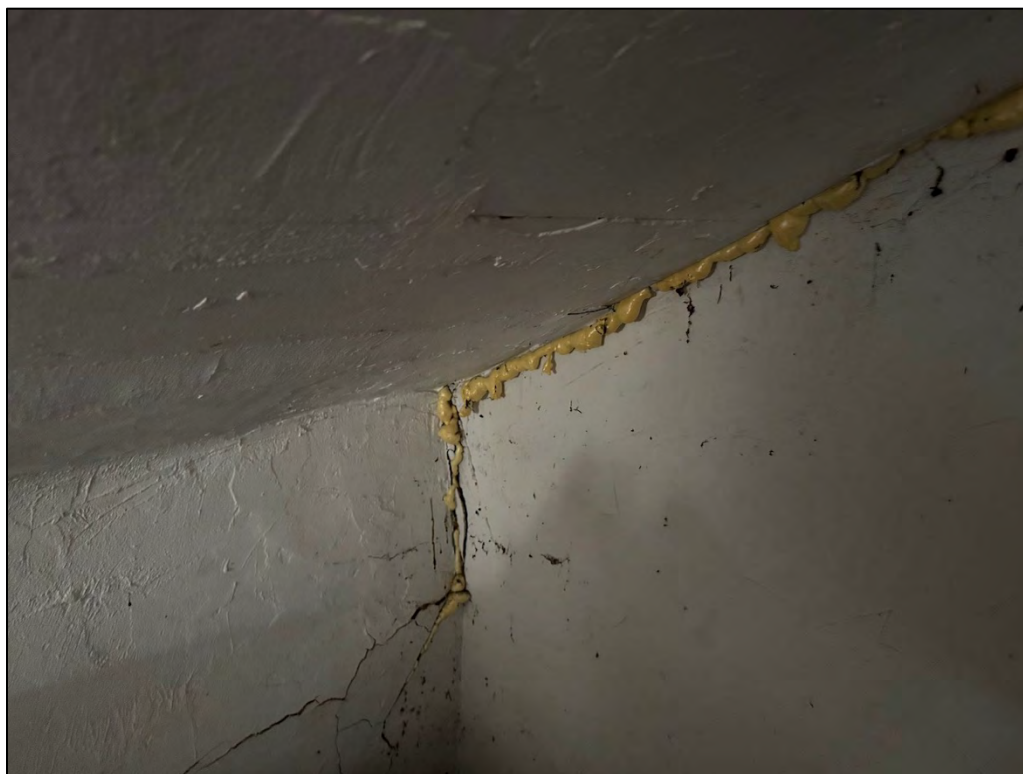
*Plate 271. Room 13, facing southeast. Note crack infilled with spray foam and thick plaster.*

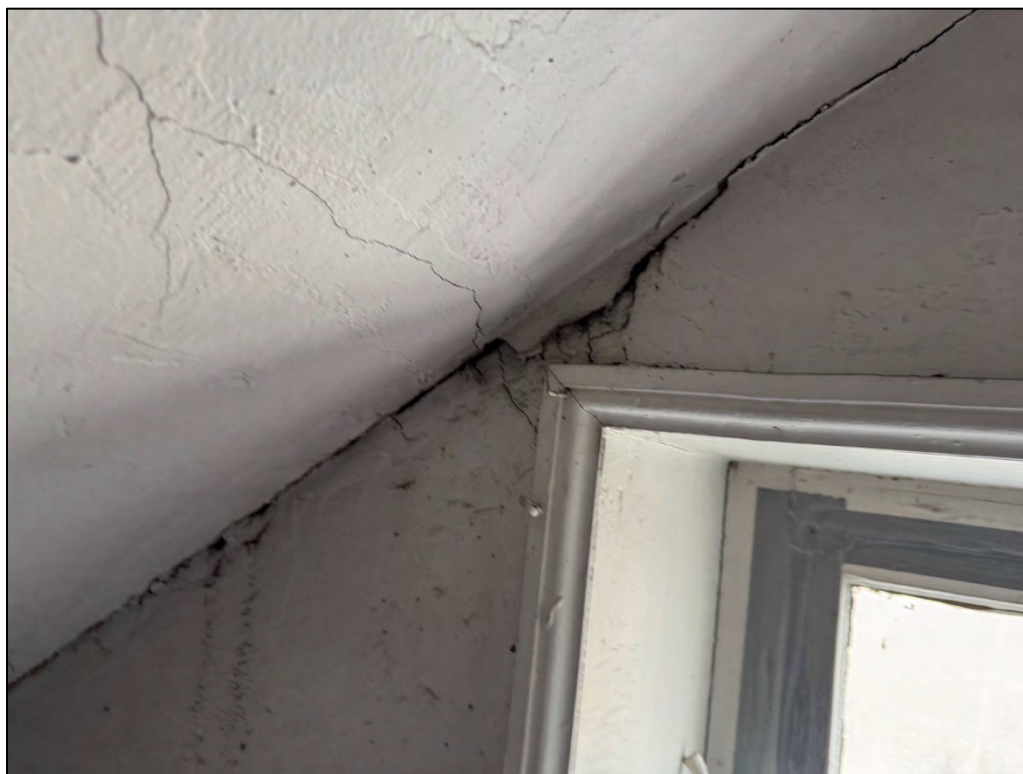
*Plate 273. Room 13, facing north. Crack at ceiling/wall juncture.*

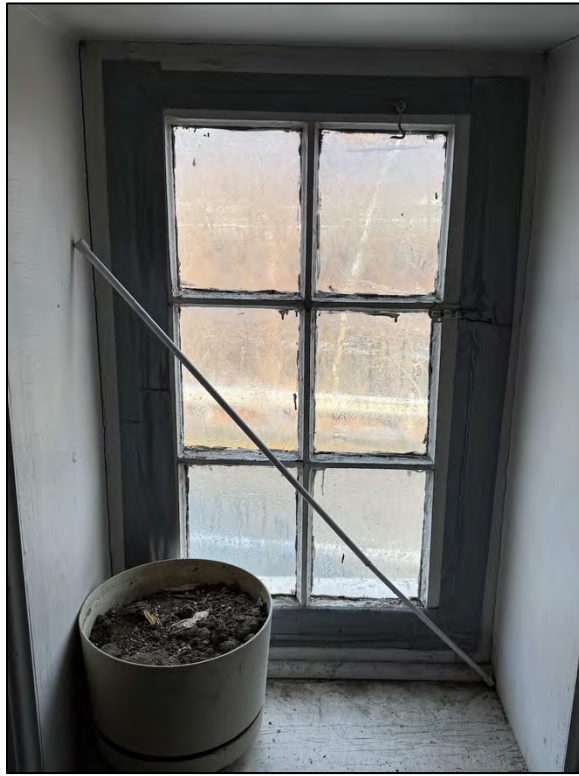
*Plate 275. Room 13 window, facing north.*

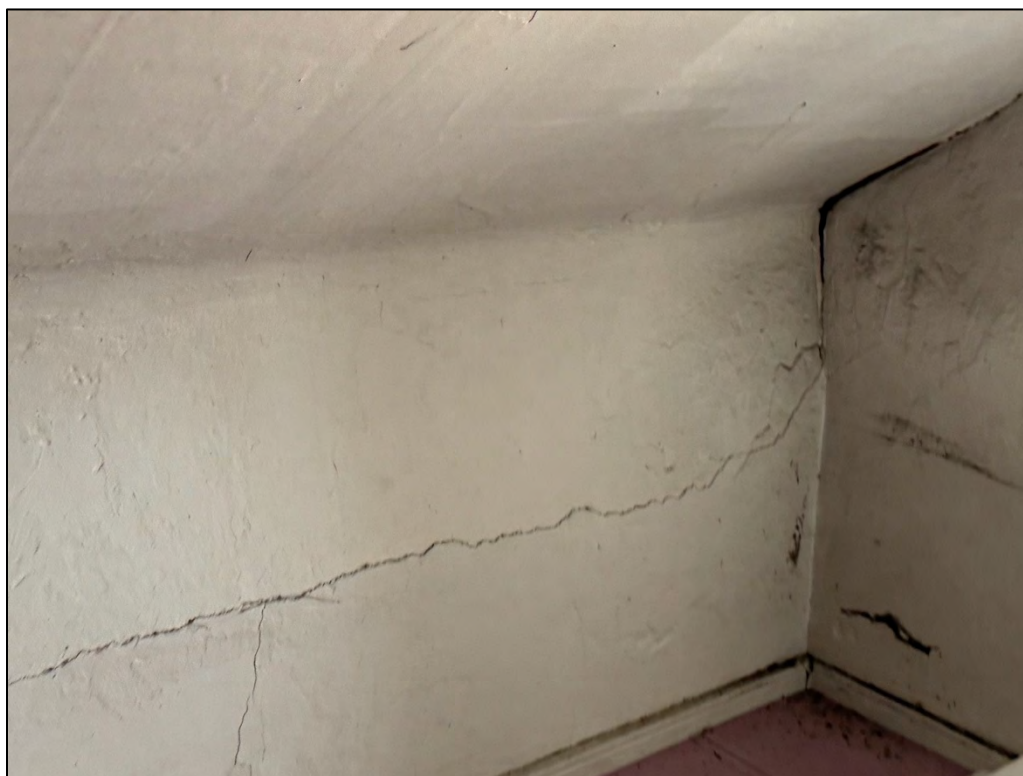
*Plate 277. Room 13, detail of crack, facing west.*

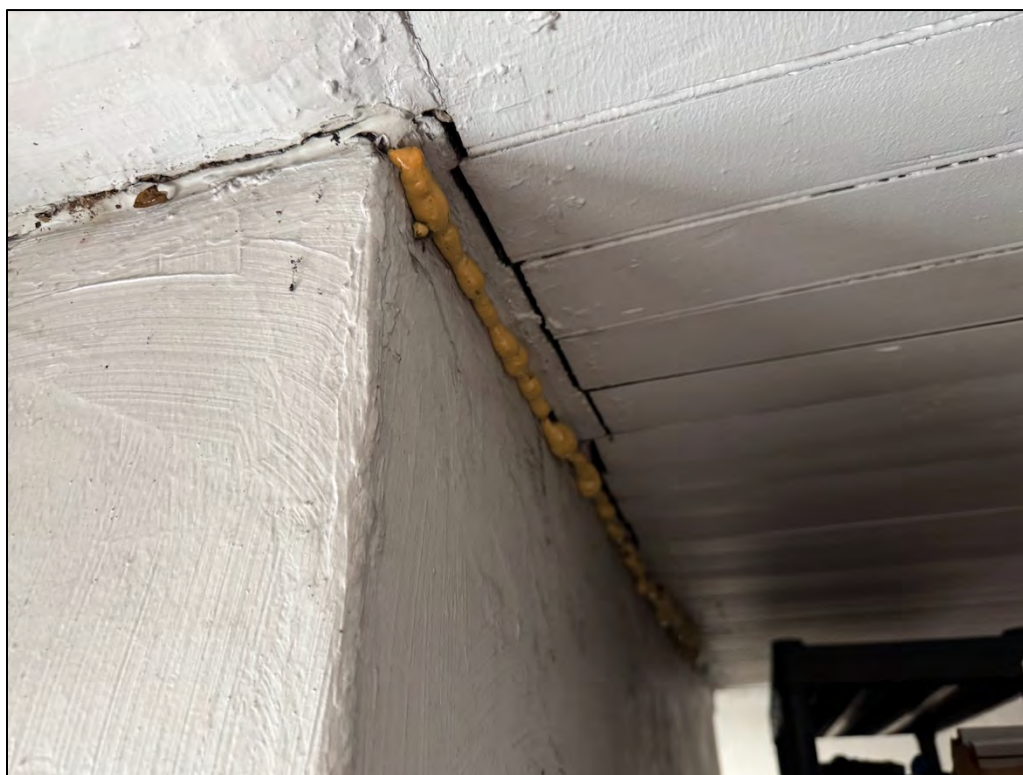
*Plate 278. Room 13, detail of spray foam at the chimney/ceiling junction.*

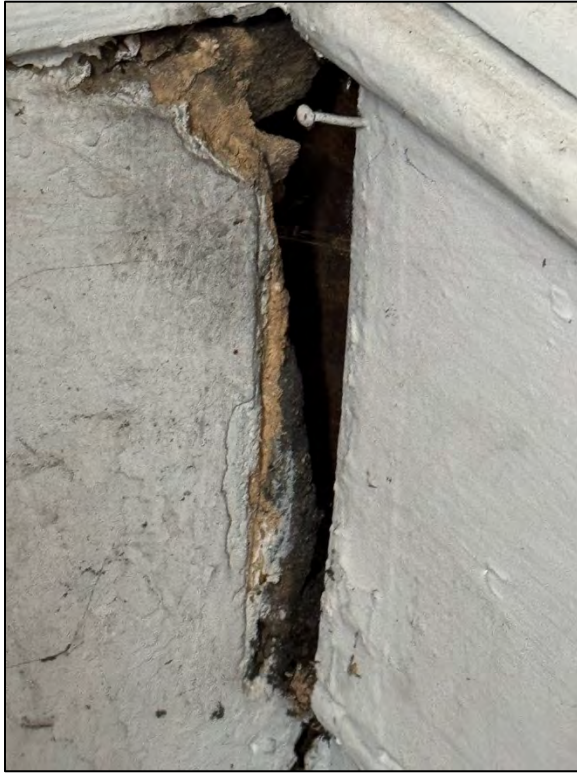
*Plate 279. Room 13, large crack in wall, facing east.*

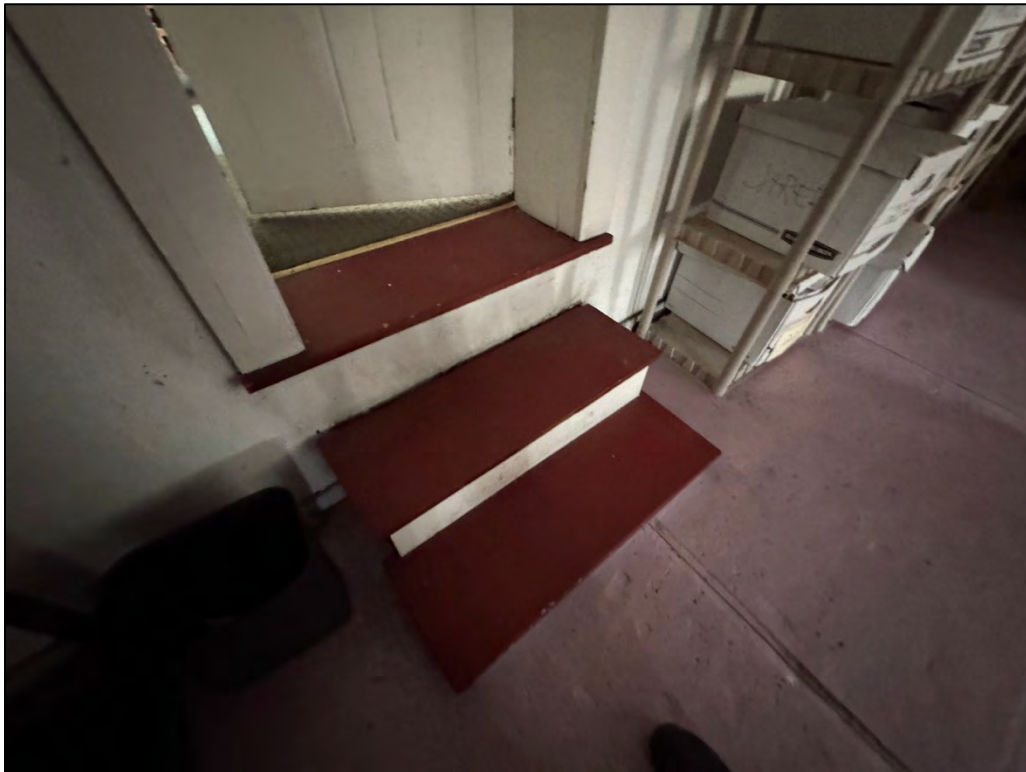
The rigid foam insulation covering the floor prevents evaluation of the underlying historic flooring. The stair treads leading upward to Room 14 appear to be settling slightly, whereas the winder staircase descending to Room 4 appears to be in stable condition.

*Plate 280. Entry stairs to Room 14, facing south.*

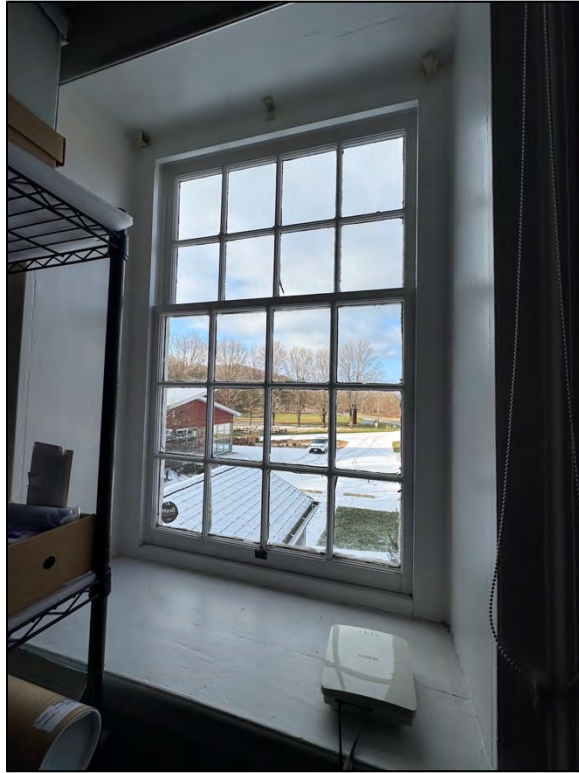
The room contains four windows in total: two on the east elevation (W2-5 and W2-6) and two on the west side (W2-3 and W2-4). The vinyl windows on the east elevation are in good condition and appear to be functioning as intended. The wood replacement windows on the west elevation, likely installed during the ca. 1980 renovation- signs of deterioration with paint flaking, weathering, separation of the stile from the rails and failed glazing. Daylight is visible through portions of the window assemblies, indicating air infiltration and a potential pathway for insects to enter into the building.

*Plate 285. Typical wood window, facing west.*

windows and the installation of interior storm windows would significantly improve thermal performance and help mitigate temperature fluctuations caused by exterior conditions.

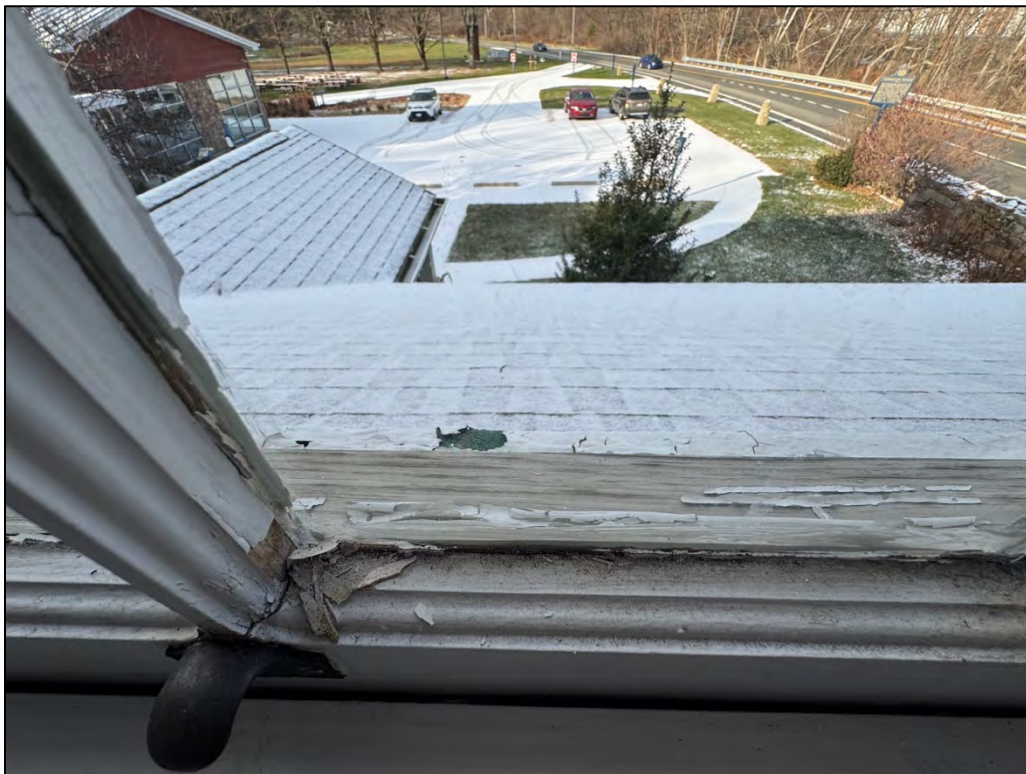
*Plate 286. Detail of wood sash deterioration, failed glazing, chipped paint and overall weathering.*

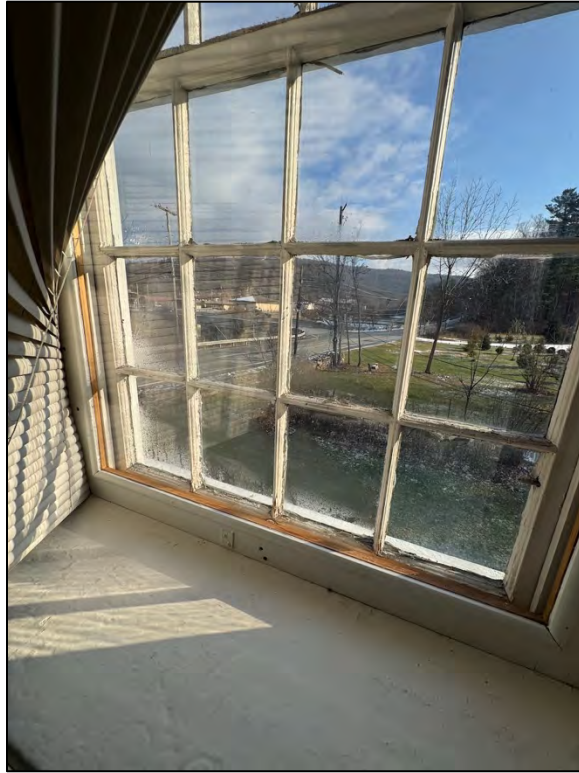
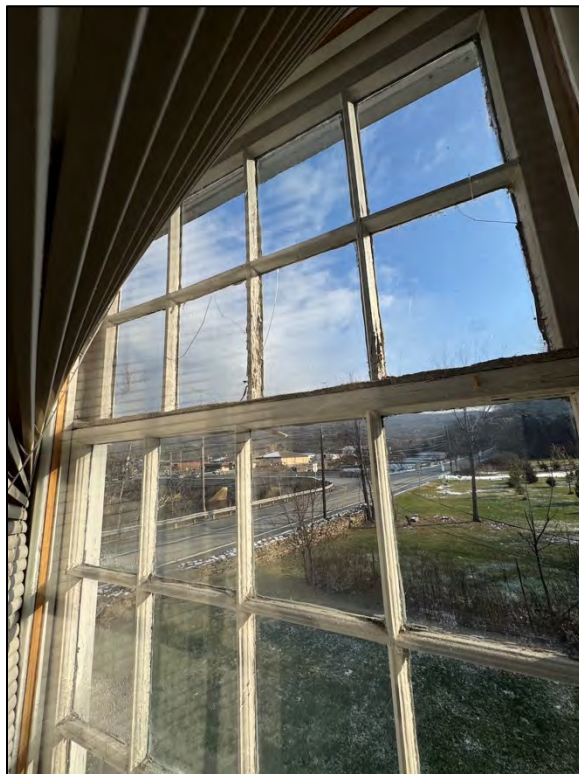
The most significant concern in this room is the simple wood window on the east elevation. Although the window does not appear to be original, it closely matches the glazing pattern of the historic windows elsewhere in the building. The window is in advanced deterioration: glazing is missing, several panes are cracked and the muntins exhibit rot with visible mold growth accelerating decay. An interior storm window is installed, which appears to be exacerbating the condition by trapping moisture. At the time of the site visit, visible condensation was present between the storm window and the exterior sash. This window requires immediate attention to prevent further deterioration and potential moisture-related damage to surrounding materials.

*Plate 295. Lower sash of window 2-11, facing east. Note interior storm window.*

*Plate 296. Upper sash of Window 2-11, facing east.*

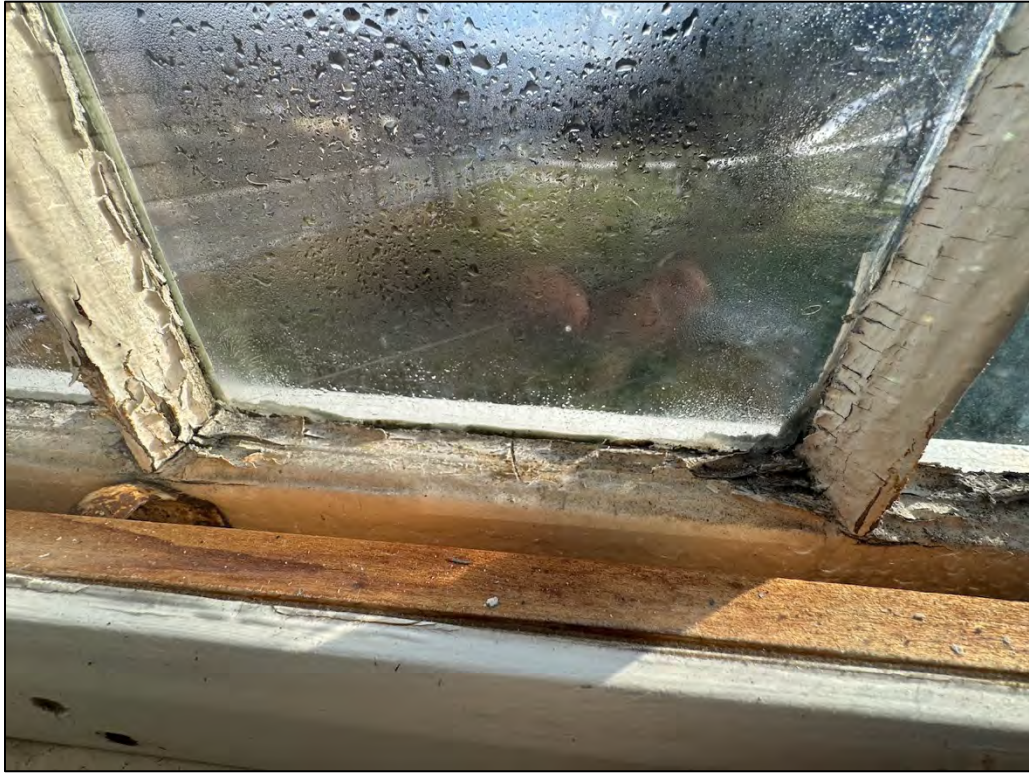
*Plate 297. Detail of deterioration caused by condensation, insects and sunlight, facing east.*

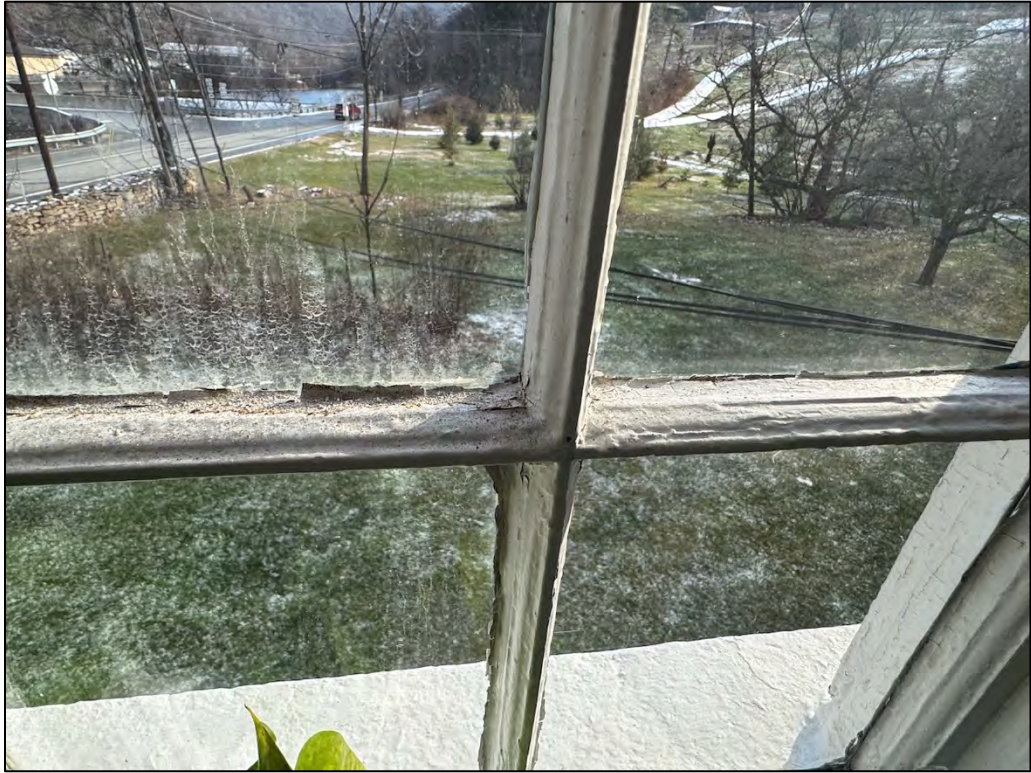
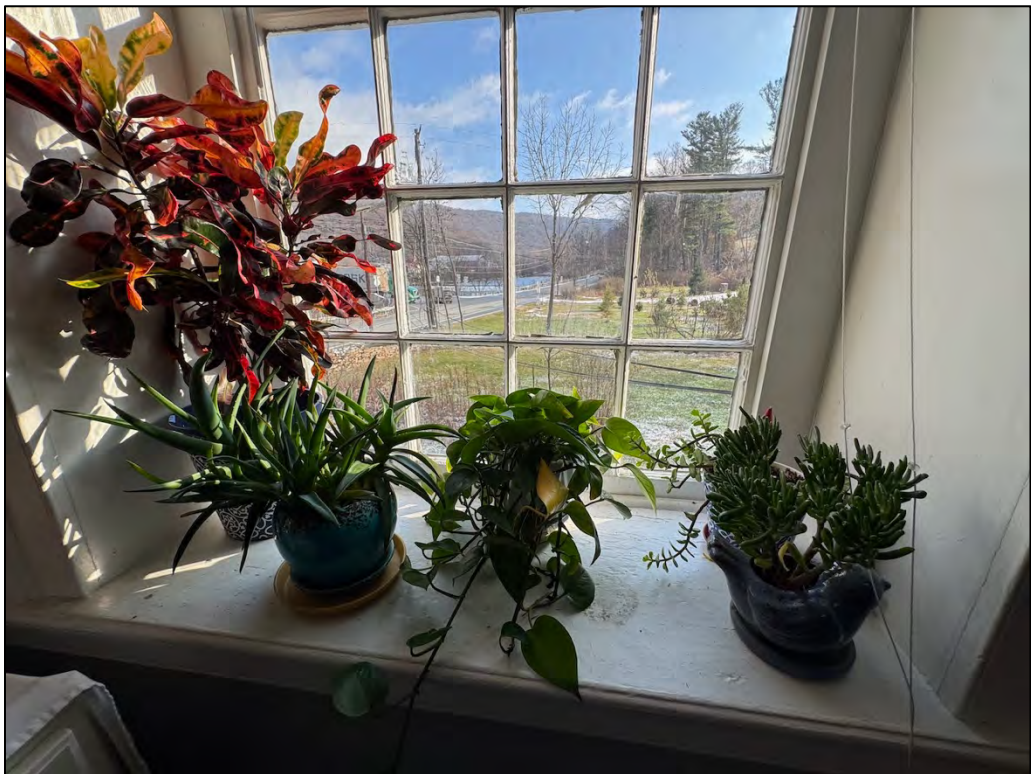
The primary concern in this room is the wood window on the east elevation, which needs rehabilitation. The window exhibits glazing failure, cracked panes, and general signs of weathering. Its poor thermal performance necessitates the use of supplemental heating, contributing to the inefficiencies of temperature regulation within the space.

*Plate 306. Detail of wood window, facing east.*

*Plate 307. Wood window, facing east.*

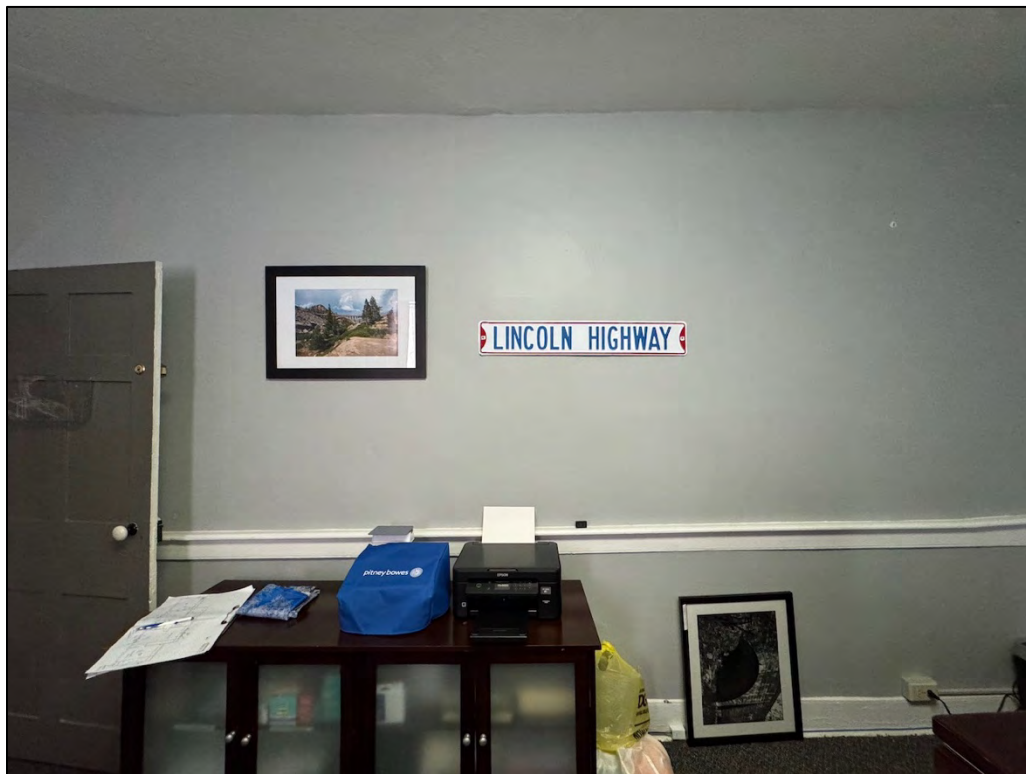
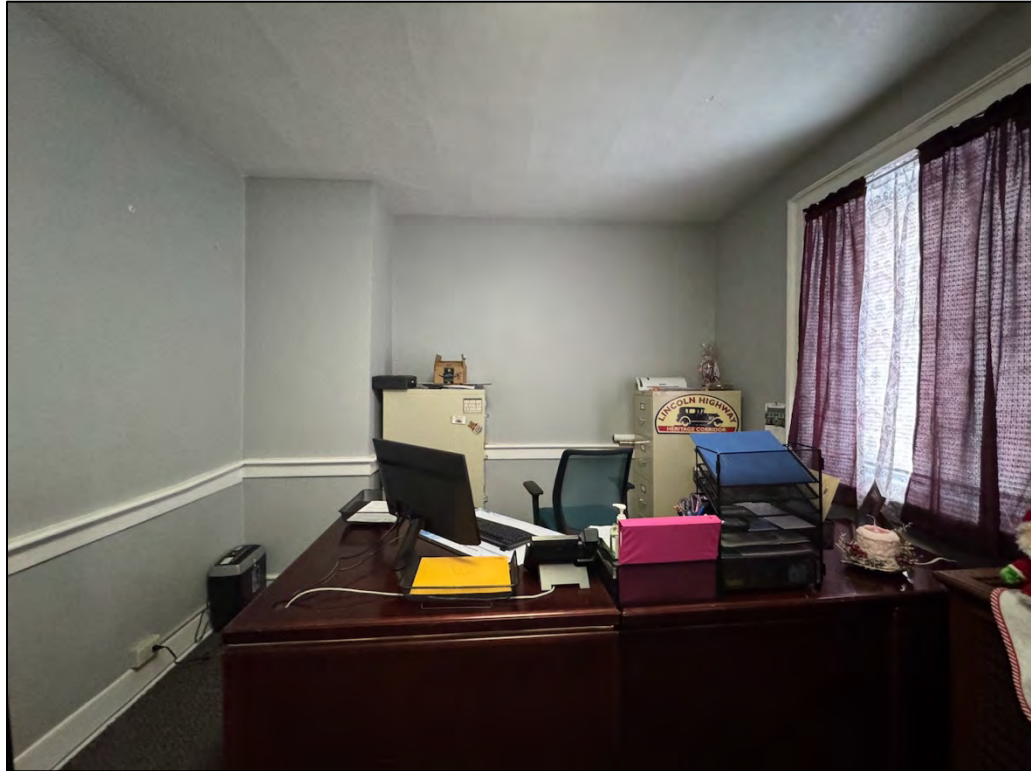
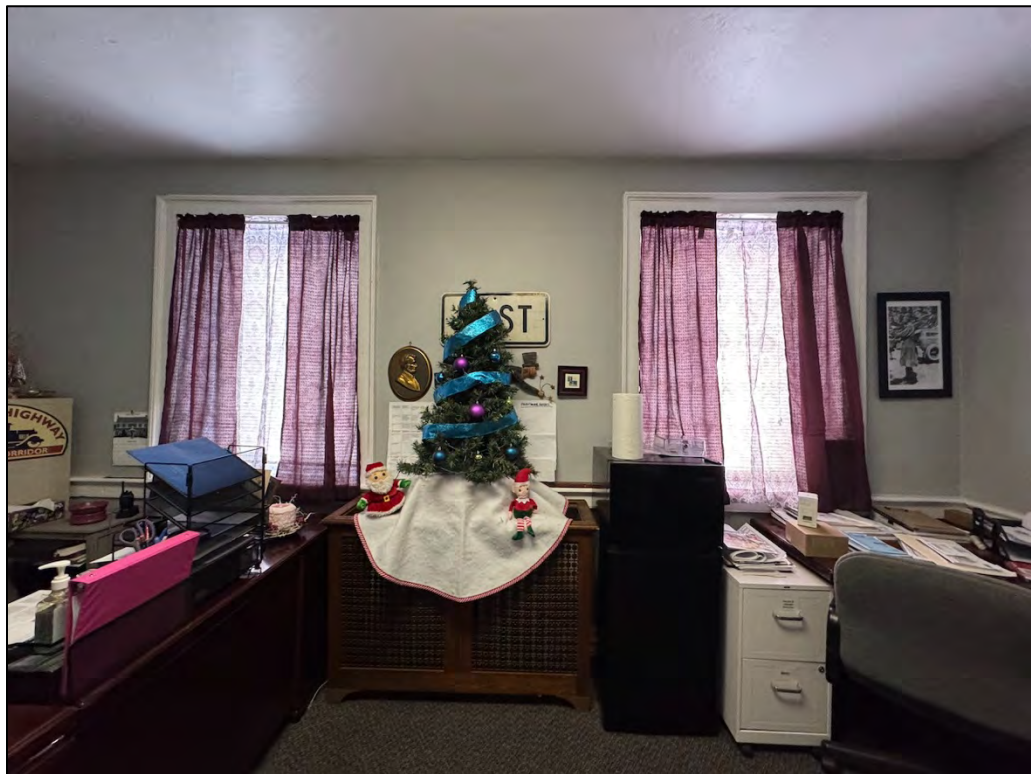
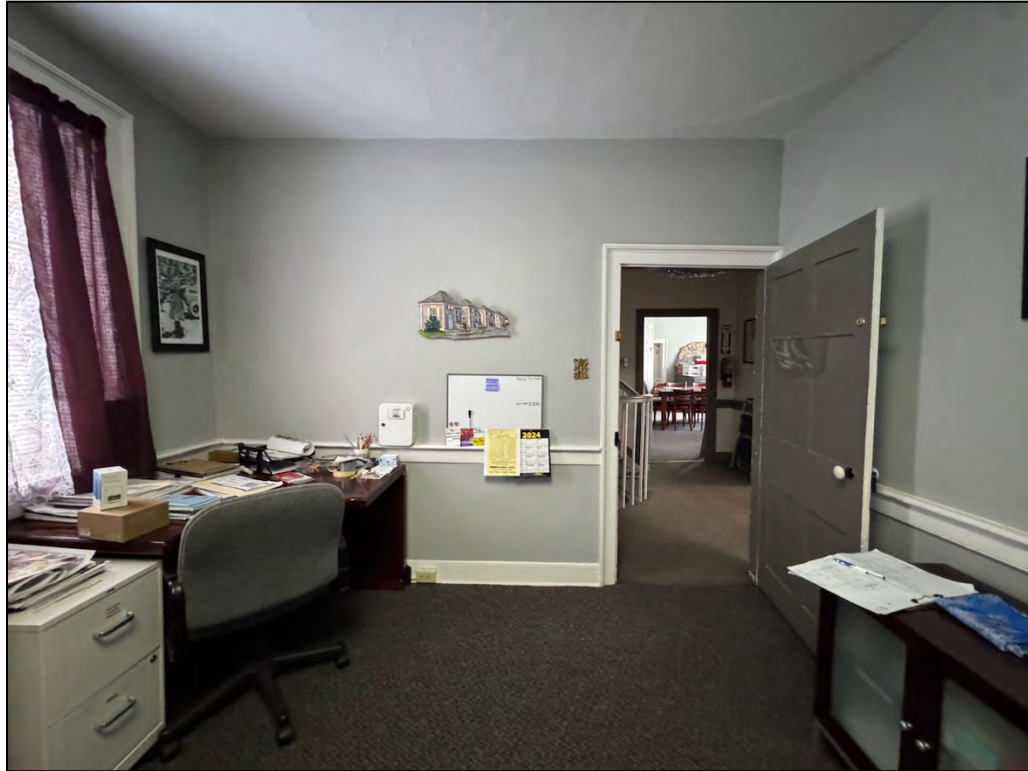
Overall, this room is in good condition. The carpeted floor conceals the original flooring material and prevents a full assessment of its condition. The plaster walls are smooth and show no visible signs of cracking. The ceiling appears to contain multiple layers of plaster, resulting in a rough and uneven surface; however, there is no evidence of active moisture infiltration, suggesting this condition may be the result of early repairs rather than a current failure.

*Plate 312. Room 17. Facing east.*

*Plate 313. Room 17, facing south.*

*Plate 314. Room 17, facing west.*

*Plate 315. Facing north.*

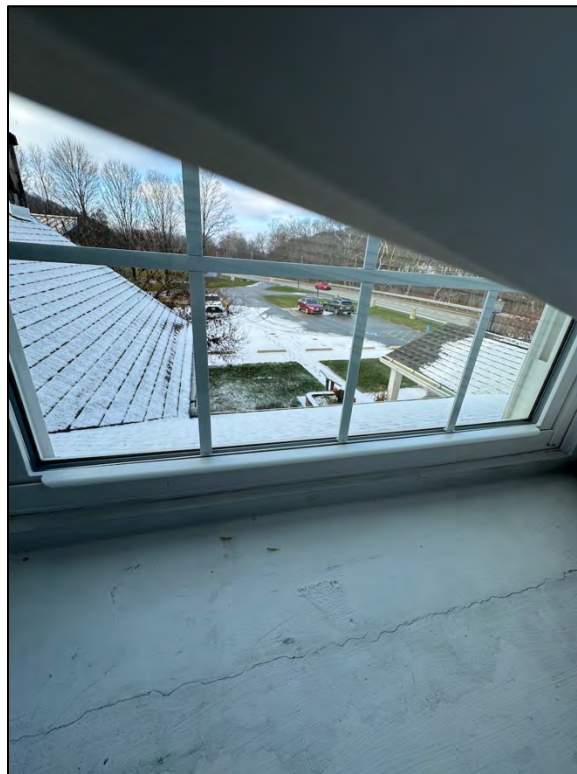
The fenestration consists of one vinyl replacement window and one wood replacement window. The vinyl window, located on the south side of the west elevation, is in good condition. The adjacent windowsill exhibits a minor crack but is otherwise stable.

*Plate 316. Vinyl window, facing west.*

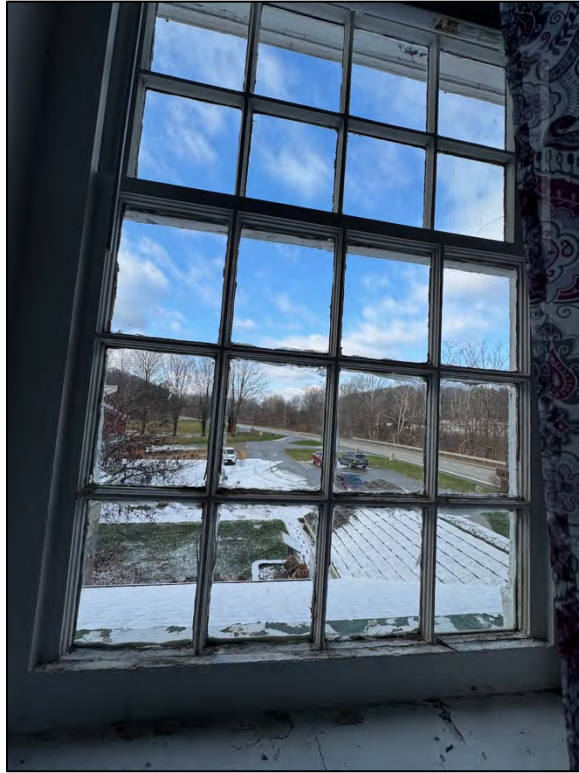
The wood replacement window needs rehabilitation. The muntins show advanced weathering and deterioration, with several cracked panes of glass; at least one pane appears to be a recent replacement. Staining and discoloration on the sill indicate past moisture infiltration, which has contributed to the deterioration of the wood components.

*Plate 317. Wood window, facing west. Note cracked sill.*

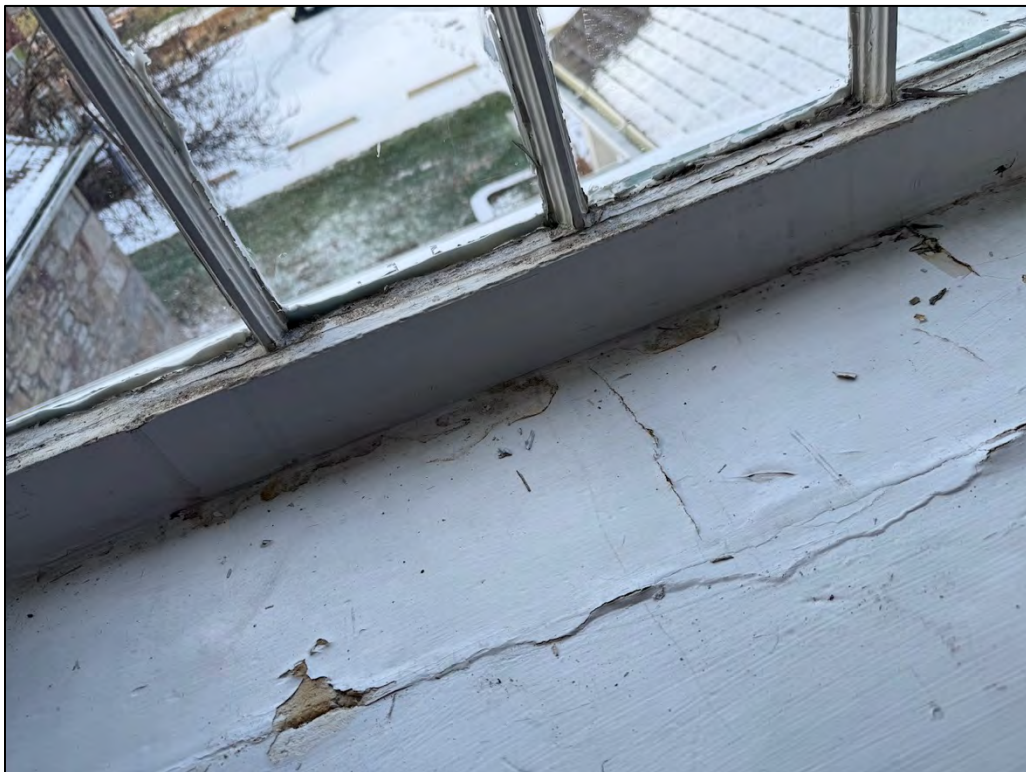
*Plate 318. Detail of wood window and apron deterioration.*

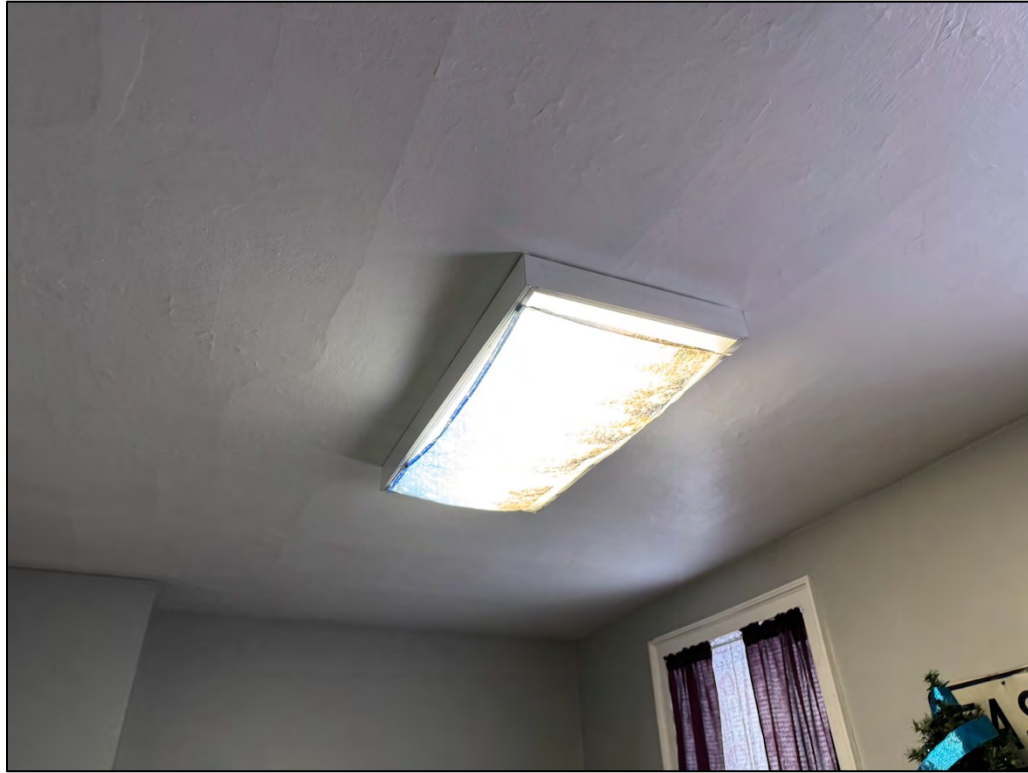
*Plate 319. Note layers of uneven plaster on ceiling.*
