# CONDITION ASSESSMENT REPORT

## THE LINCOLN HIGHWAY HERITAGE CORRIDOR

3435 State Route 30 East  
Latrobe, Westmoreland County, Pennsylvania

Abbreviated  
Condition Assessment Report  
Alexander Johnston's "Kingston House"

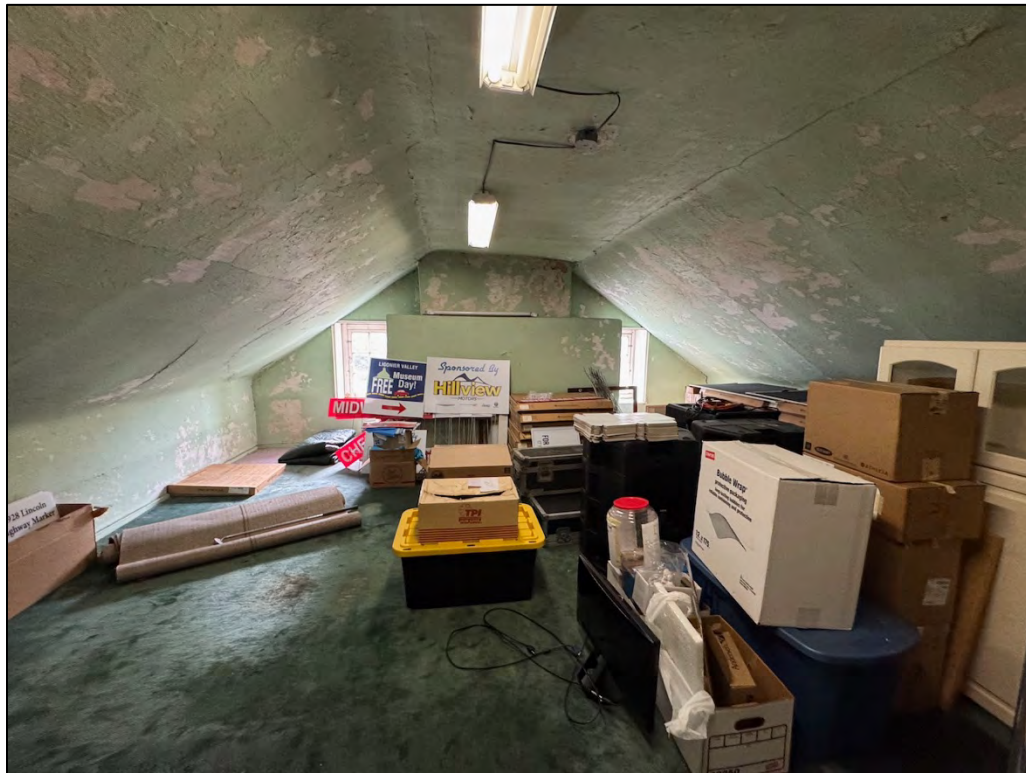
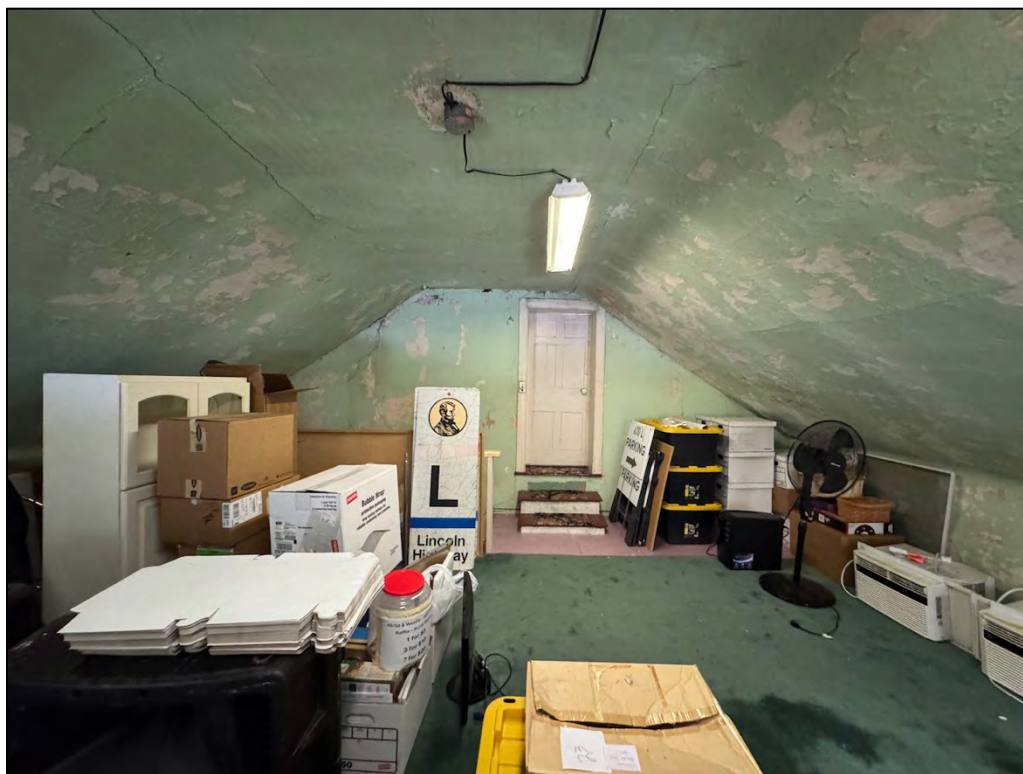
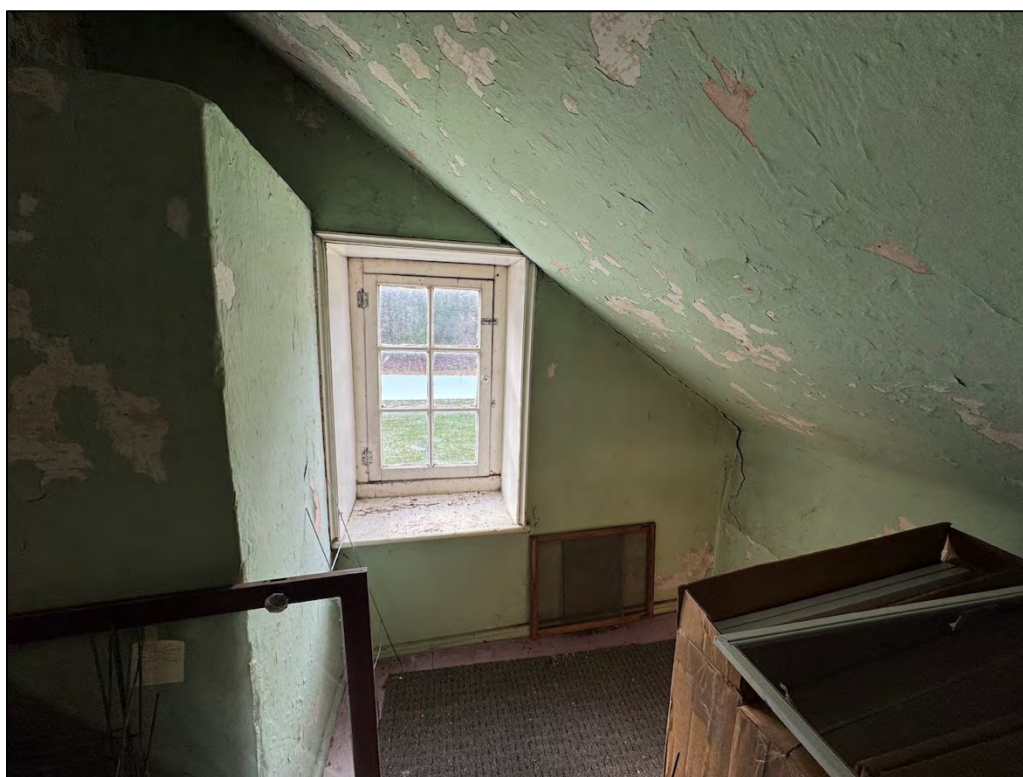
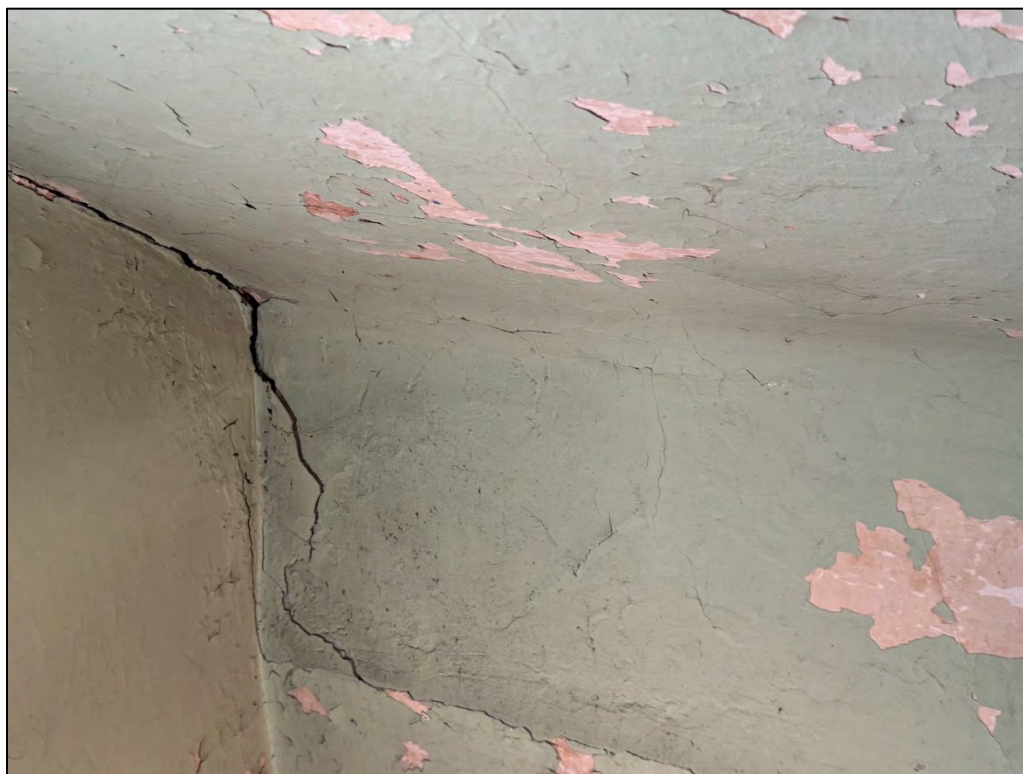
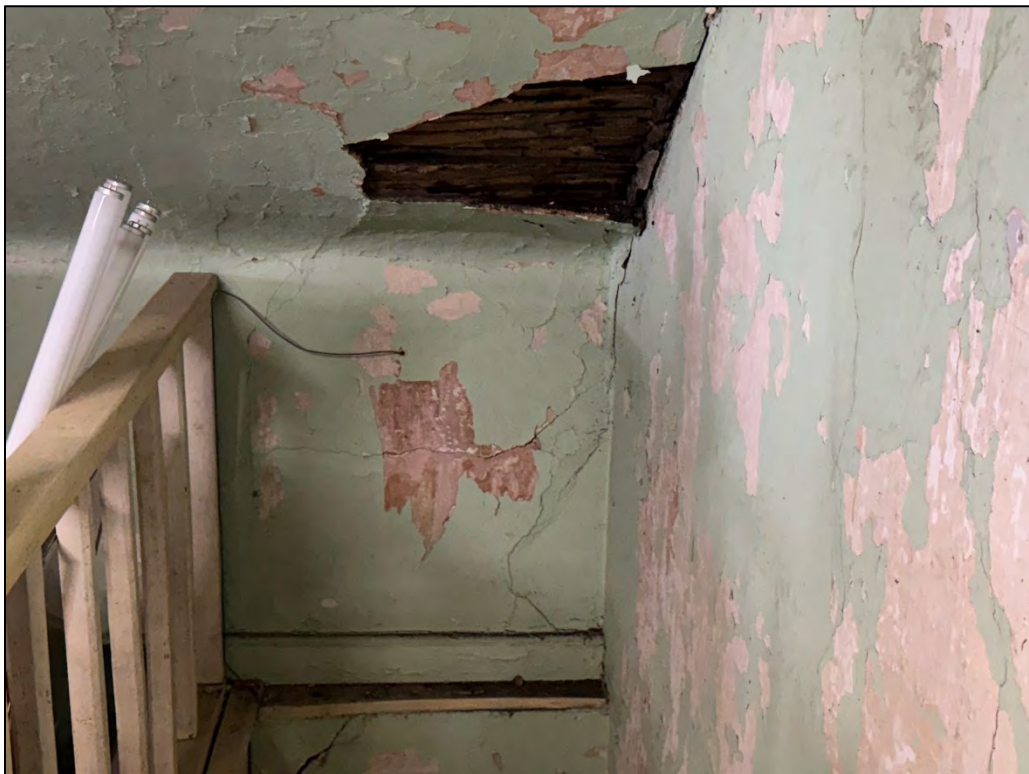
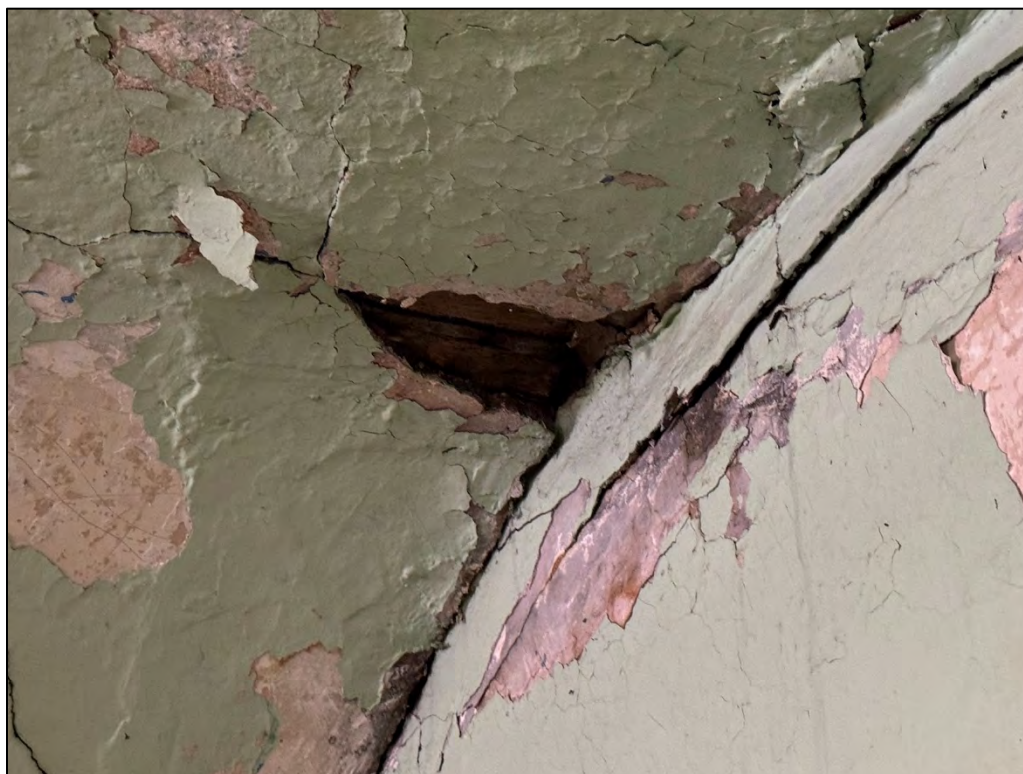
The plaster walls exhibit significant deterioration and evidence of repeated repair campaigns, with at least six layers of plaster visible on portions of the wall. The cumulative weight of these additional layers of plaster appears to have exceeded the capacity of the underlying lath in some areas, resulting in large sections of plaster detaching and exposing the original wood lath beneath. The light green paint applied to the top layer of the plaster is also cracking and flaking, likely due to temperature fluctuations associated with the lack of constant conditioning. Although the roof has been repaired, the plaster damage likely originated from earlier water infiltration.

*Plate 320. Room 18, south wing upper storage area, facing south.*

*Plate 321. Room 18, south wing upper storage area, facing north.*

*Plate 322. Room 18, south wing upper storage area, facing south.*

*Plate 325. Room 18, south wing upper storage area, facing west.*

*Plate 328. Room 18, south wing upper storage area, facing west.*

*Plate 329. Room 18, south wing upper storage area, facing west.*

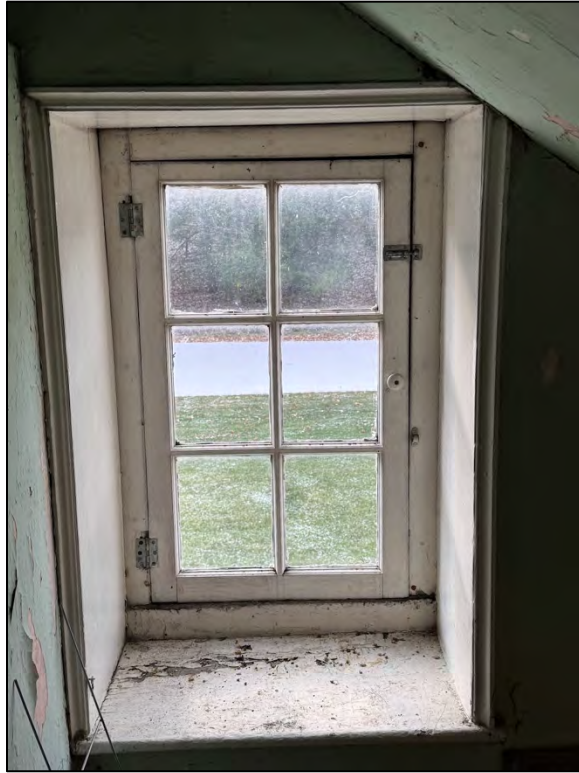
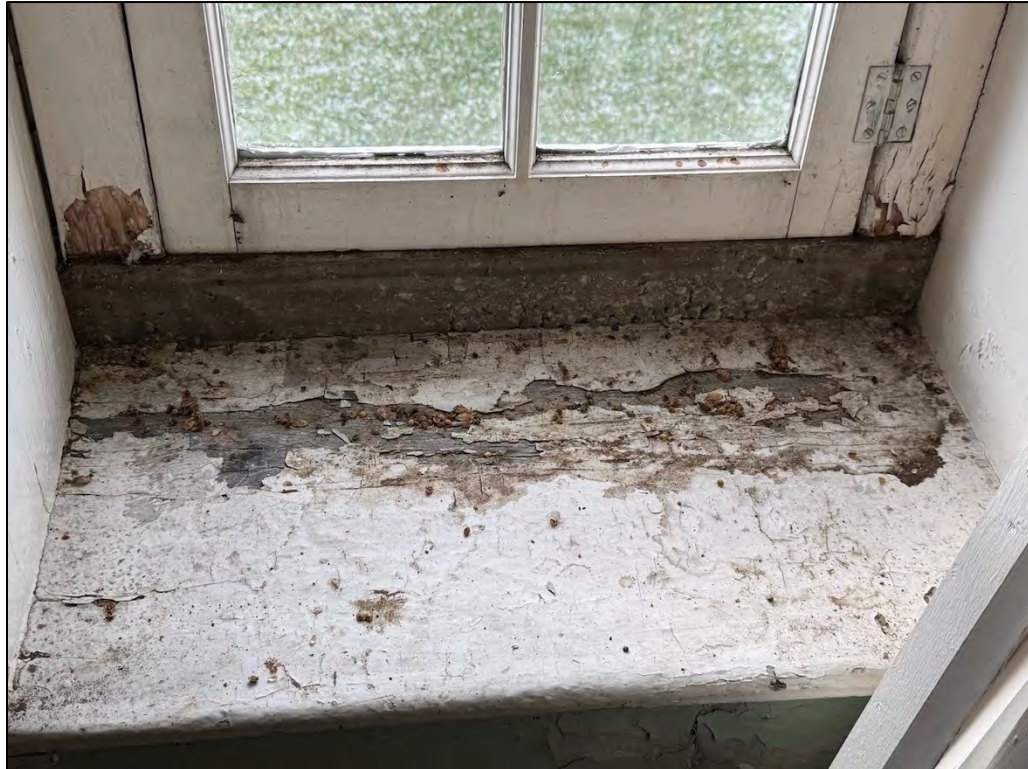
The wood casement windows are most likely not original; however, they are appropriate to the historic character of the home. The wood windows are showing signs of weathering and water infiltration and need rehabilitation.

*Plate 323. Room 18, south wing upper storage area, southwest window.*

*Plate 324. Room 18, south wing upper storage area, southeast window.*

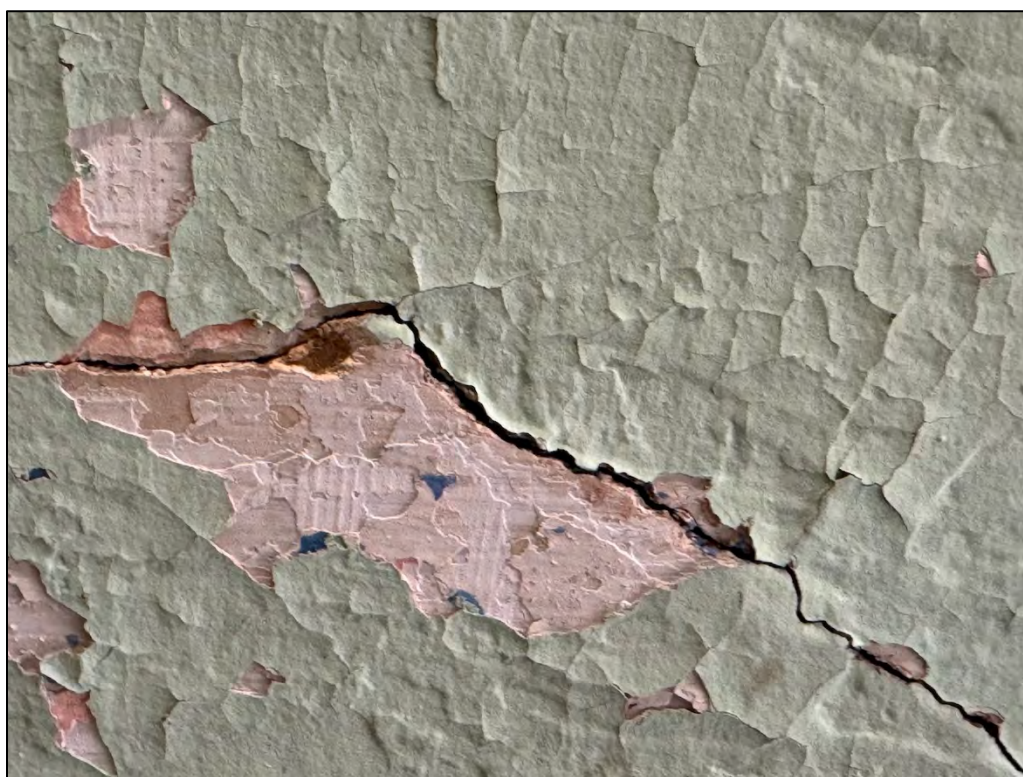
*Plate 326. Room 18, south wing upper storage area, detail of plaster crack.*

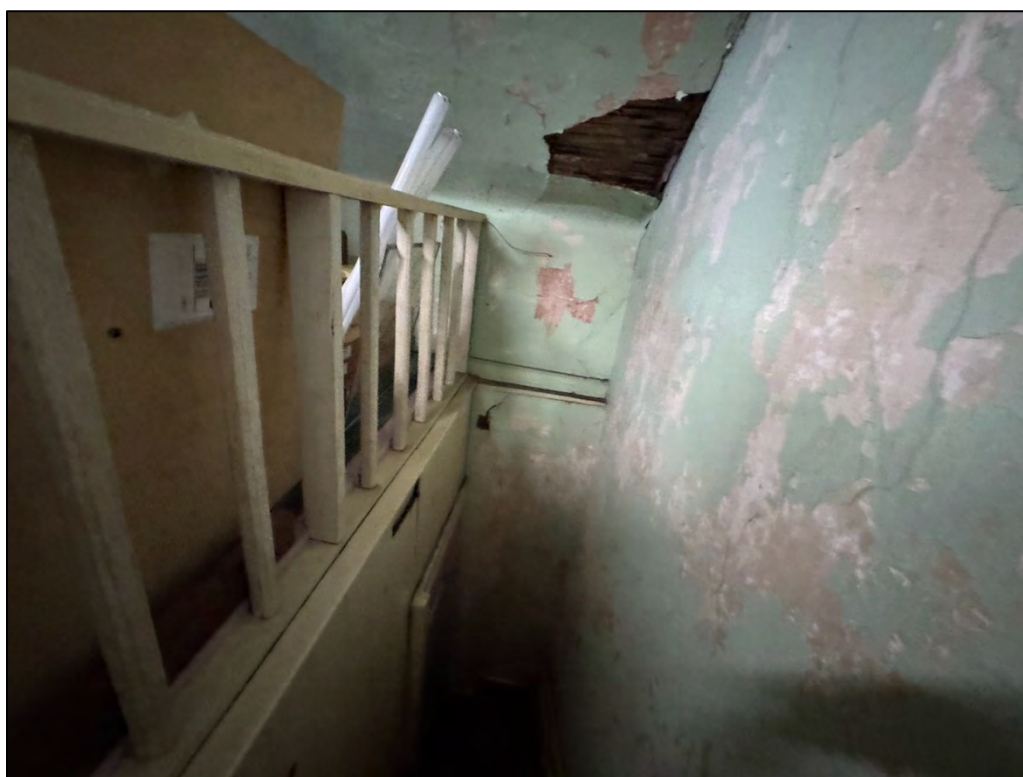
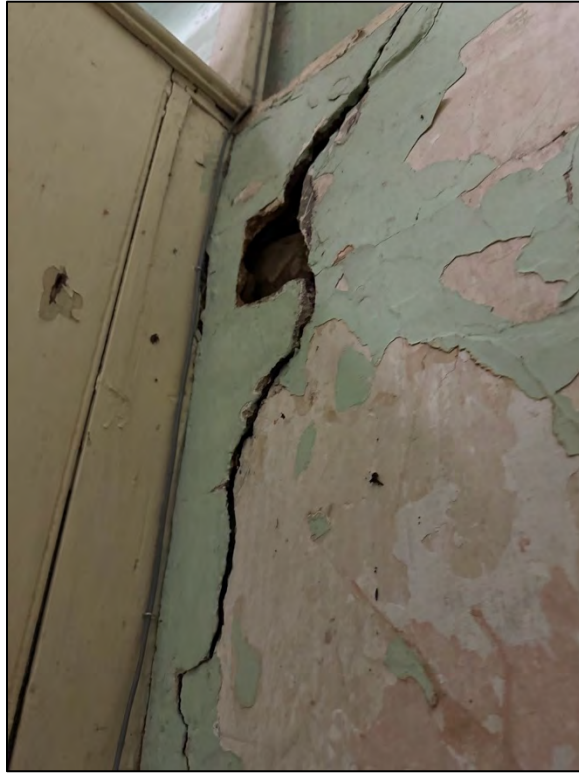
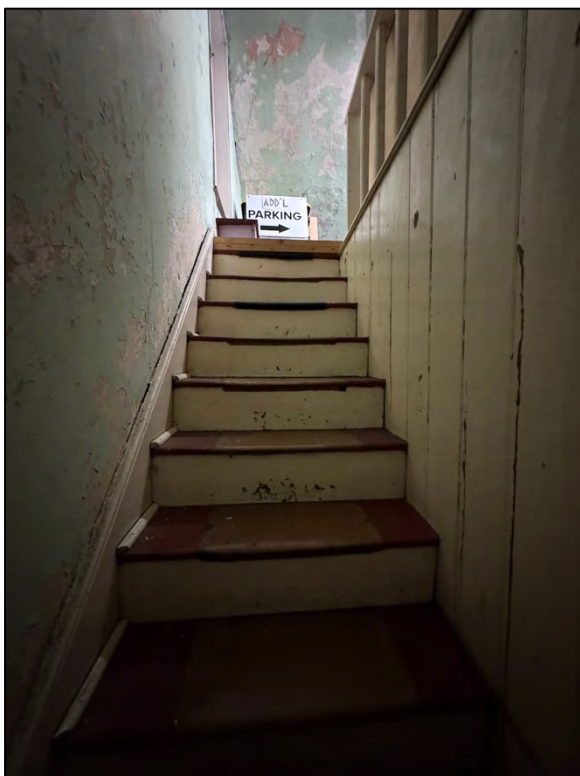
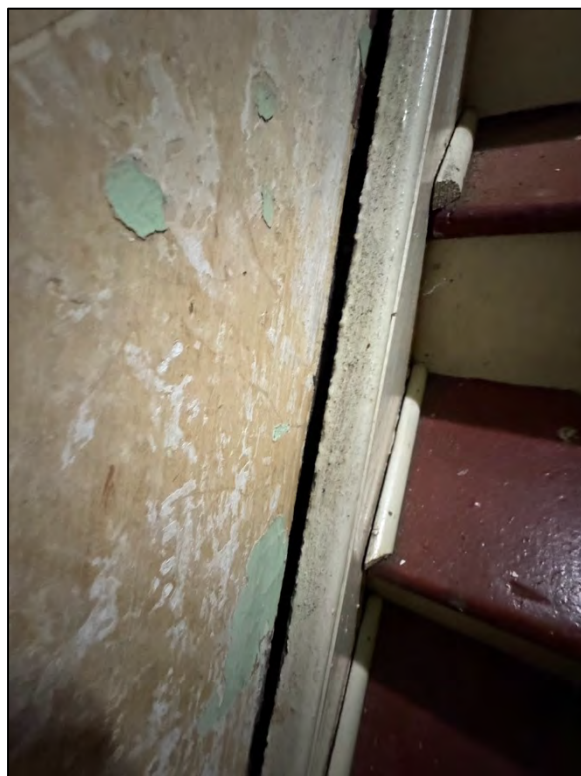
The winder staircase connecting to this room from the Ship Room below is beginning to pull away from the adjacent wall and should be evaluated by a structural engineer. It should be properly secured to prevent further movement and potential safety concerns.

*Plate 330. Room 18, south wing upper storage area, facing west (stairwell).*

*Plate 331. Room 18, south wing upper storage area, facing west (stairwell).*

*Plate 333. Stairs leading to Room 18 from Room 10 (Ship Room).*

*Plate 334. Stairs separating from the wall.*

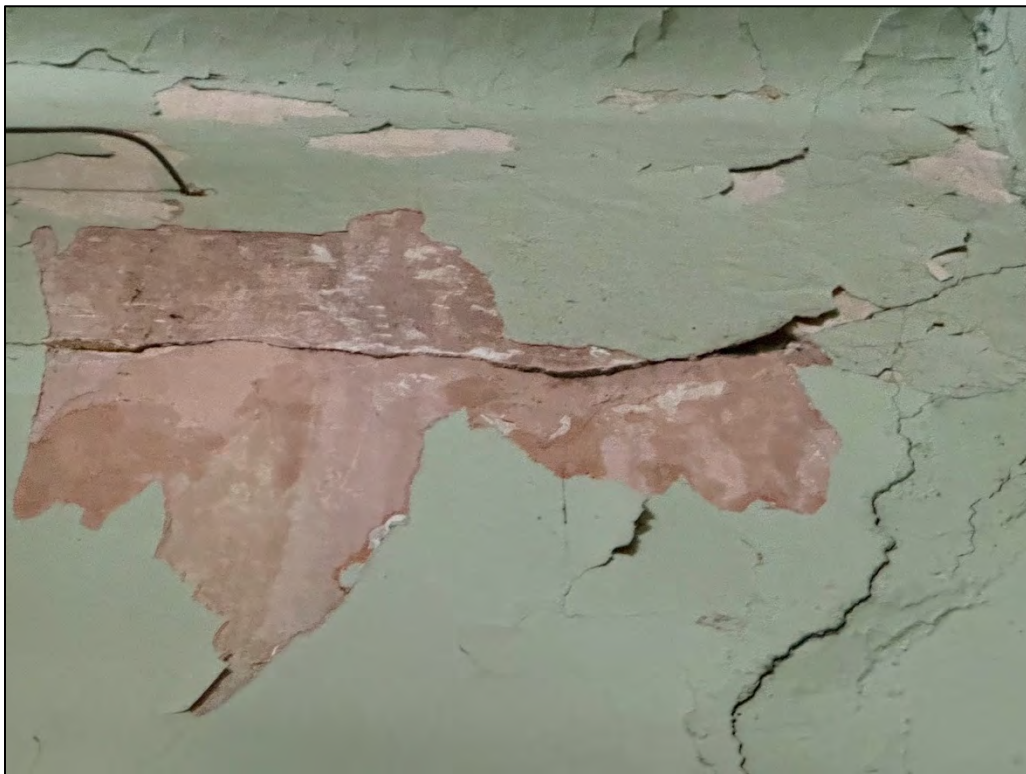
*Plate 332. Detail of plaster damage and repair.*

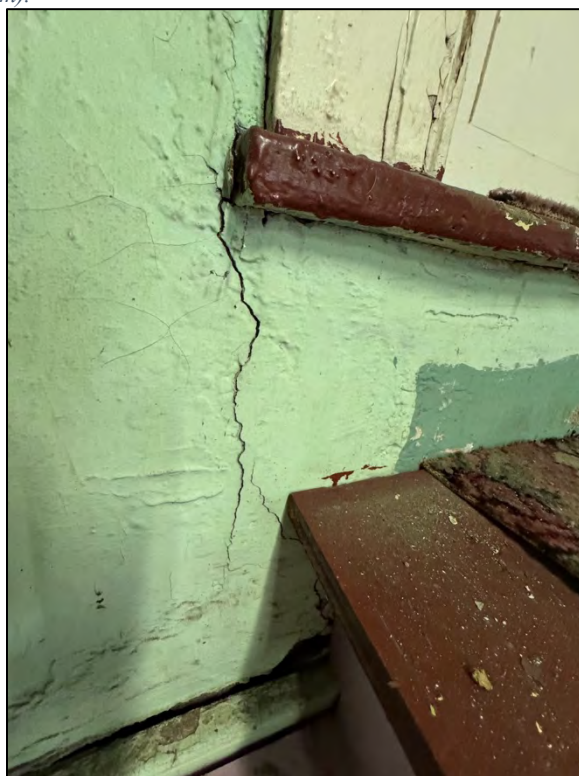
*Plate 335. Crack beneath access door, facing north.*

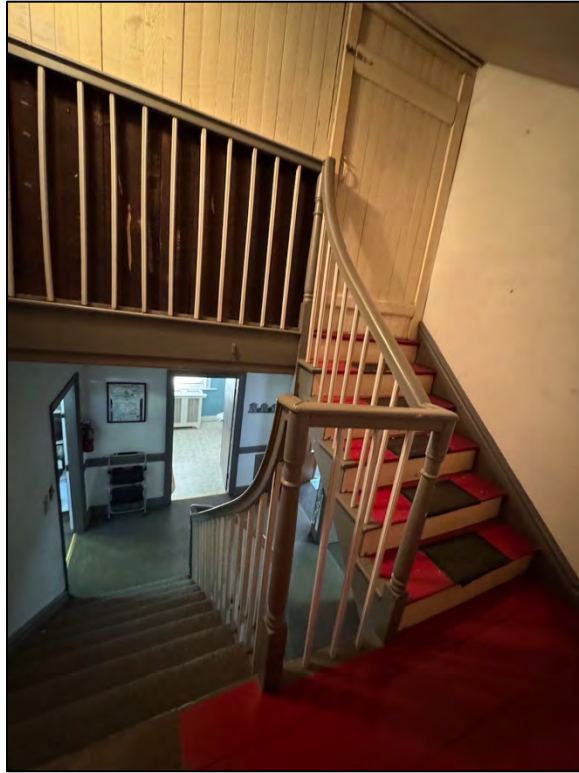
**Existing Conditions:** The attic space exhibits evidence of historic smoke exposure, with soot staining visible on the ceiling near the staircase access opening.

*Plate 336. Access to the third level attic, facing east.*

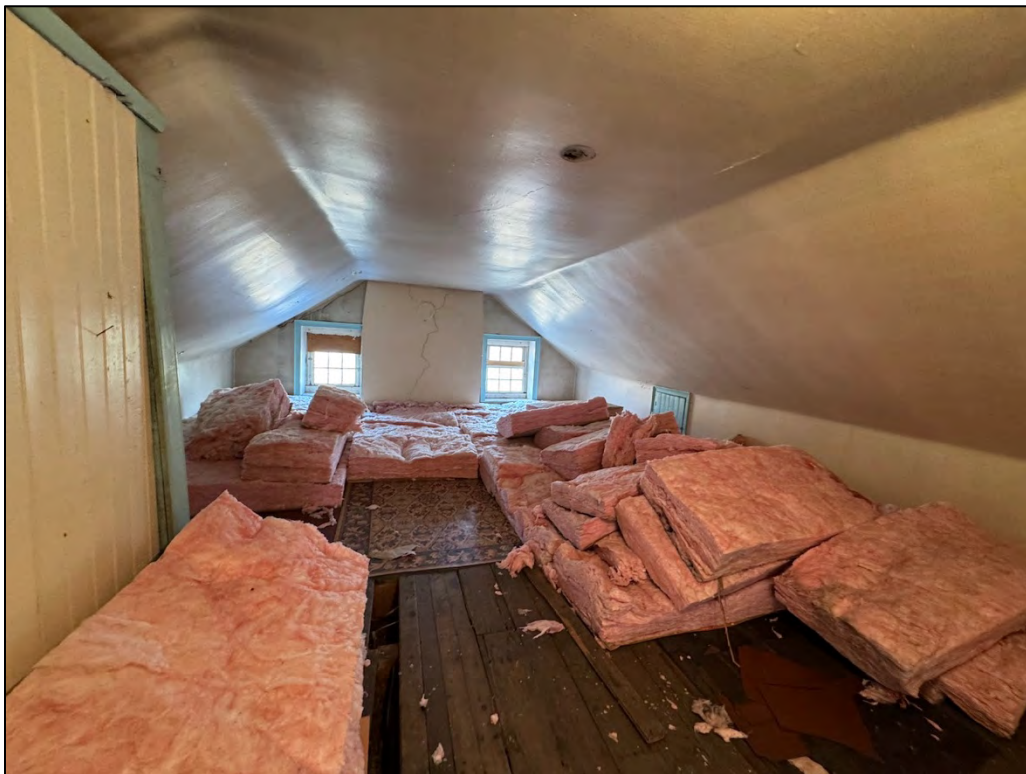
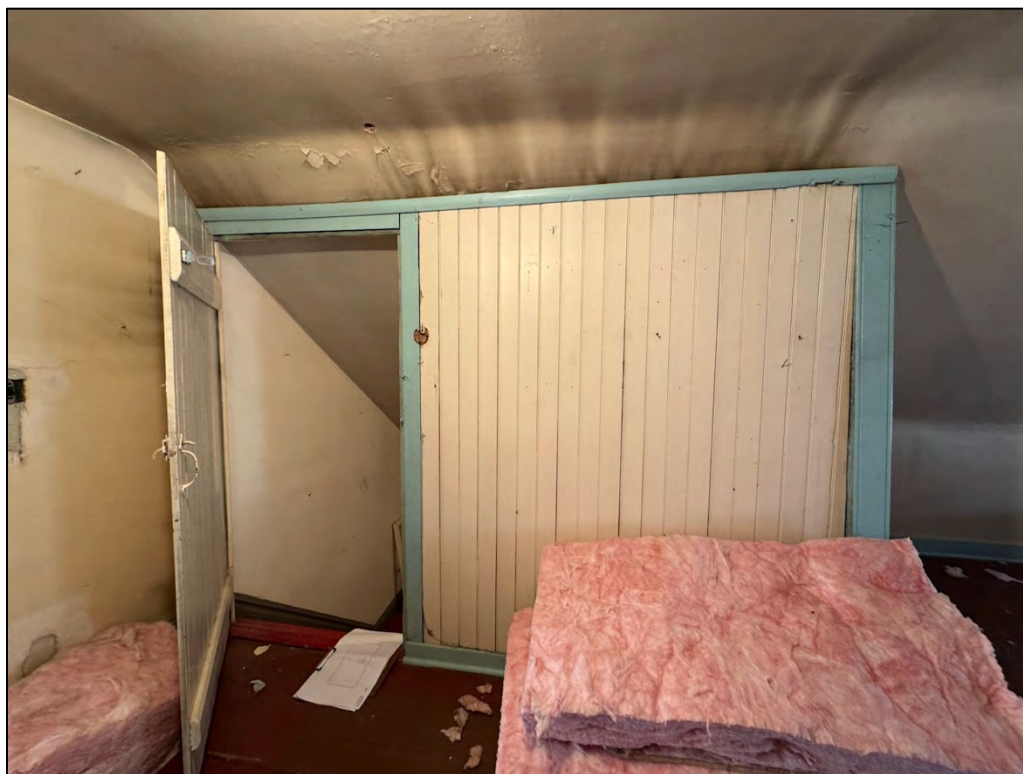
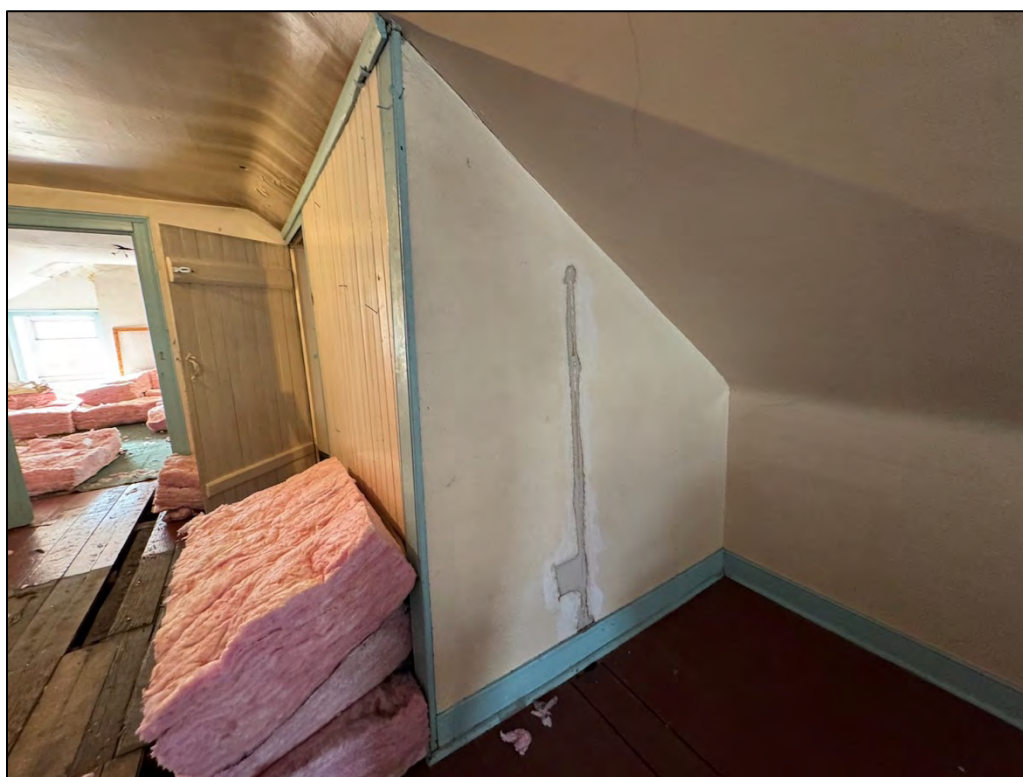
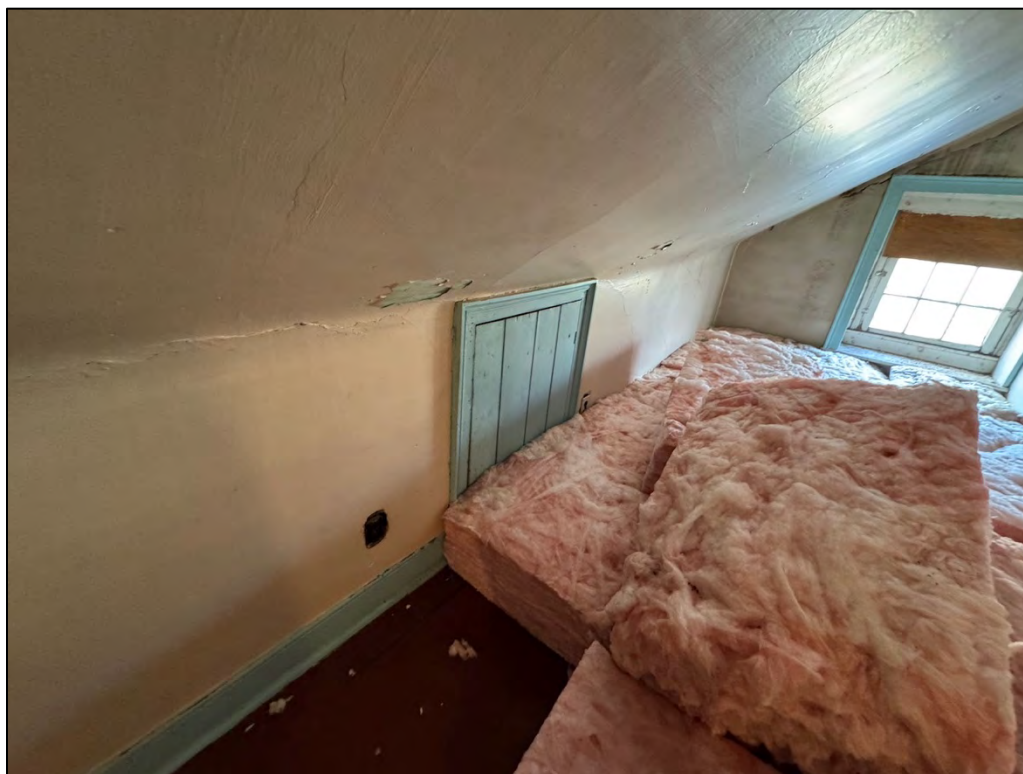
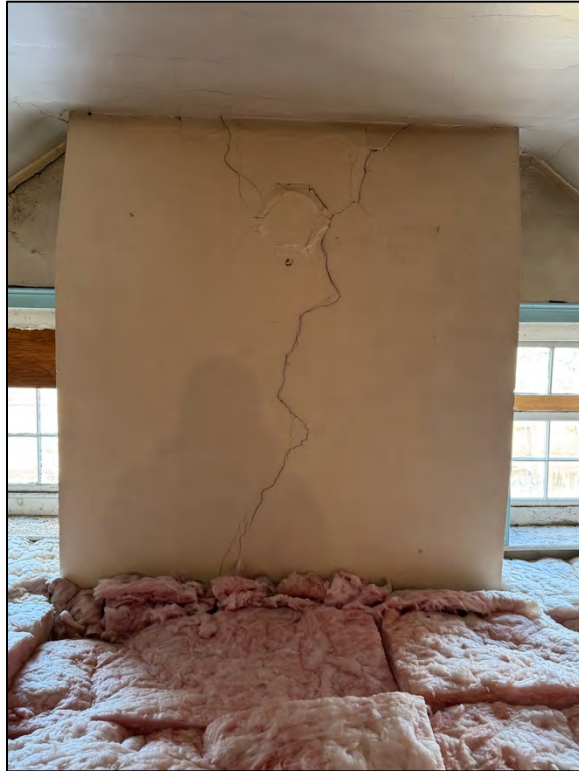
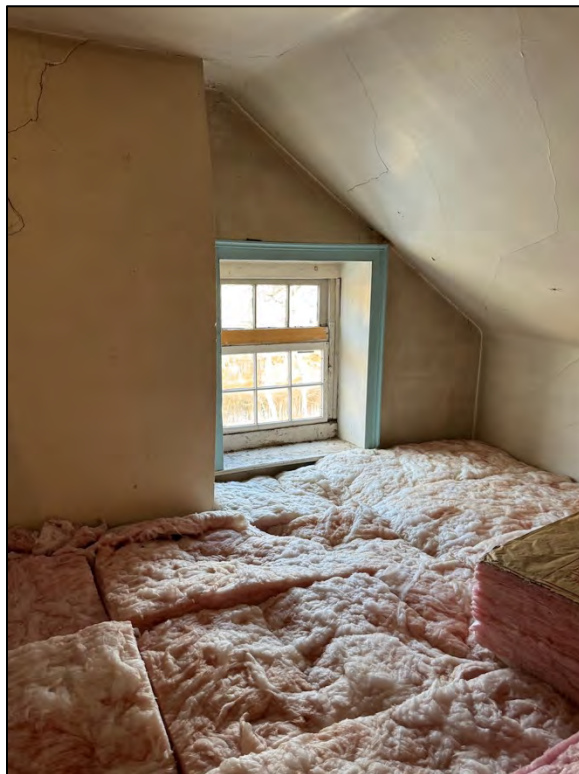
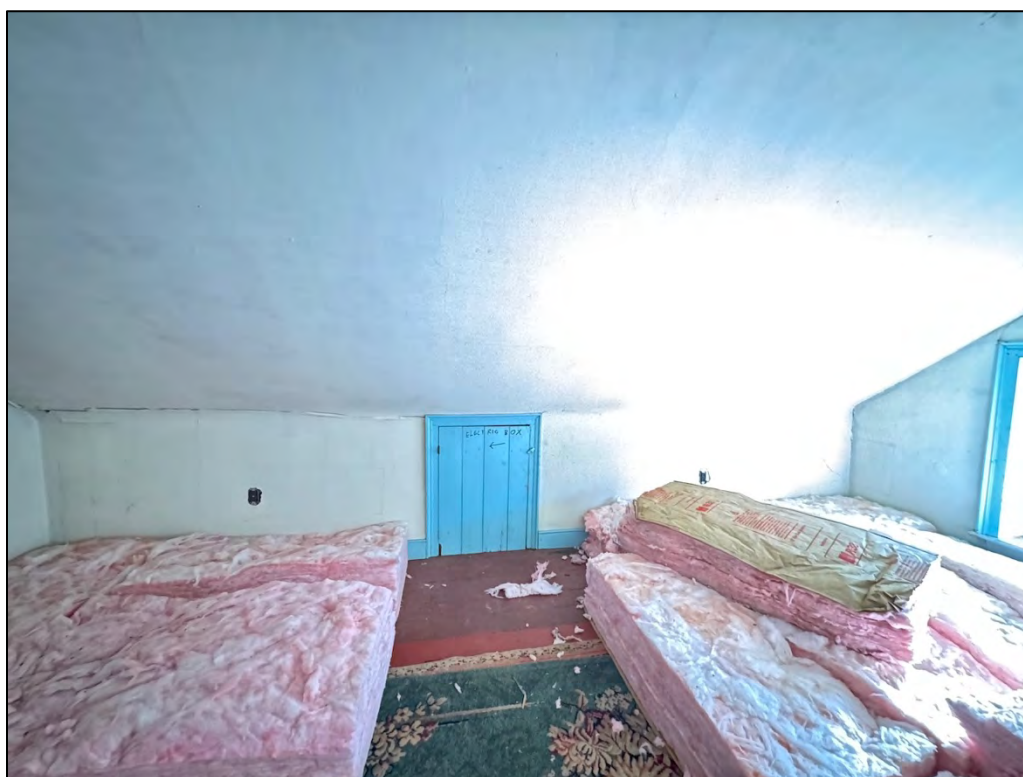
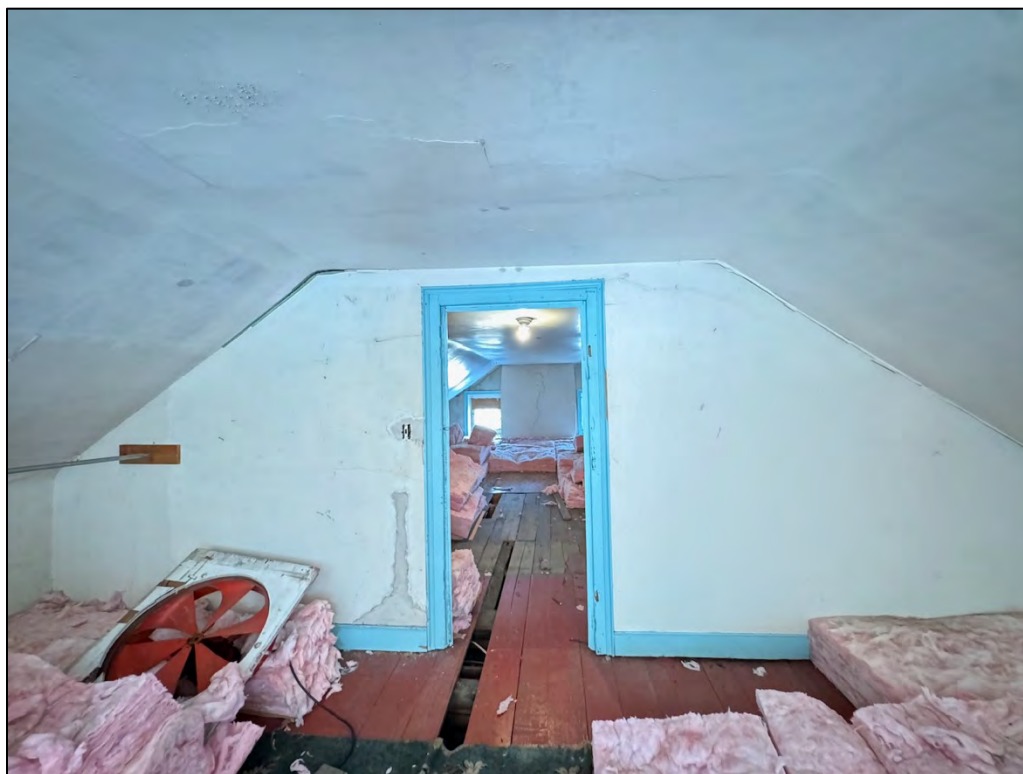
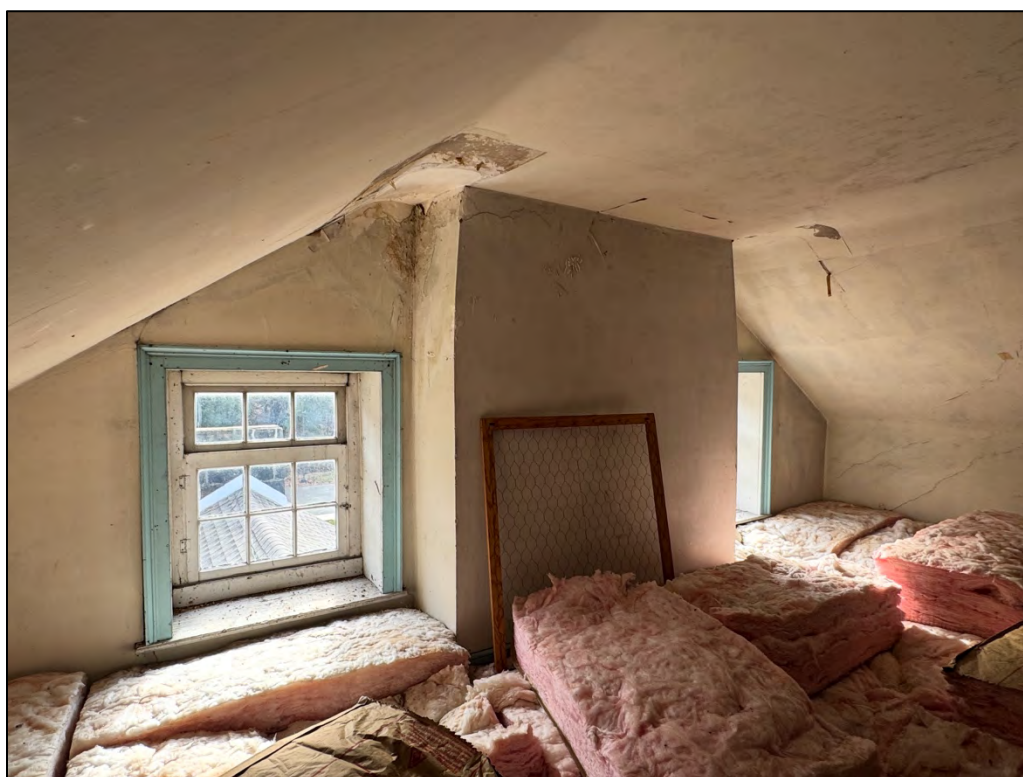
The plaster shows widespread cracking, including significant fractures near the south gable and along the chimney stack. Although the roof has been replaced- likely addressing the source of the previous water infiltration- the plaster near the south elevation remains bubbled, flaking and deteriorated, reflecting earlier moisture damage.

*Plate 337. Facing north.*

*Plate 338. Facing west.*

*Plate 339. Facing south.*

*Plate 340. Facing northwest.*

*Plate 342. Facing north.*

*Plate 343. Facing north.*

*Plate 345. Facing east.*

*Plate 346. Facing north.*

*Plate 347. Attic, facing south.*

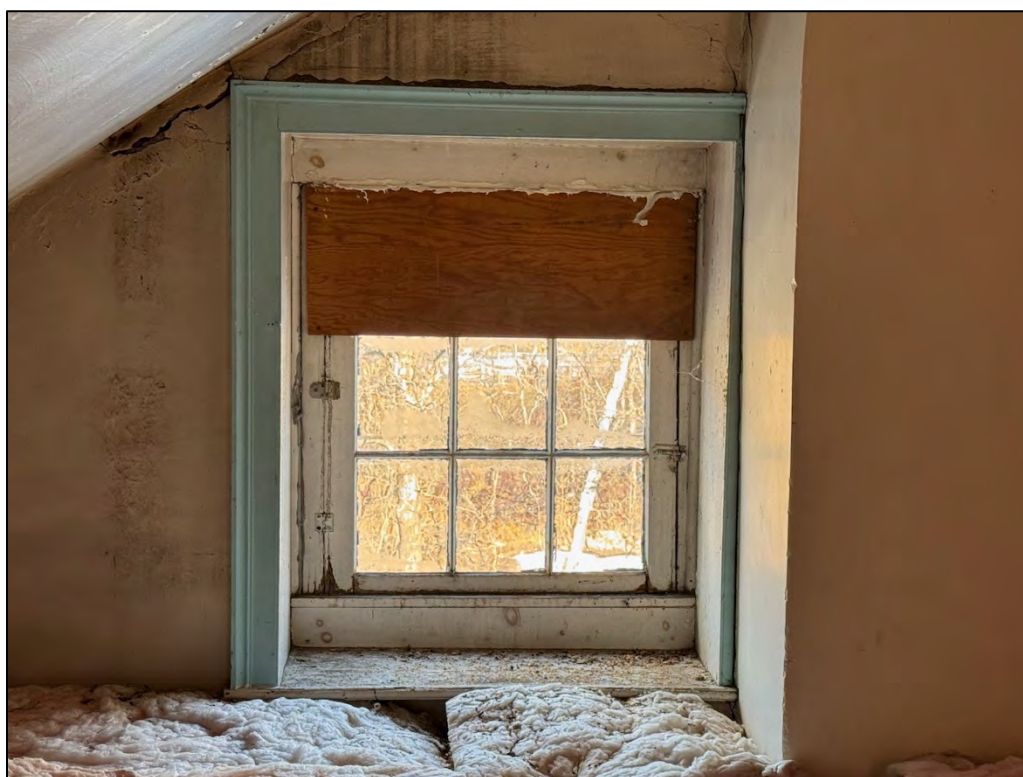
The gable end windows appear to be six-light casement wood windows with a three-light transom. Both windows are in poor condition and require substantial rehabilitation. Insect remains, dust accumulation and debris are present on the windowsills and within the openings.

*Plate 341. Detail of window, facing north.*

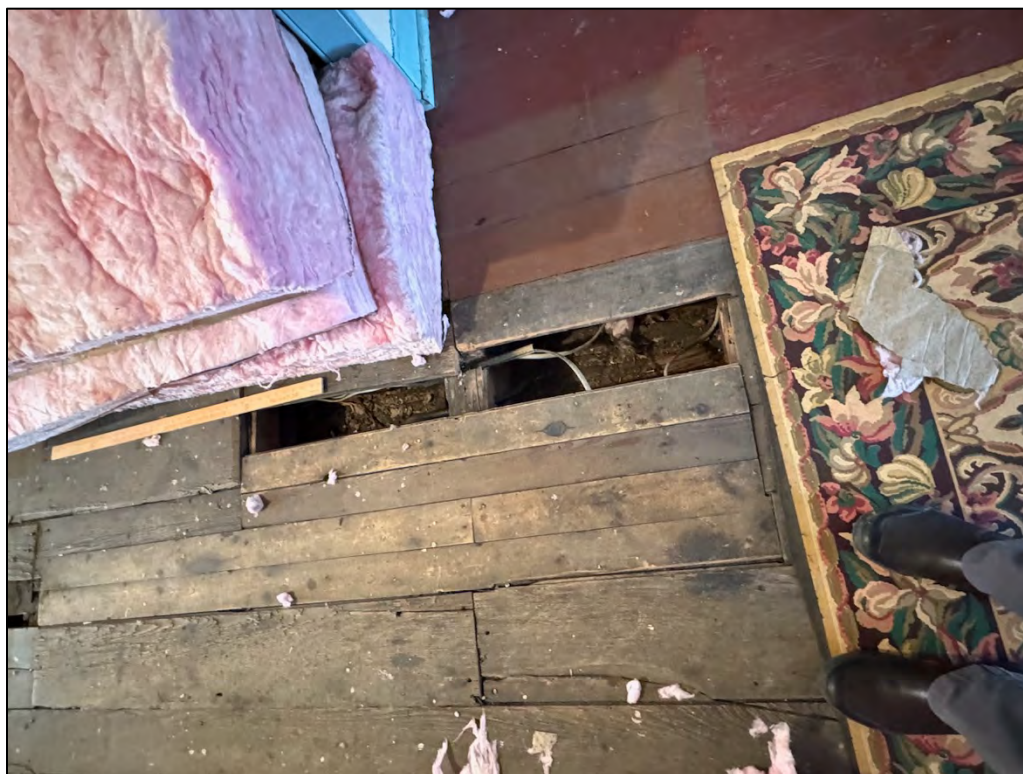
In several areas, the floorboards are missing, exposing joists and accumulated debris representing long term dust and material build-up. Exposed electrical wiring is visible along portions of the ceiling and within the floor framing, raising safety and code compliance concerns.

*Plate 344. Attic floorboards.*

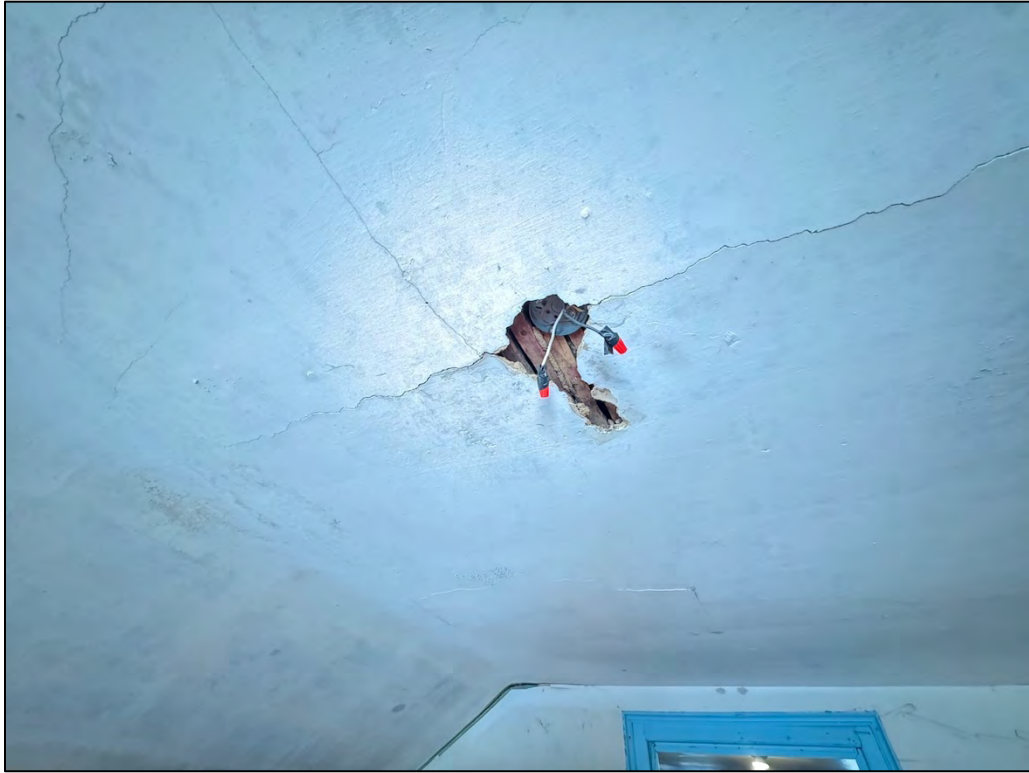
*Plate 348. Electrical outlet on ceiling.*

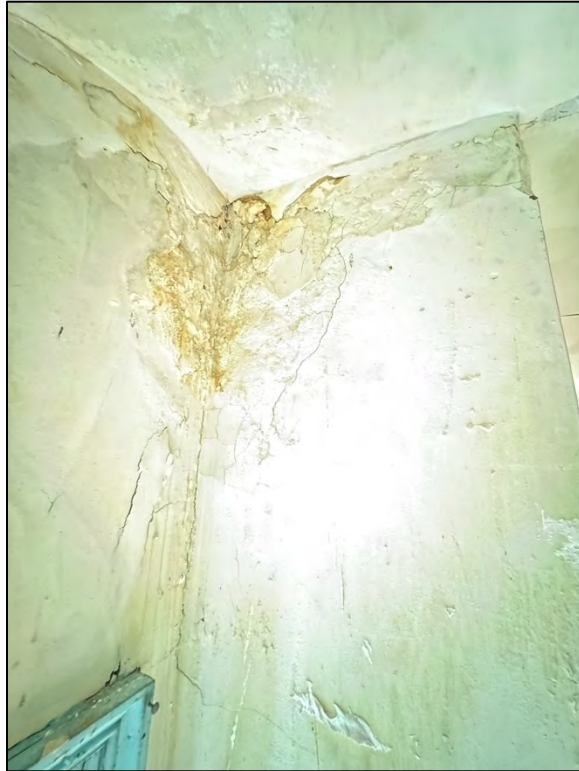
*Plate 350. Plaster walls facing southwest.*

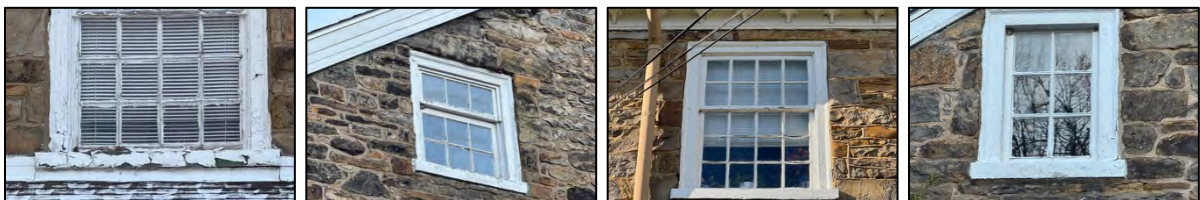
- 1. Exterior Window Rehabilitation.** It appears as though many of the original wood windows have been replaced, either with replica wood windows or vinyl windows. Regardless, the wood windows need to be rehabilitated before they deteriorate any further.

Much of the fenestration on the exterior of the building is in poor condition. It appears that each wood window, except four interior windows (W1-9, W1-10, W1-11, and W1-12) were wood replacement windows with modern float glass (either ca. 1980 or ca. 2020). All wood windows should be rehabilitated or replaced in-kind. The vinyl windows that are in good condition should be retained until the end of their serviceable use; however, no new vinyl windows should be installed in the building. Wood windows are most appropriate, although aluminum clad wood windows with simulated divided lights may be appropriate in some instances. See Table 3 for list of proposed window treatments.

To repair the wood windows, carefully remove all loose, cracking, chipping, and flaking paint from all wood sashes, muntins, and sills. Prepare all surfaces thoroughly by sanding and cleaning, ensuring a sound base for new coatings. For areas exhibiting rot, carefully remove all decayed wood. Treat the remaining sound wood with an appropriate wood consolidate to strengthen it. Repair or patch these areas using Dutchmen repairs with new wood matching the original species, grain, and profile, or use epoxy wood repair compounds for smaller areas. Where rails and stiles are separating, realign and re-secure using appropriate joinery techniques, such as epoxies, dowels, or screws, ensuring the sash operates correctly. Carefully inspect all window glazing. Remove all deteriorated glazing putty and re-glaze with new, historically appropriate glazing compound, ensuring a tight seal for all glass panes. Replace missing elements to match existing. Historic wood should be repaired, then have a high-quality, breathable exterior primer applied to the wood, followed by two finish coats of historically appropriate exterior paint. The new paint should match the existing or documented historic color and sheen. Inspect the interface between the window frames and the surrounding masonry or cladding. Remove any deteriorated caulk or sealant and apply new, flexible, and paintable exterior sealant to prevent water infiltration around the window openings.

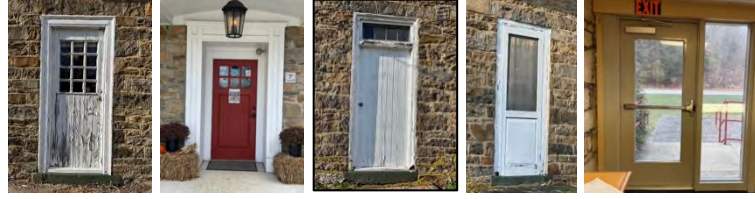
- 2. Exterior Door Rehabilitations.** None of the exterior doors are original to the building; the three doors on the east elevation of the Kingston House were replaced circa 1980. The west elevation door appears to be a circa 2020 fiberglass door while the Postcard Corridor exterior door is constructed of metal framed glass. Each door (except the Postcard Corridor Door) appears to suffer from wood rot and is allowing moisture and possibly vermin to enter the building. The doors should be either rehabilitated or replaced to match existing or historic.

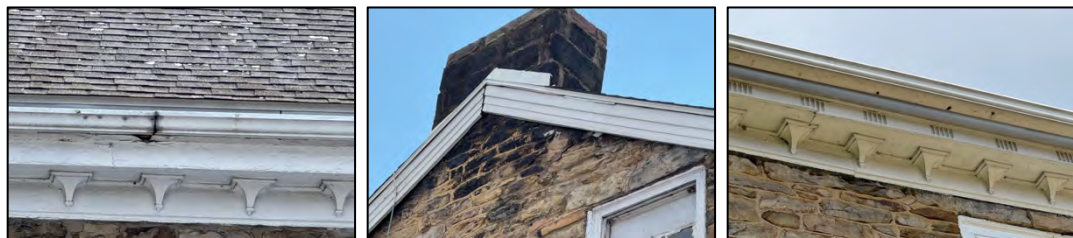
3. **Soffits, Fascia and Cornice Rehabilitation.** Weathered wood, flaking paint, and areas pulling away from the building require repair and repainting to prevent moisture intrusion and further deterioration.

Before repairing the soffits, fascia or cornice, ensure that all moisture issues are corrected. Determine if flashing is necessary near the gable/chimney junction. Distinguish between sound wood, repairable deterioration and sections beyond repair. Carefully remove loose and failing paint using the gentlest means possible. Treat deteriorated areas with a wood consolidate. Repair localized damage using dutchman repairs with new wood matching the original in type, texture, profile, dimension and finish. Ensure all historic profiles and configurations are retained. Prime all bare wood with a high-quality paint, apply two coats of compatible exterior paint. Follow guidance in *Preservation Brief 10: Exterior Paint Problems on Historic Woodwork*.
