# CONDITION ASSESSMENT REPORT

## THE LINCOLN HIGHWAY HERITAGE CORRIDOR

3435 State Route 30 East  
Latrobe, Westmoreland County, Pennsylvania

Abbreviated  
Condition Assessment Report  
Alexander Johnston's "Kingston House"

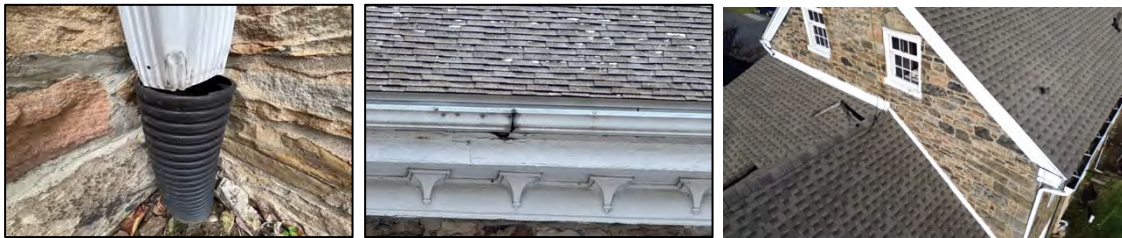
Deteriorated gutters and missing downspout sections are directing water onto siding and foundation areas, contributing to moisture-related deterioration. Replacement and proper reconnection to drainage systems are essential to protect the building envelope. Instead of K-style aluminum gutters, consider a half-round gutter and a round downspout (galvanized, or galvalume with a factory-finished matte/low-gloss coating in a historically appropriate color, perhaps dark bronze or grey). Gutters

should be attached to fascia where feasible, minimizing penetrations and avoiding damage to the historic cornice and stone. Downspouts should be extended outward away from the foundation.

Also consider increasing the size of the gutter to a 6-inch width; the amount of rainwater and storm intensity coming from climate change may warrant this alteration. Also ensure that gutters are properly connected to the downspouts or add downspouts where needed.

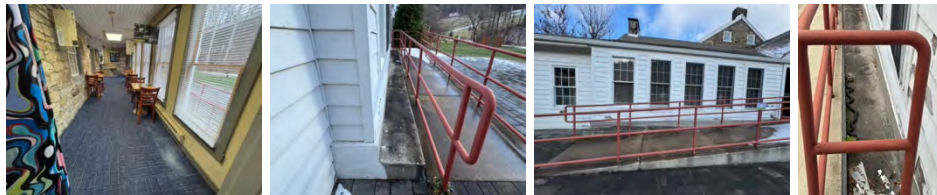
- 5. ADA Ramp and Water Infiltration at the Postcard Corridor.** Water intrusion at the interface between the concrete slab and the wood-clad wall is causing persistent moisture, mold, and interior deterioration. Immediate sealing of slab cracks, joint failures, and installation of appropriate flashing or re-sloping is necessary to prevent continued infiltration. Redirecting the discharge from the southwest downspout may also help reduce the moisture in this structure. Additionally, a vapor barrier may be needed to be installed beneath the carpet tiles.

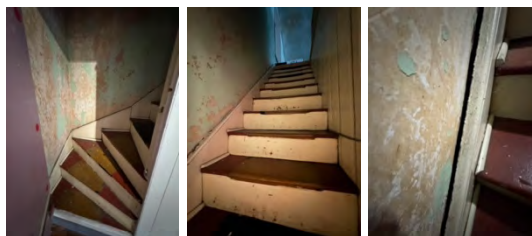
- 6. Structural Investigation of Stairs Between Ship Room and Storage Room #2.** Although they feel sturdy, the winder stairs between the Ship Room and the Storage Room #2 appear to be pulling away from the wall. A qualified structural engineer should assess the condition of the stair structure and provide recommendations to secure and rehabilitate them.

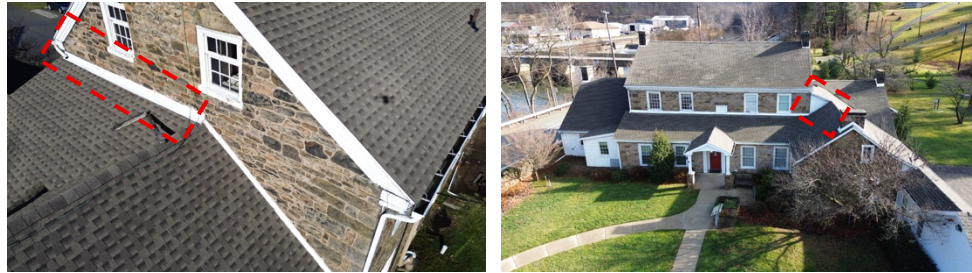
- 7. Investigate Flashing Where Original Building Connects to Postcard Corridor and Tot Room.** This issue may already have been addressed when the roof was

resheathed, however, the current downspout from the main building discharges onto the Postcard Corridor roof (south elevation). Ensure the flashing is correctly installed on the south elevation as well as on the west elevation near the junction with the Western Ell (Tot Room).

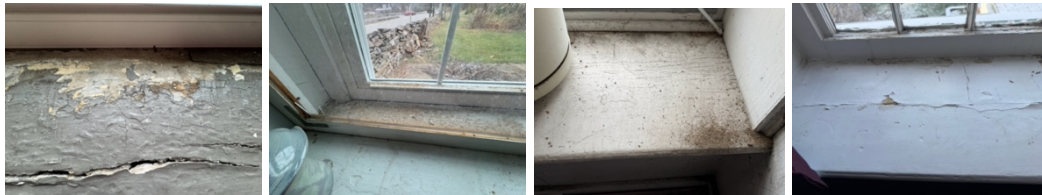
In general, almost all the windowsills within the historic opening exhibit evidence of moisture infiltration, including peeling, cracking and alligatoring paint. Many windowsills exhibit visible water damage, cracks, and flaking paint at the window and sill junction, indicating ongoing moisture issues. Interior storm windows may have been installed in the past, potentially trapping moisture and contributing to localized deterioration of surrounding wood elements, including the pocket shutters.

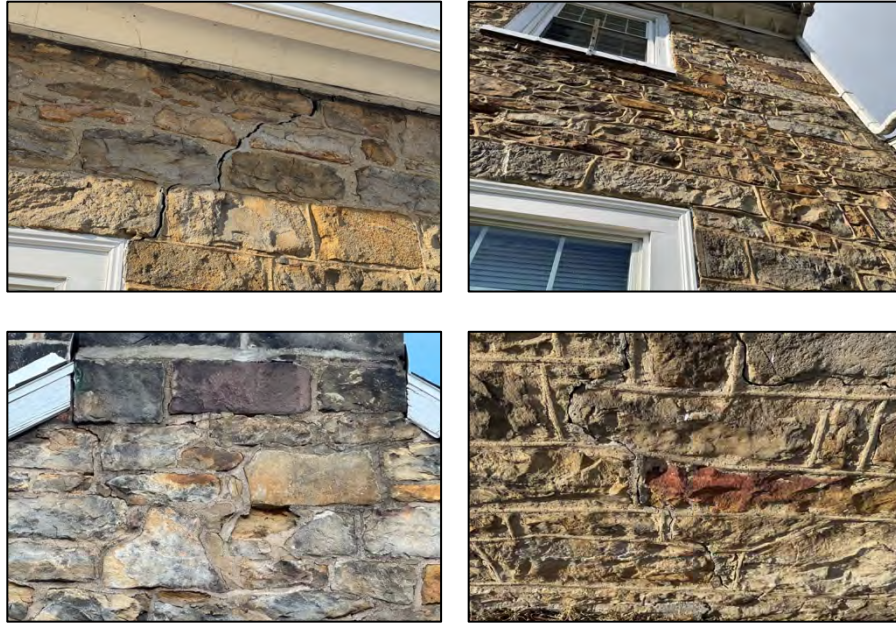
**2.1 Exterior Masonry Rehabilitation.** Localized mortar failure, cracking, and the presence of incompatible Portland cement mortar—particularly on the east, south, and west elevations—are contributing to water infiltration and accelerated stone deterioration. Selective repointing and complete removal of incompatible mortar are required to halt ongoing damage and restore the masonry’s performance.

Using the mortar analysis in Appendix B as a guide, repoint the historic mortar as necessary, using *Preservation Brief 2, Repointing Mortar Joints in Historic Masonry Buildings* by Robert Mack, FAIA and John P. Speweik as a tool. Keep in mind that the mortar must be softer than the stone. Continue to keep vegetation and insects away from the building.

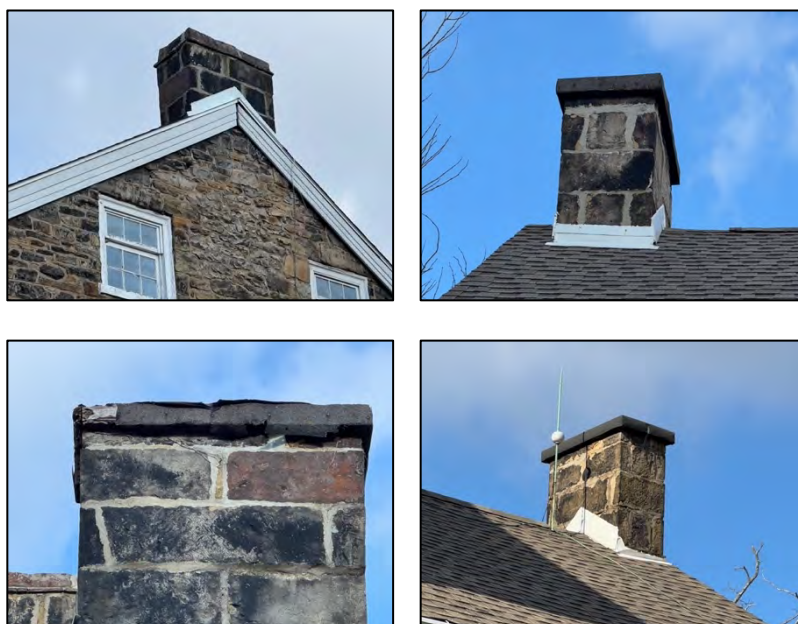
**2.2 Chimney Cap Replacement.** Deteriorated caps, tarpaper coverings, and cracked mortar joints are allowing water infiltration and pose potential safety hazards. Removal of temporary coverings, installation of appropriate weathertight caps, and selective repointing are required to stabilize these features. Additionally, ensure they are properly repointed, so the stones or mortar joints do not crack.

Note: the flues and interiors were not inspected during this site visit and should be evaluated by a qualified professional before considered fully restored and safe for use. The chimneys may also be utilized for future HVAC work, and if so, should still be evaluated and repaired prior to use.

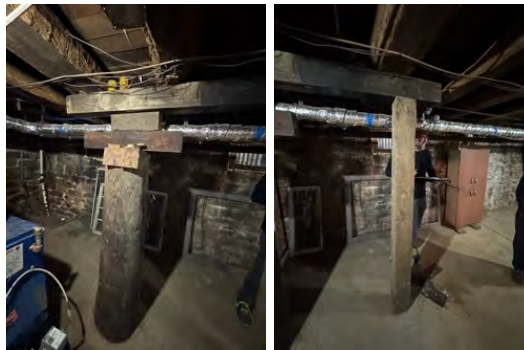
**2.3 Basement Support Column Investigation.** Non-engineered stacked wood blocking and shims at column-to-beam connections present a potential structural concern. Although they appear visually sound, several connections between these columns and horizontal beams include stacked, non-original wood blocking and small shims, indicating later, non-engineered interventions intended to adjust bearing or leveling. A structural engineer should evaluate the adequacy and safety of these supports and to determine necessary corrective measures.

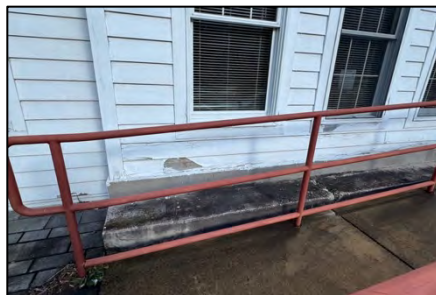
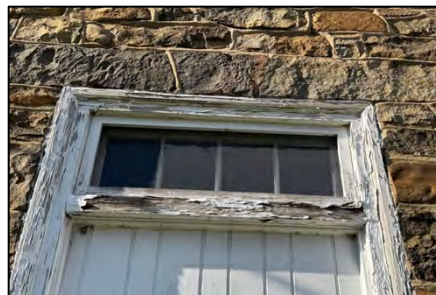
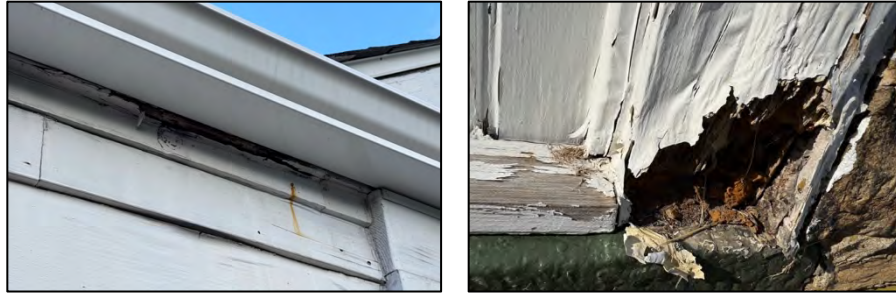
Localized areas of rot, peeling paint, and sediment accumulation—particularly on the west and north elevations—should be repaired and repainted following correction of gutter and drainage issues. Ensure exterior wood does not allow for pests to infiltrate behind the woodwork or infiltrate the building. The wood moldings around the doors and windows, especially on the east elevation, shall be scraped, repaired and painted.

**2.4 Exterior Wood Siding Rehabilitation.** The woodwork to be retained and rehabilitated includes the cornices, fascia, exterior doors and clapboard. Work would include scraping away the loose, flaking paint to the next sound layer, performing approved rehabilitation techniques to repair any damaged wood and then repainting the wood with an appropriate paint. Ensure all brackets and woodwork are structurally sound and secured to the building.

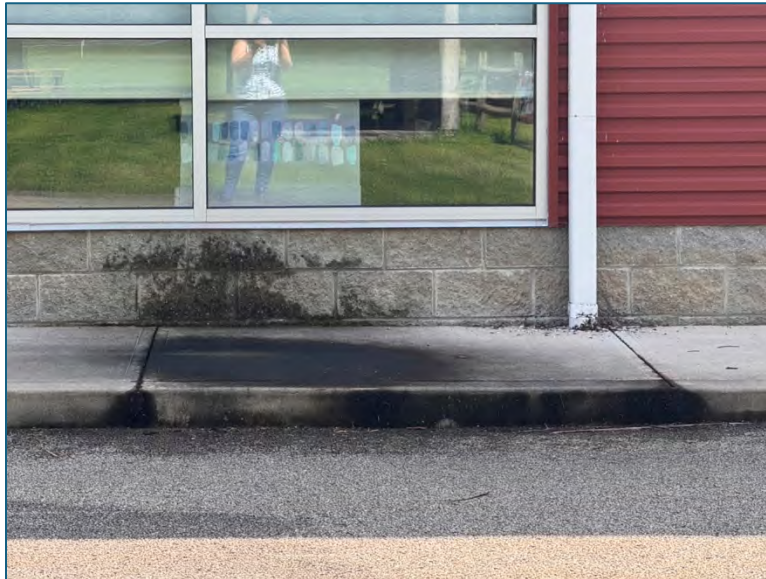
During the building walk-around, organic staining was noted on the west sidewalk near the new museum building. It was noted that the gutter was clogged and organic material was overflowing from the gutter. Additionally, it was noted that a bird's nest was located on the downspout.

*Photo 1. Organic staining on the sidewalk. Note the bird droppings at the base of the downspout.*

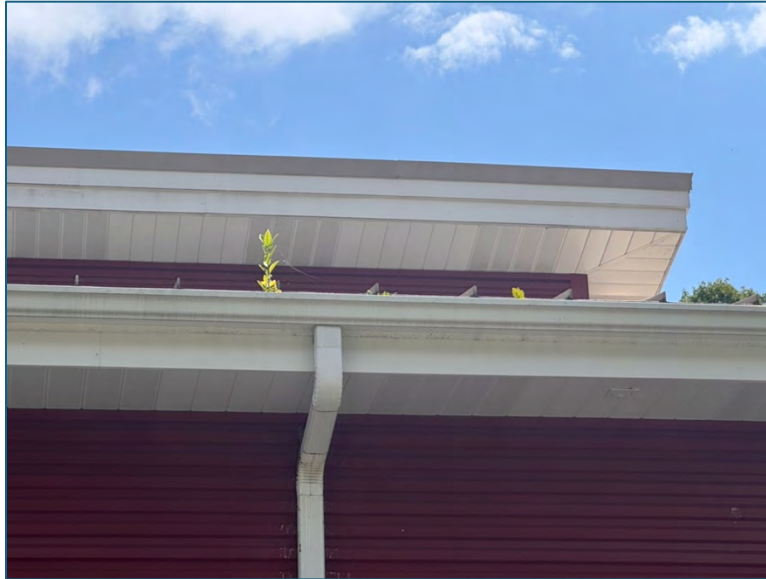
*Photo 2. Gutter on west elevation clogged with debris.*

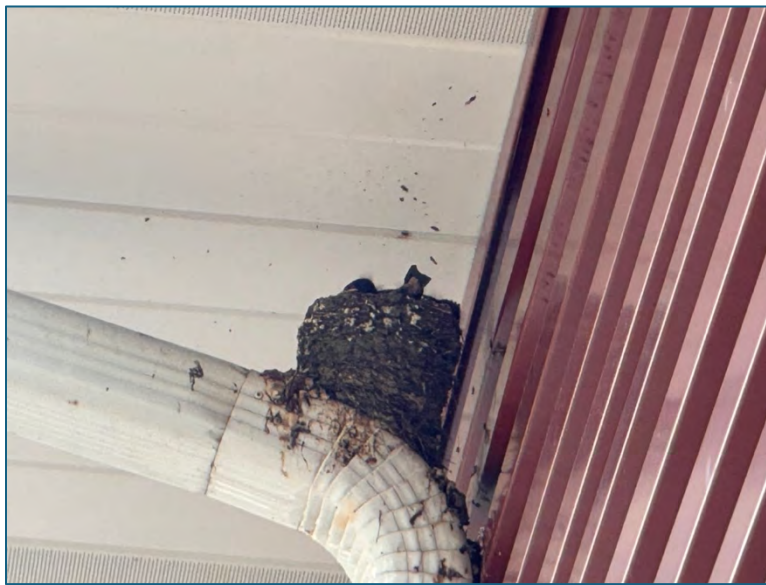
*Photo 3. Evidence of bird's nest on downspout.*

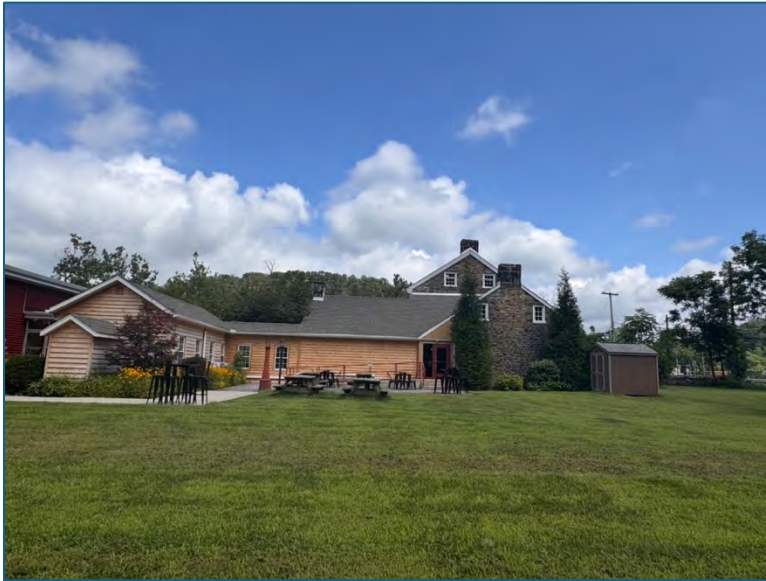
The LHHHC also removed the four windows on the south elevation, repaired the drywall and installed new wood clapboard siding on the exterior. The wall was slightly moved northward to reduce the potential for splash-back. The goal for this effort was to reduce the potential for water infiltration into the building. The introduction of an HVAC system into the Postcard Corridor may also add to moisture problems by having the condensation drain into the concrete well outside the building. Because there are existing cracks, the condensation may cause damage through freeze-thaw actions. Additionally, the exposed concrete should have the cracks filled in to prevent the entry of rainwater or moisture to return into the building and possibly, under the carpeted floor.

*Photo 4. South elevation, facing north. Note the new siding.*

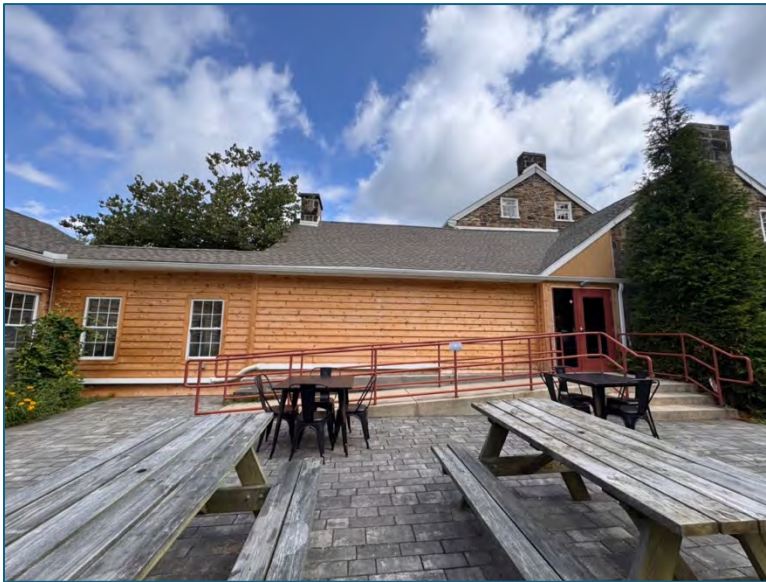
*Photo 5. South elevation, facing north. Note the new siding and the HVAC piping.*

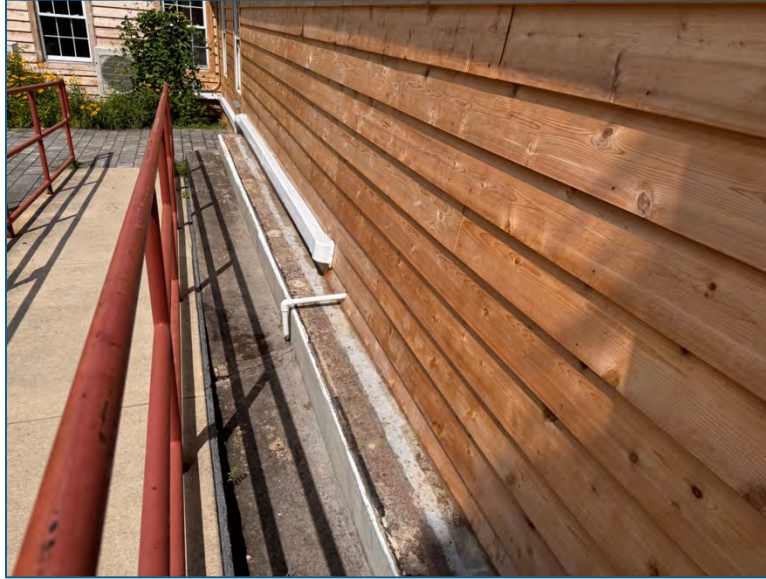
*Photo 6. South elevation, facing west. Note the wall is slightly pulled in, away from the edge of the building. The drain line empties onto the concrete below.*

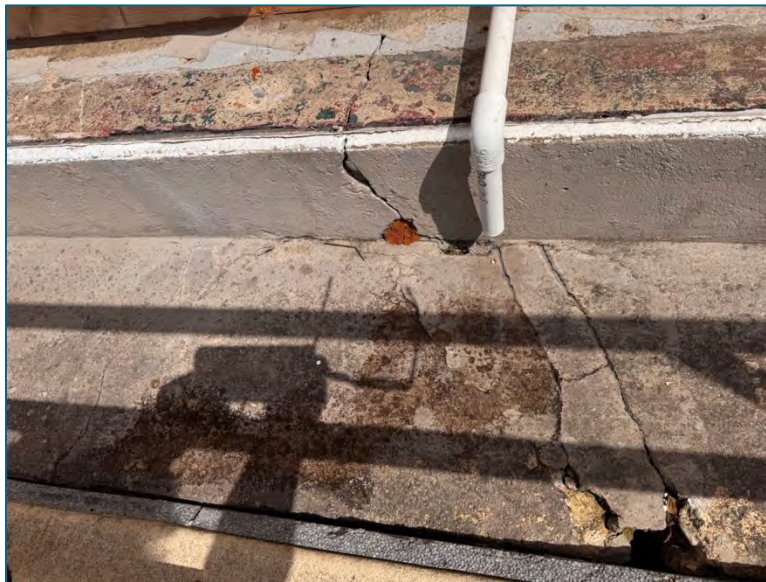
*Photo 7. The drain line is emptying into a concrete basin. This has the potential to cause freeze-thaw deterioration of the concrete.*

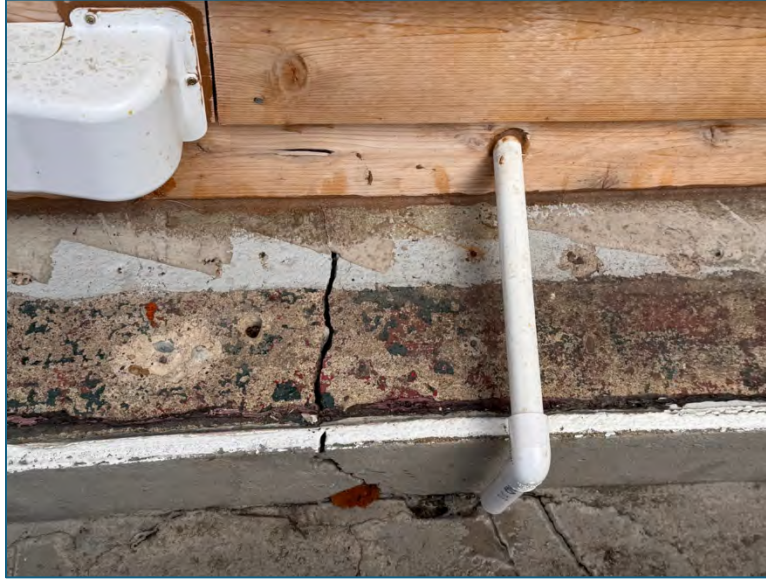
*Photo 8. Note the condition of the concrete wall. The cracks are allowing water to infiltrate the masonry and should be addressed.*

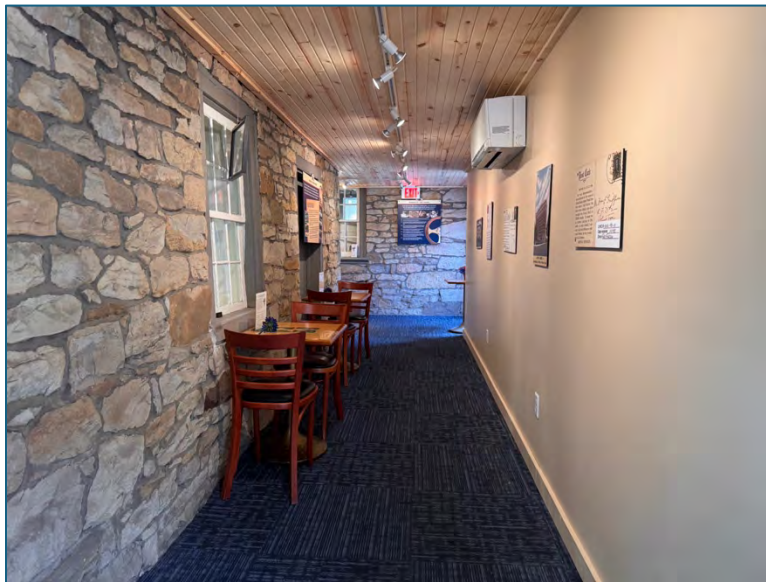
Additionally, the LHC also installed an HVAC system in the Postcard Corridor and the Ship Room. The Postcard corridor system is set into the exterior frame wall and is vented outdoors. The ceiling in the Postcard room was also replaced with a similar beadboard material.

*Photo 9. The HVAC system is placed on the exterior wall in the Postcard Corridor.*

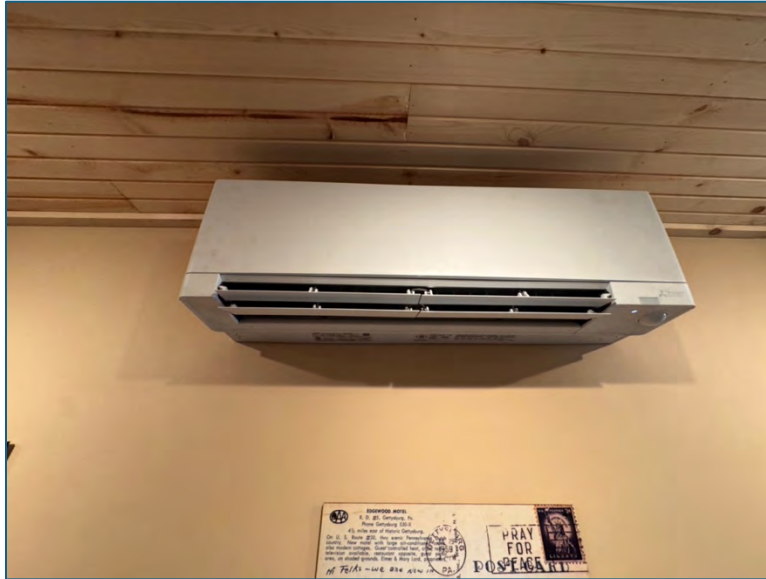
*Photo 10. Detail of the HVAC system in the Postcard Corridor.*

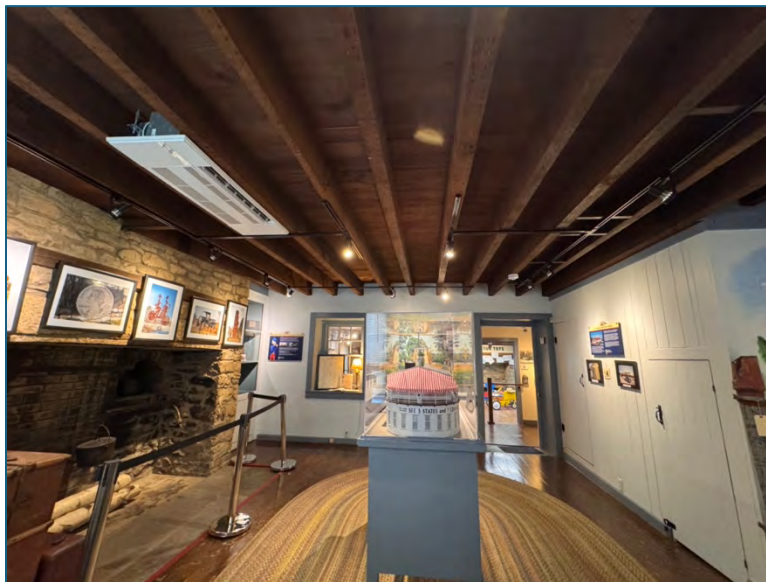
The HVAC system in the Ship room is tucked away within the exposed rafters.

*Photo 11. View of the HVAC system in the Ship room, facing west.*

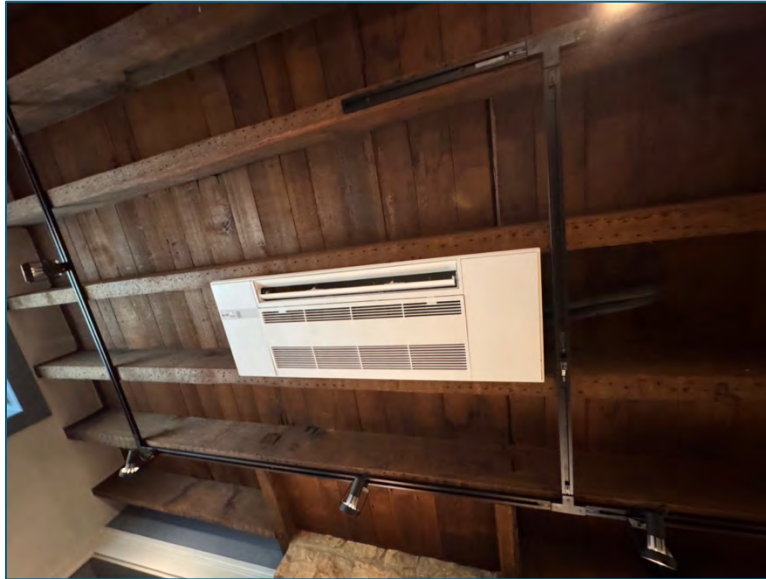
*Photo 12. Detail of the HVAC system in the Ship room.*

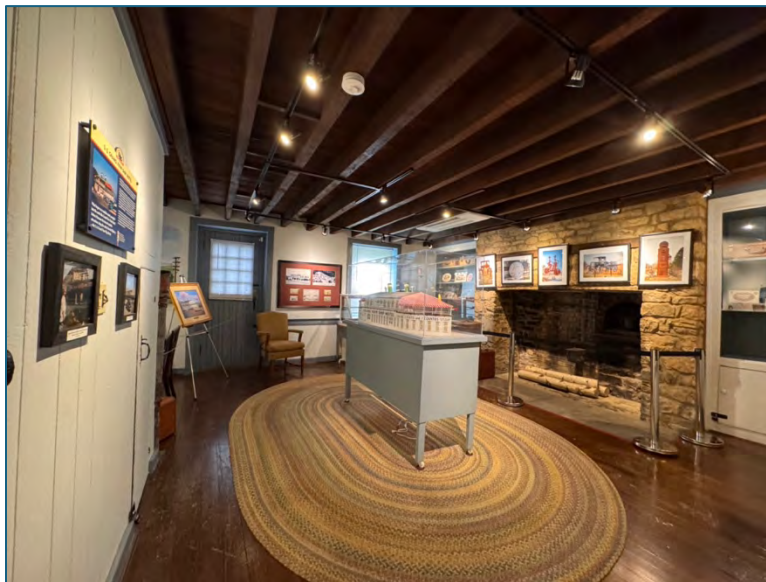
*Photo 13. HVAC system in the Ship room, facing east.*

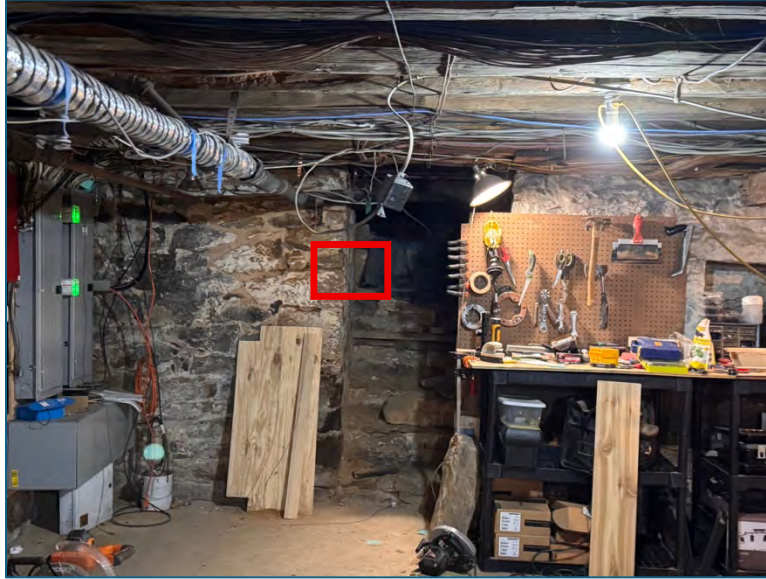
Finally, the Practical Preservation team took another mortar sample from the basement foundation and submitted it for analysis. The results from the conservator's report are included in this addendum, but numerous different mortars were utilized in the basement. The mortar sample became very soft and revealed that portions of the foundation may need to be repointed.

*Photo 14. Sample retrieved from the area highlighted in red.*

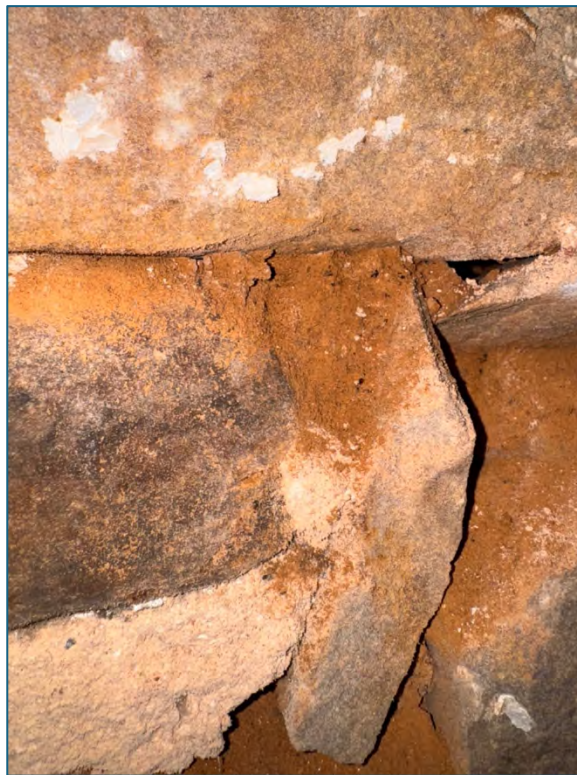
*Photo 15. Detailed photograph of mortar sample site.*
